Stillaguamish Tribal Response Program

Public Record Packet Summary

Lind Property Site Assessment

Assessment date: January 19, 2023

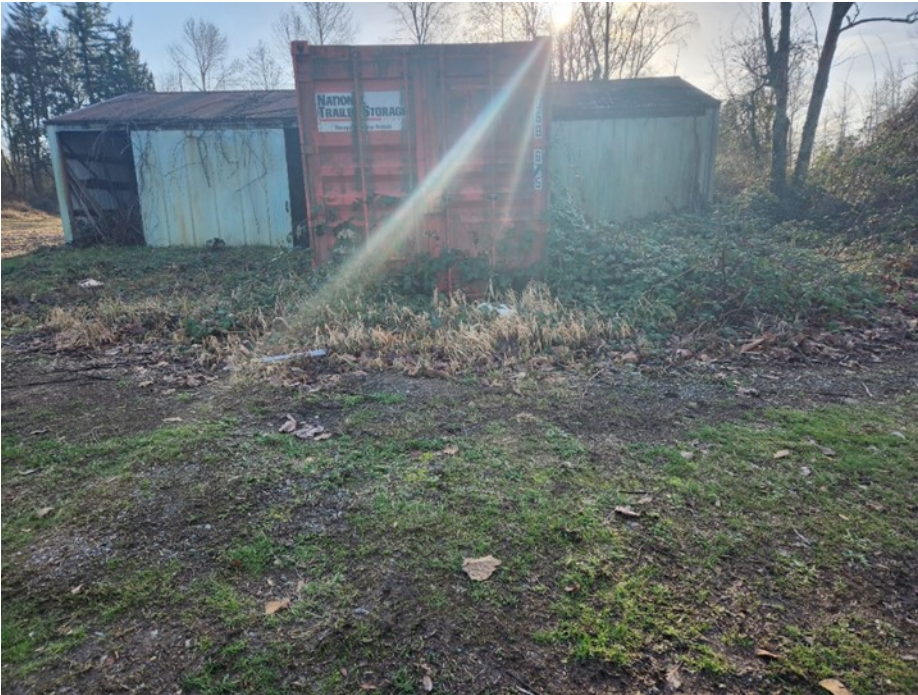
Photo 39: Shingle/shake finishing building, along with a conex storage container.

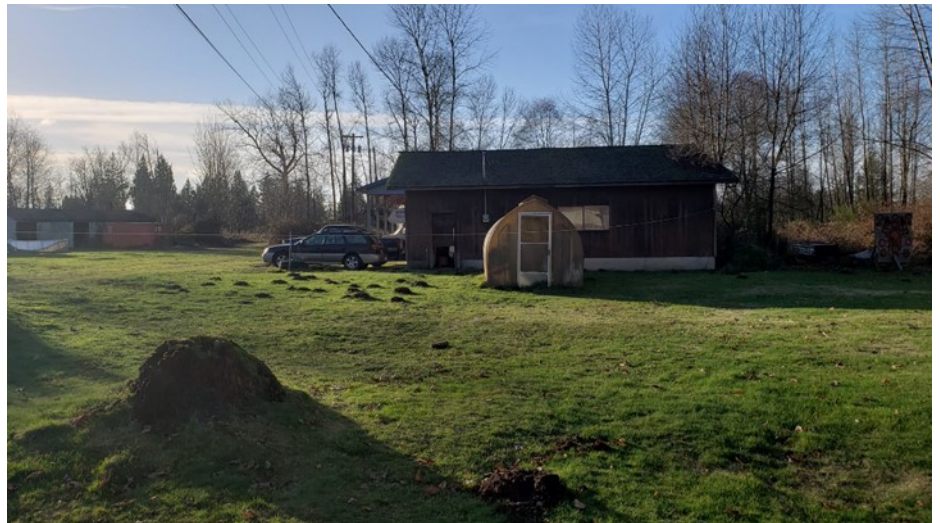
Photo 45: Taken from the 'back yard' of the mobile, looking west. This photo is helpful to gain perspective of the location of other outbuildings of the property.

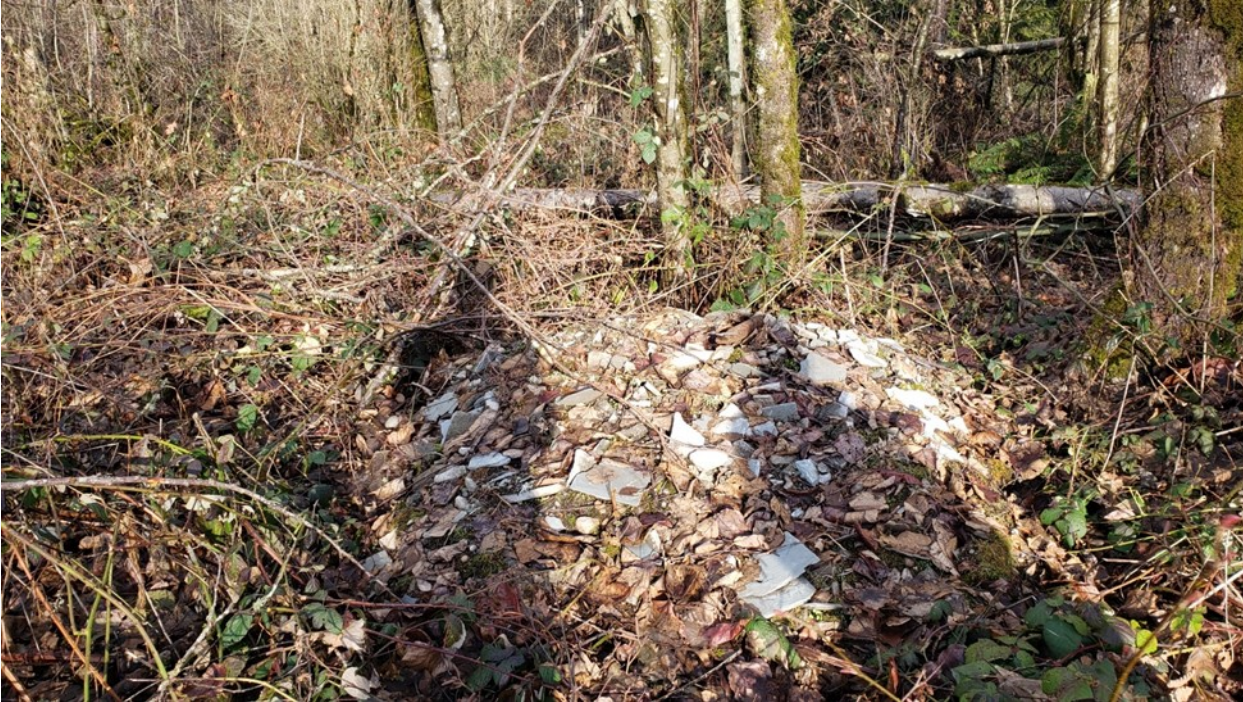
Photo 50: In the forested portion of the property, a pile of tile, slate and concrete was found, down the hill from the mill.

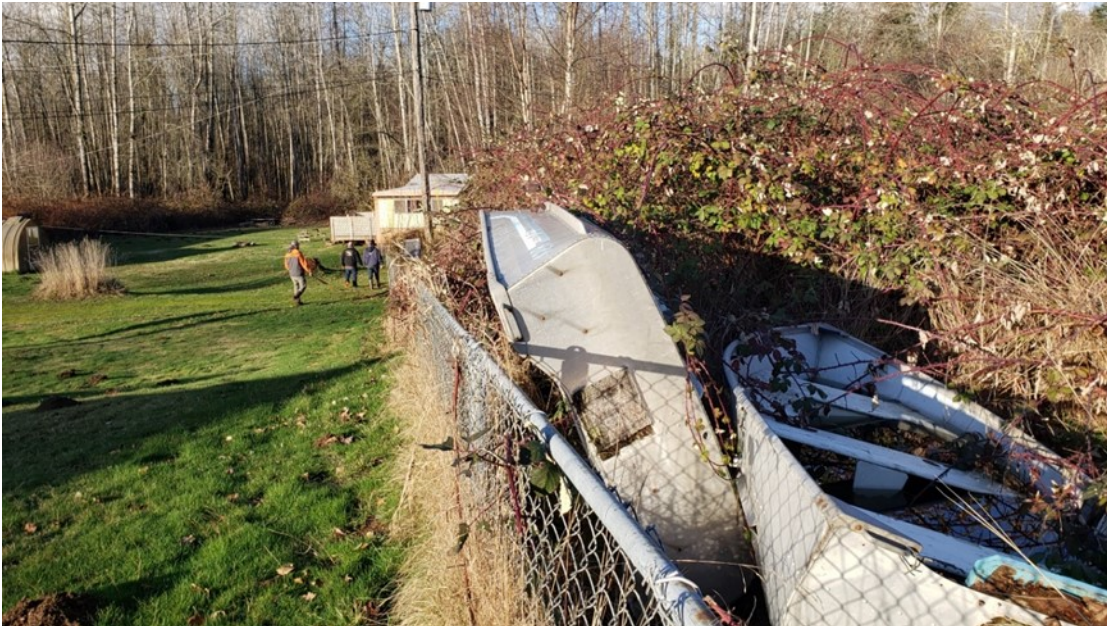
Photo 52: Along the eastern edge of the property, between the main residence and mobile, two boats were found along the fence line.

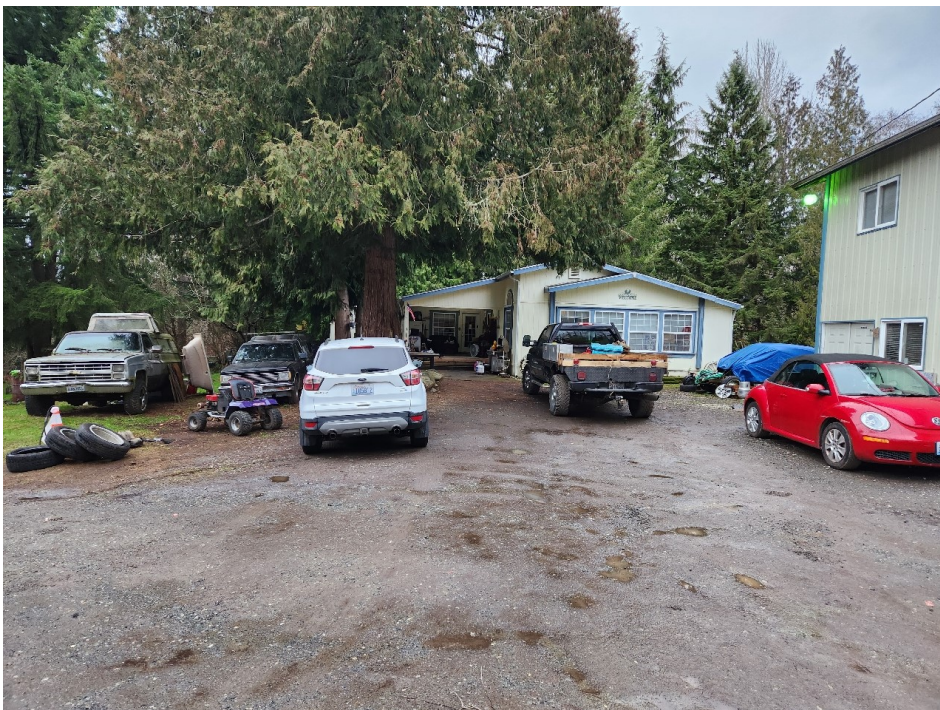
Photo 2 (Map Number 2): The main residence on the property, including a shop with attached apartment. Many broken down vehicles and oil spots were evident in this parking lot. Photo taken looking north.

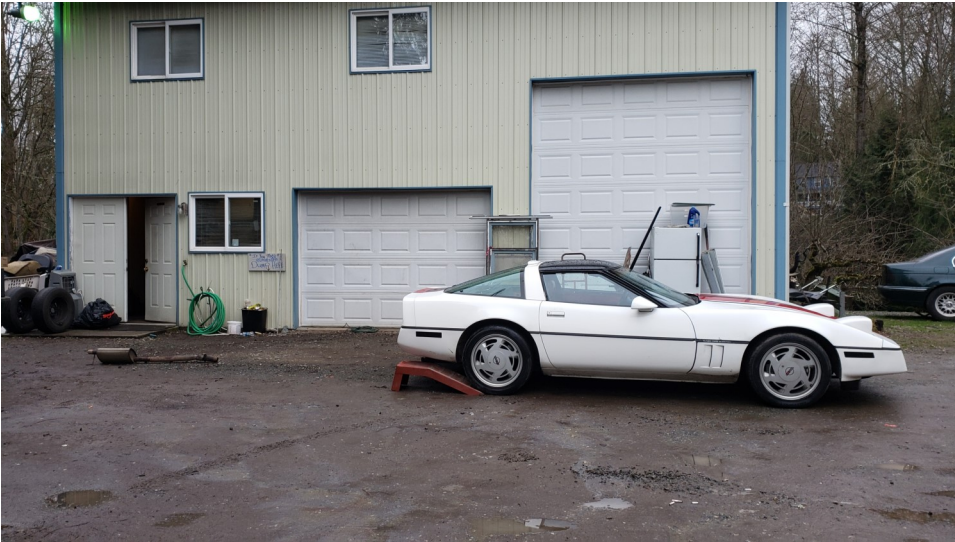
Photo 3: The shop on the property, including the lofted apartment. The current owner uses the shop to fix up older vehicles. There were many oil stains in the parking lot just outside the shop and main residence. The owner gave us access into the shop area, no oil stains or hazmat were clearly visible.

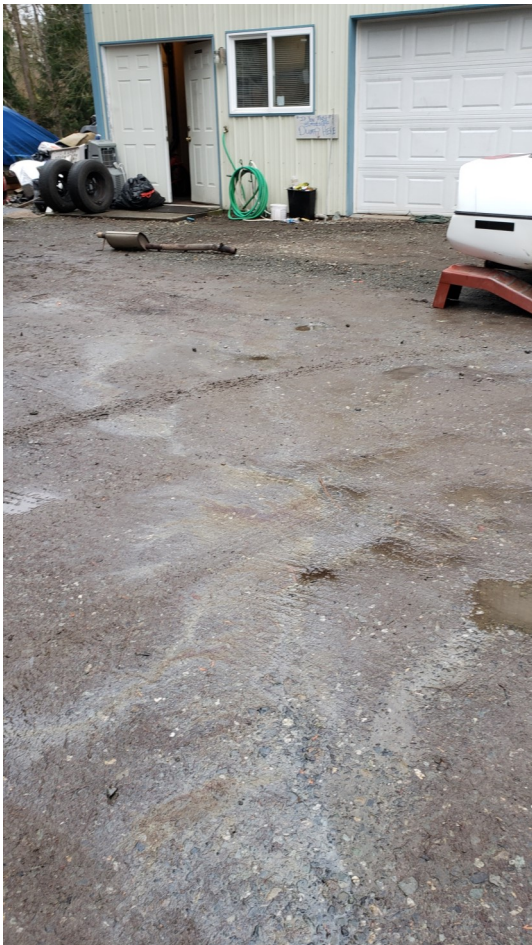
Photo 4: A closer view of the oil spills in the parking area outside the shop.

We recommend that all garbage, refuse, rubbish, vehicles and other items be properly removed and disposed. The black drainage pipe, next to the RV parking, should be further investigated to ensure it wasn't being used to transport black waste. The oil spots around the shop's parking area are unlikely to harbor deep contamination, but should be cleaned up and checked. Soils underneath the various derelict vehicles should be investigated for surface level oil contamination. Otherwise, staff were not aware of any significant threat of oil or HAZMAT contamination. **Low Level of Risk that can be Mitigated.**

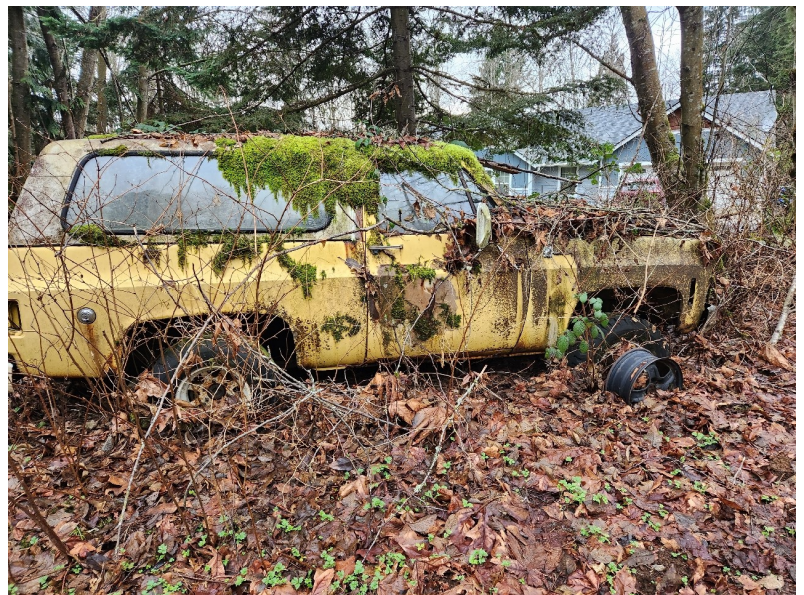
Photo 11 (Map Number 8): A derelict vehicle which has been sitting for years. Staff were unable to assess the substrate for oil contamination, but it could be of concern. However, no oil/gas was smelled. The building in the background is the neighboring property (to the west).

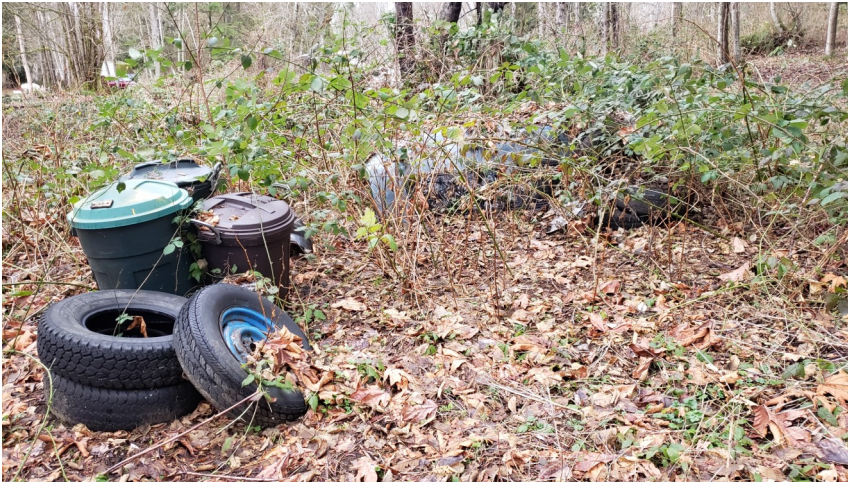
Photo 12: Another pile of tires, garbage cans, and a truck canopy being reclaimed by blackberries were found near the western property boundary.

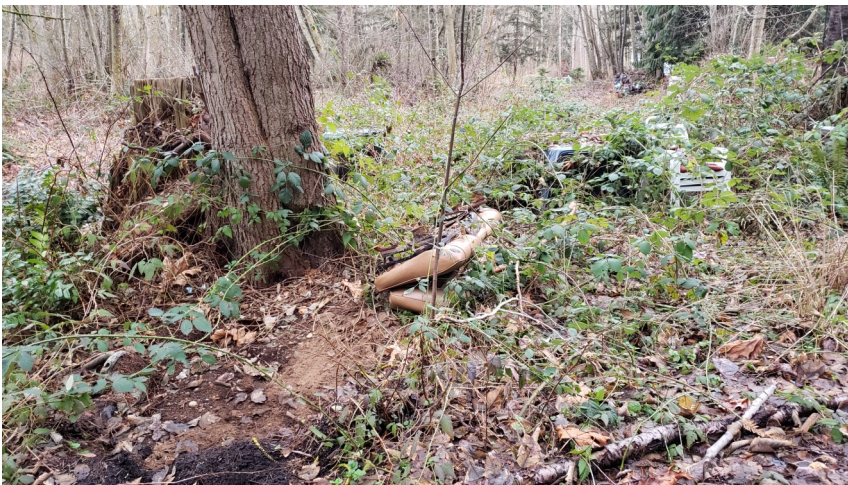
Photo 13: Another pile of rubbish, a car bench seat, and a cleared area. This is just to the north of Photo (12). Photo was taken looking generally west, near the western property boundary.

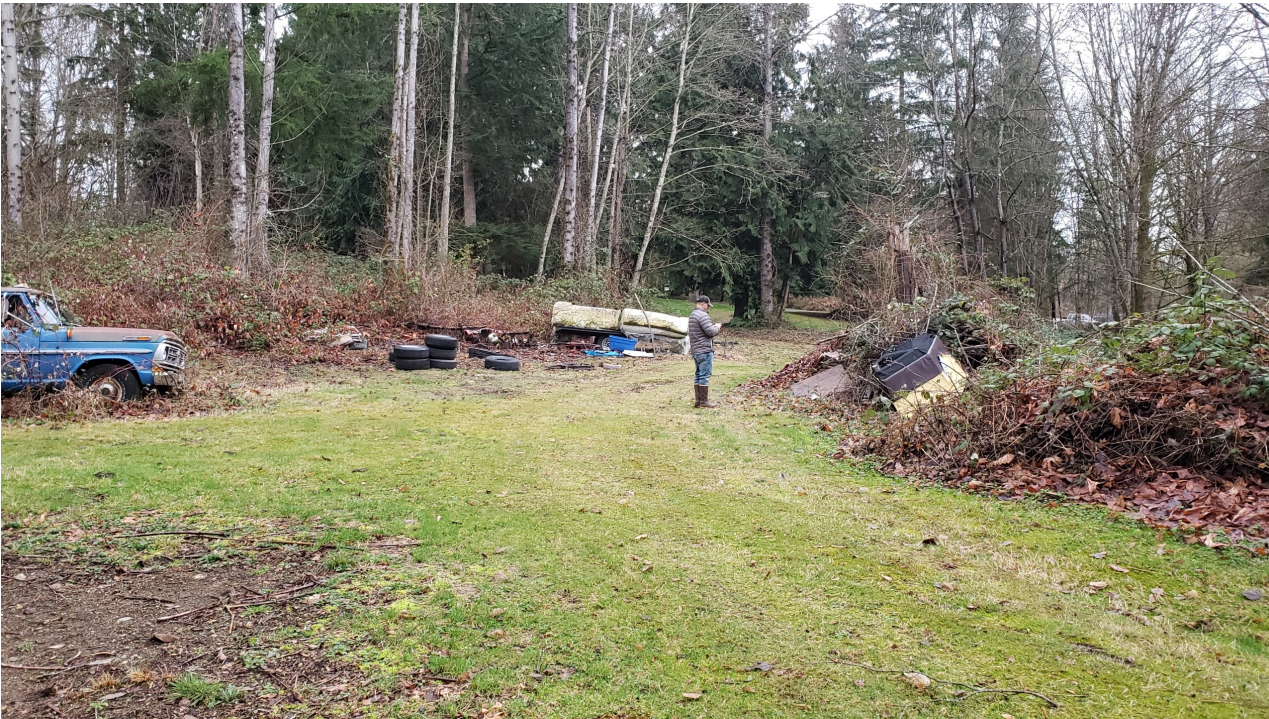
Photo 23: Looking east from the northwest corner of the property, the piles of rubbish seen in Photos (20-22) can be seen in a wider view. Additionally, a broken down truck was also found (no signs of oil contamination). As you head east the northern property line (towards the east) the property gently slopes up back to the main residence.

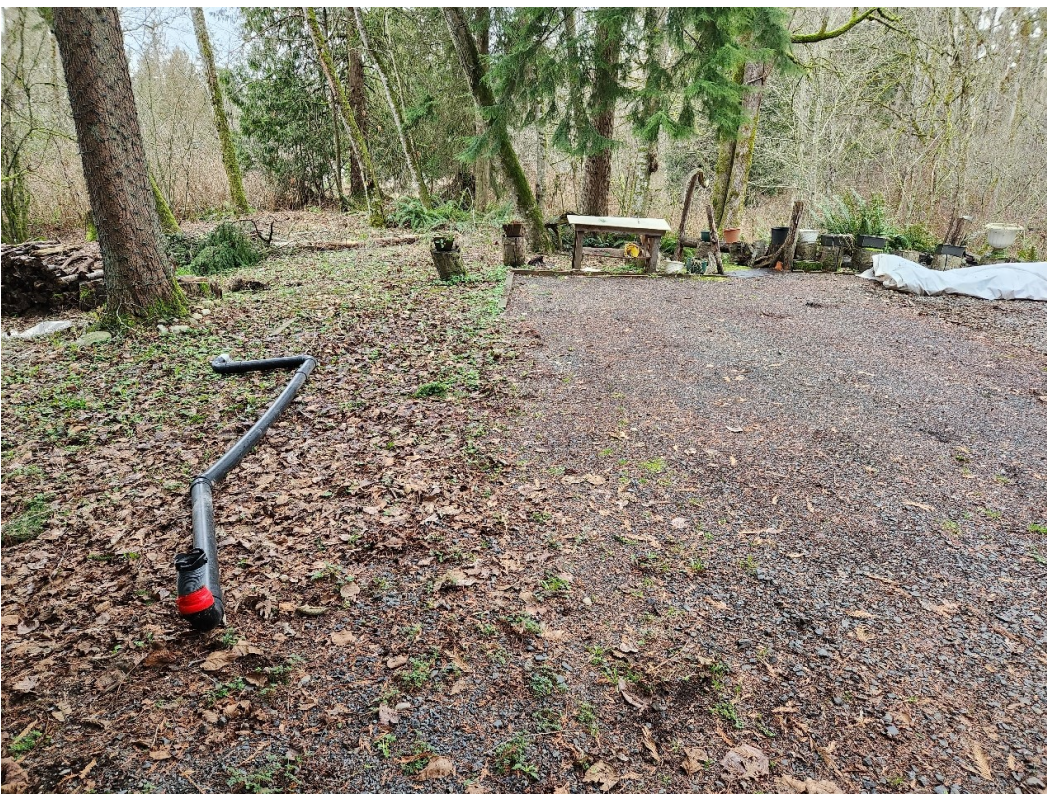
Photo 24 (Map Number 12): A RV/fifth wheel parking area, including water/electricity hook-ups, just northwest of the main residence. A drain pipe was also found, likely for grey water, but we can't say for certain. The pipe terminus was undiscovered. The use of this pipe should be explored further.

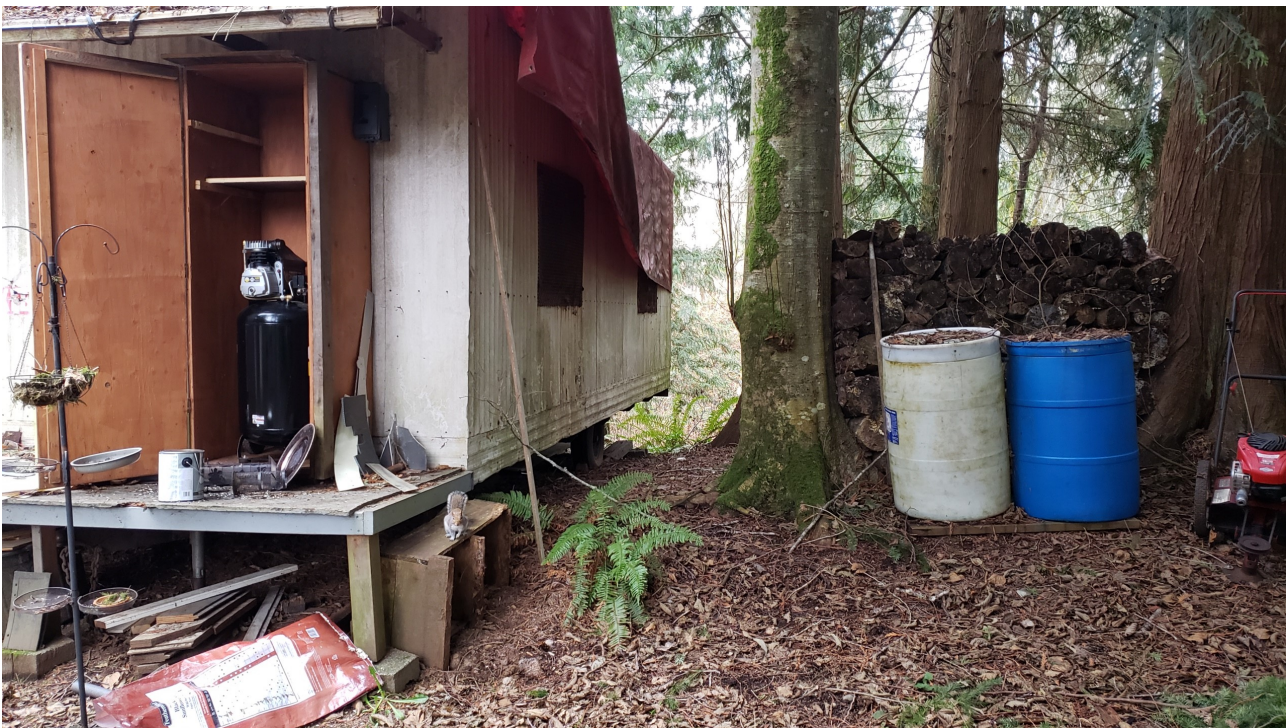
Photo 28: The east side of the mobile. An air compressor and two (empty) 55-gallon drums were found.

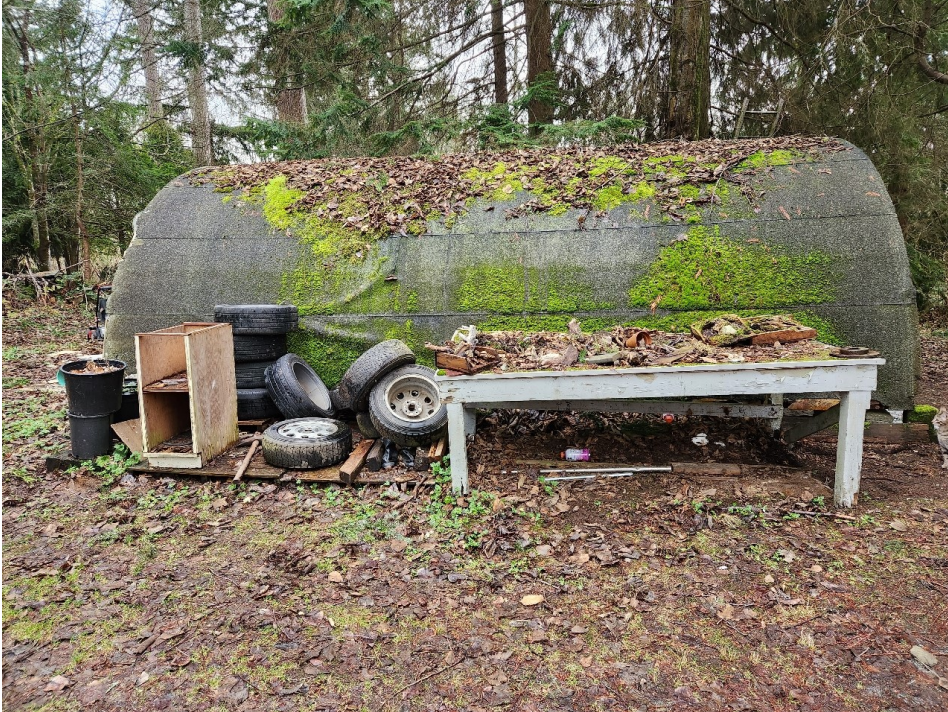
Photo 29 (Map Number 13): Another hoop shed on the property, with tires, household items, and other rubbish surrounding it.

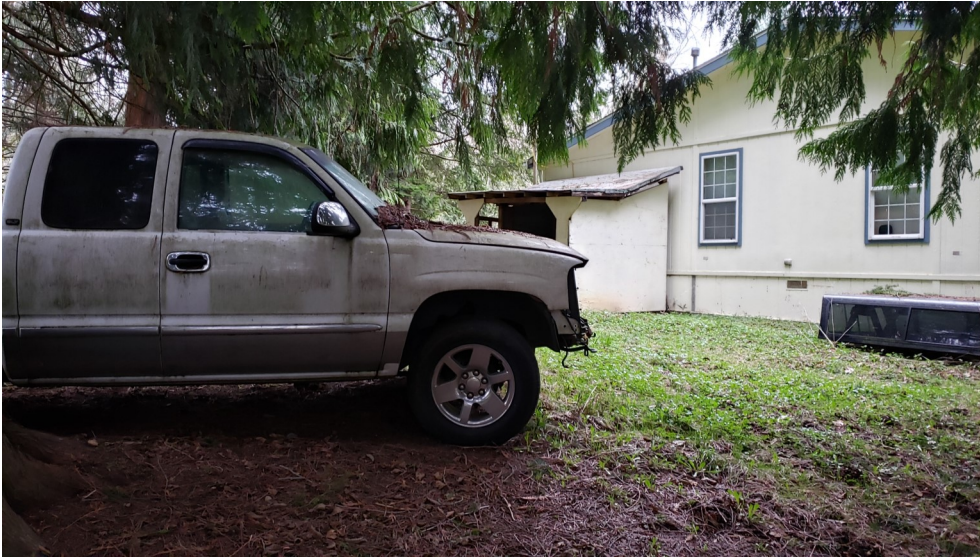
Photo 36: Another broken down truck found on the western side of the main residence. No apparent oil contamination was seen or smelled.

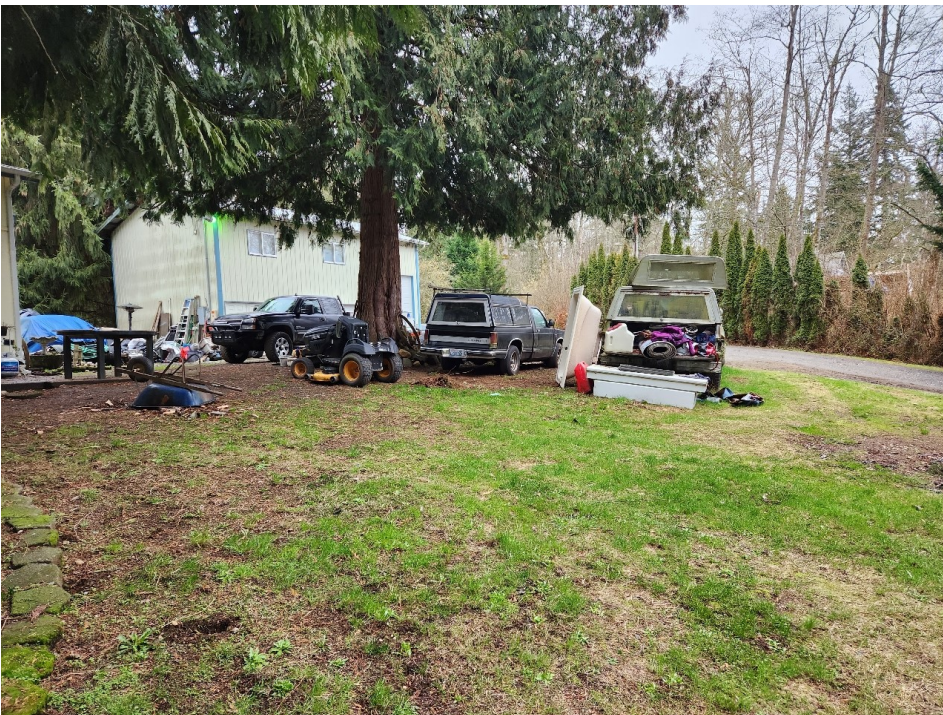
Photo 40 (Map Number 17): The front yard of the main residence, another broken down truck was found. No apparent oil contamination was seen or smelled. Photo taken looking southeast.

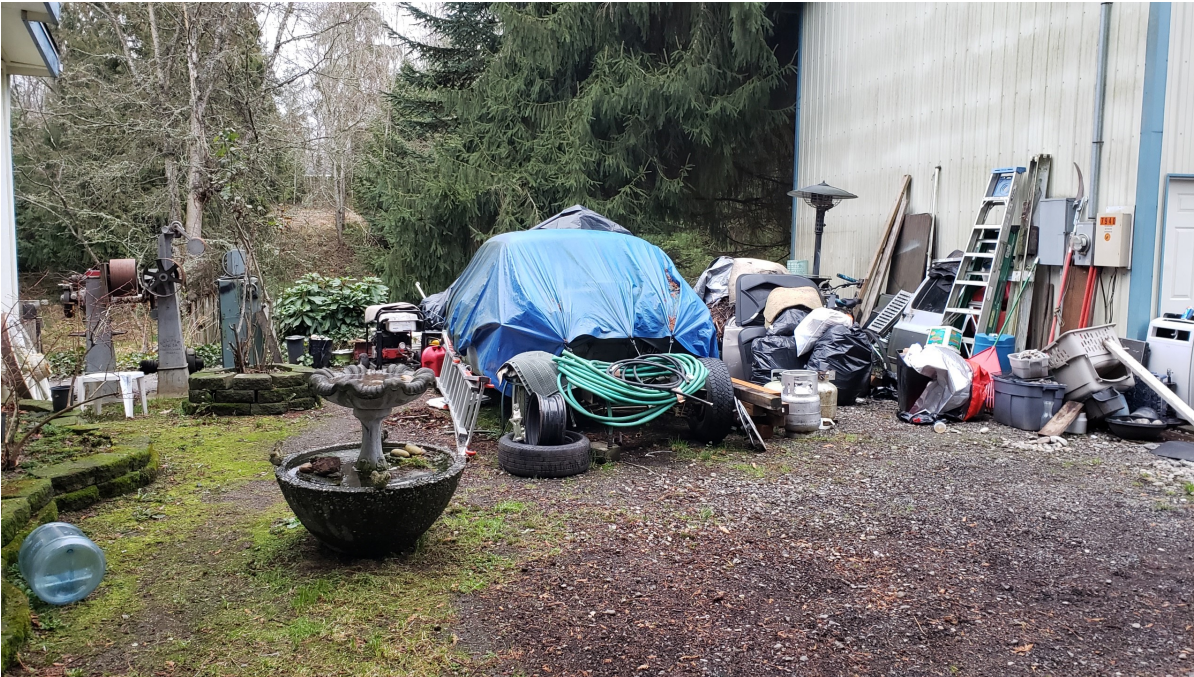
Photo 41: An old vehicle, garbage, and other equipment found between the main residence and the shop. Photo taken looking northeast.

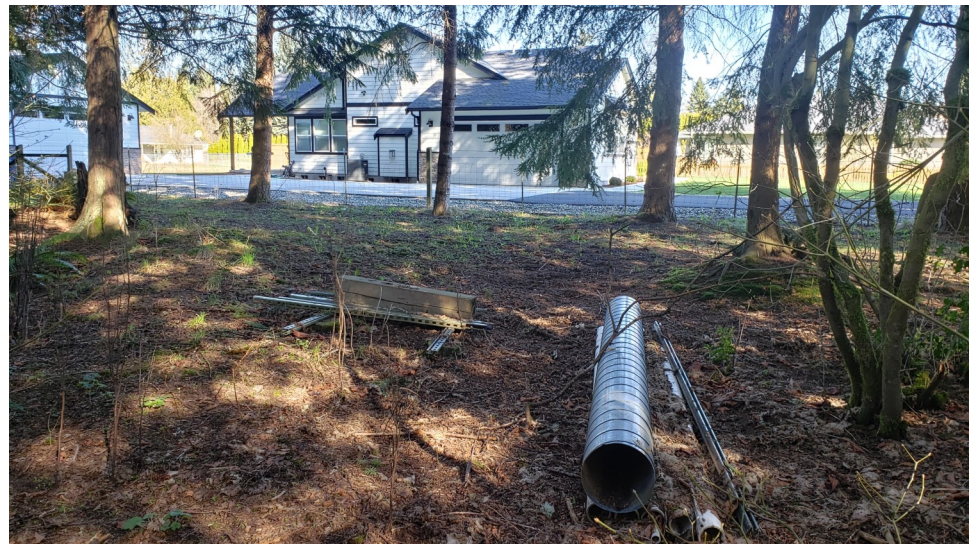
Photo 5: A few 3-4 foot long pieces of dimensional lumber and a large metal pipe, found along the northern property line across from the residence to the north. Photo taken looking north.

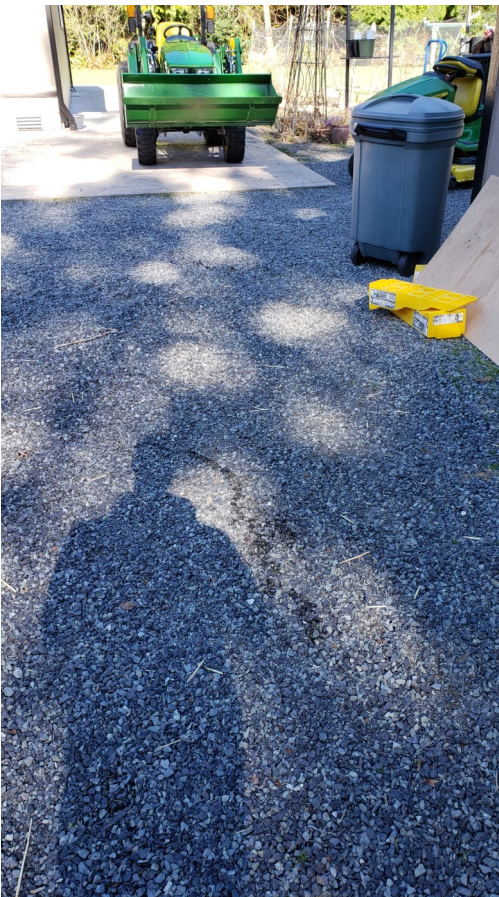
Photo 23: Some small oil stains in front of the garage. Oil appears to be only surface level. Photo taken looking towards the main residence, northwest.

This property was in great condition and doesn't appear to show any significant environmental risks. However, there are some areas that should be given attention and removed, including: the small oil spots in the gravel driveway, the used oil, paint, and radiator fluids, and the various small piles of wood/equipment. If these items are properly disposed of this property shows **No Apparent Risk**.

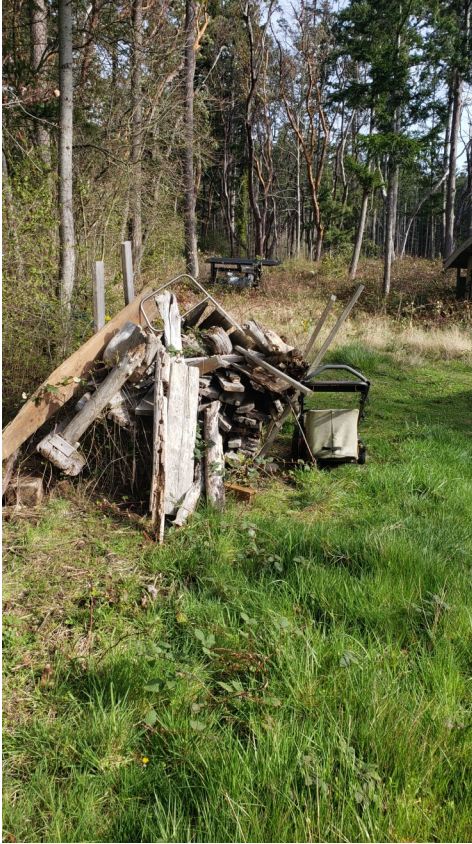
Photo 4: The western property line, looking north. The main residence is just to the right (east) of this photo. A small pile of wood/lumber and trailer was found along the property line.

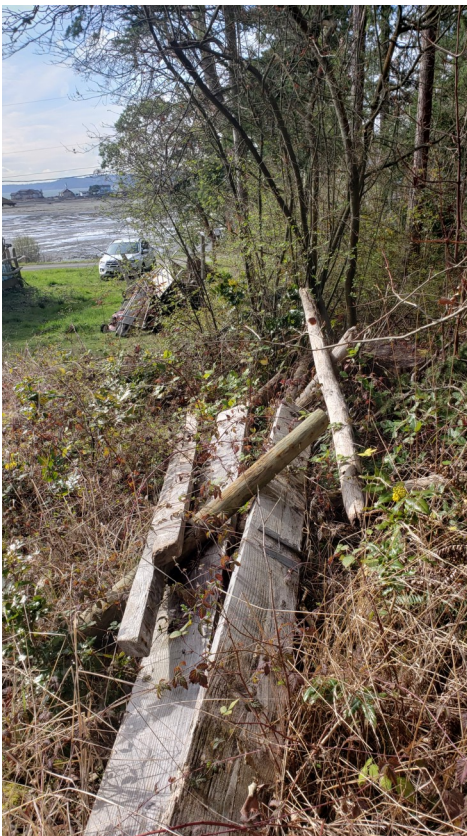
Photo 6: Looking down the western property line and just to the north of Photo (4) another pile of wood was found. Photo taken looking south.

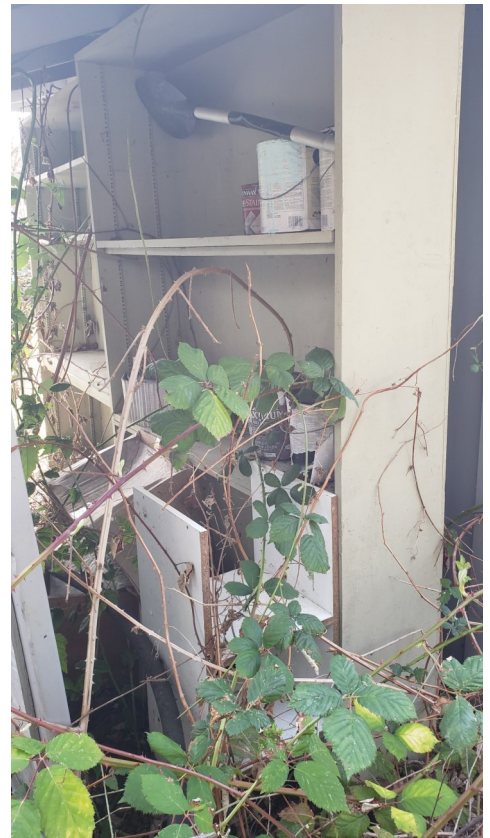
Photo 9: The backside (north) of the outbuilding from Photo (6). An assortment of used paint cans and other household materials were found. These items should be properly disposed of prior to closing.

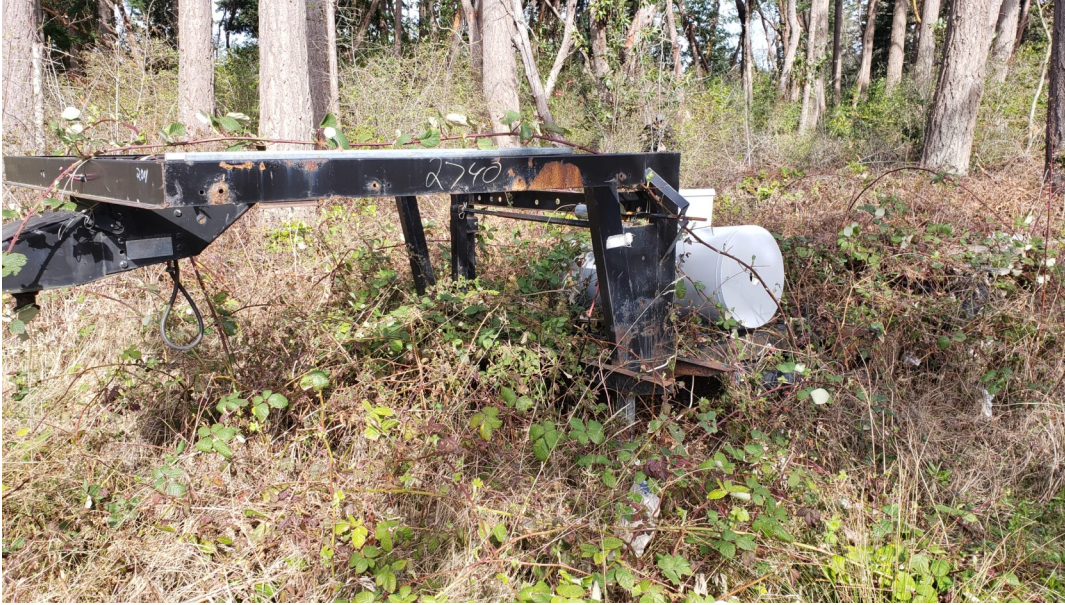
Photo 10: The large gooseneck flatbed trailer on the property, found along the western property line, near the central portion of the property, behind (north) the residence. A tank, toilet, electrical wire and wood was found on the trailer. All of these items, including the trailer, should be removed and properly disposed of prior to closing.

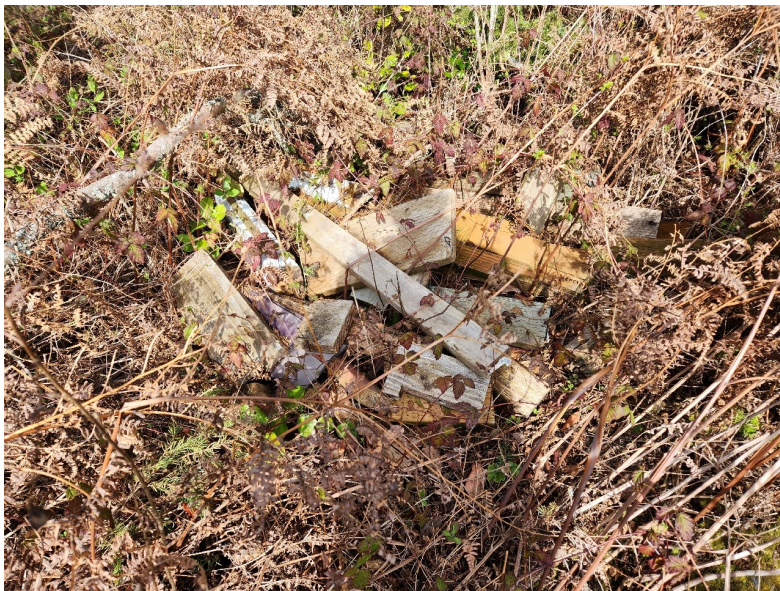
Photo 14: A small pile of wood found near the northern property line.

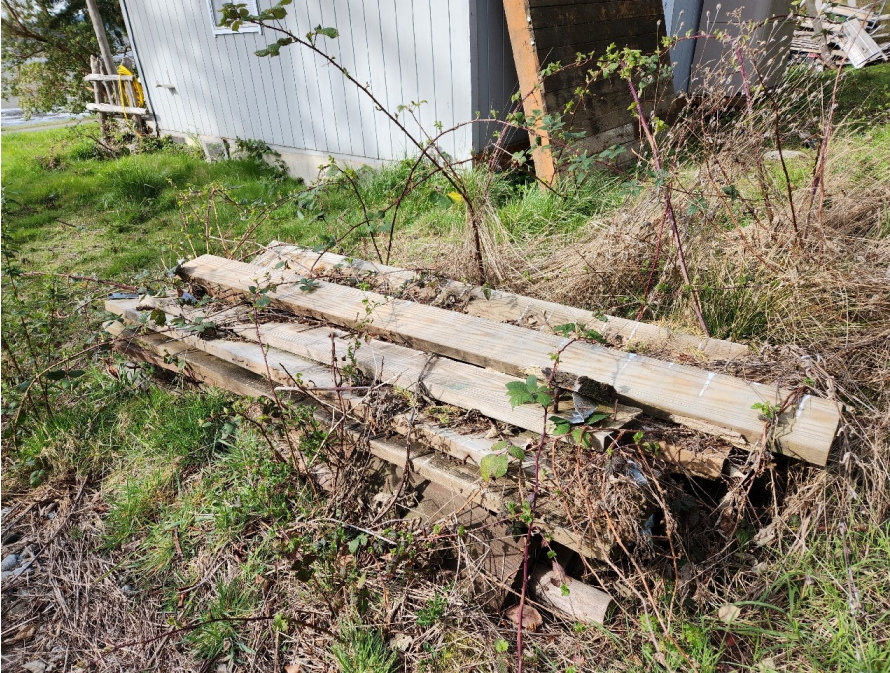
Photo 19: Another pile of lumber found off the northeast corner of the residence. Photo taken looking southwest.

This property was in decent condition and doesn't appear to show any significant environmental risks. However, there are some areas that should be given attention and removed, including: the piles of lumber, corrugated metals, trailer and trailer items, paint cans, and other household/outdoor material and equipment strewn throughout the property. If the above items can be disposed of, this property shows **No Apparent Risk**.

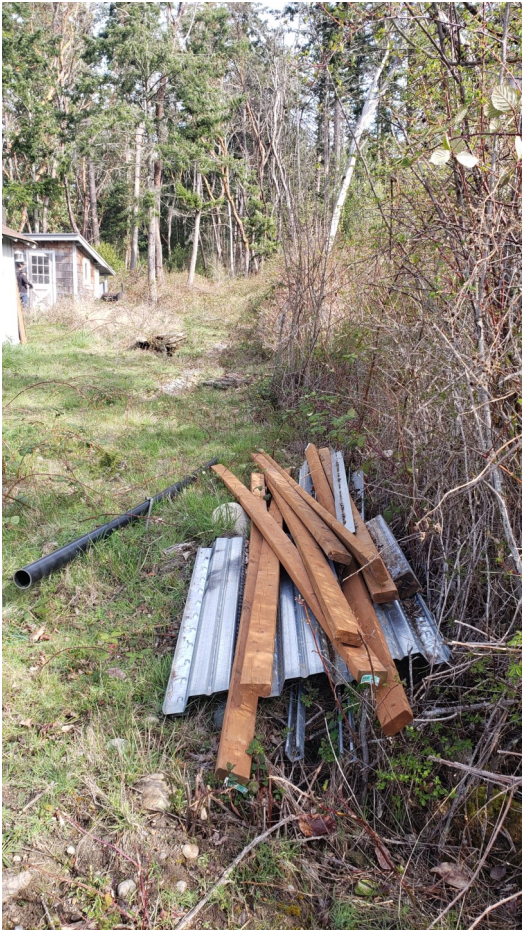
Photo 21: Another pile of lumber and corrugated sheet metal found along the eastern property line, just to the east of the residence. These materials should be removed prior to closing. Photo taken looking north.

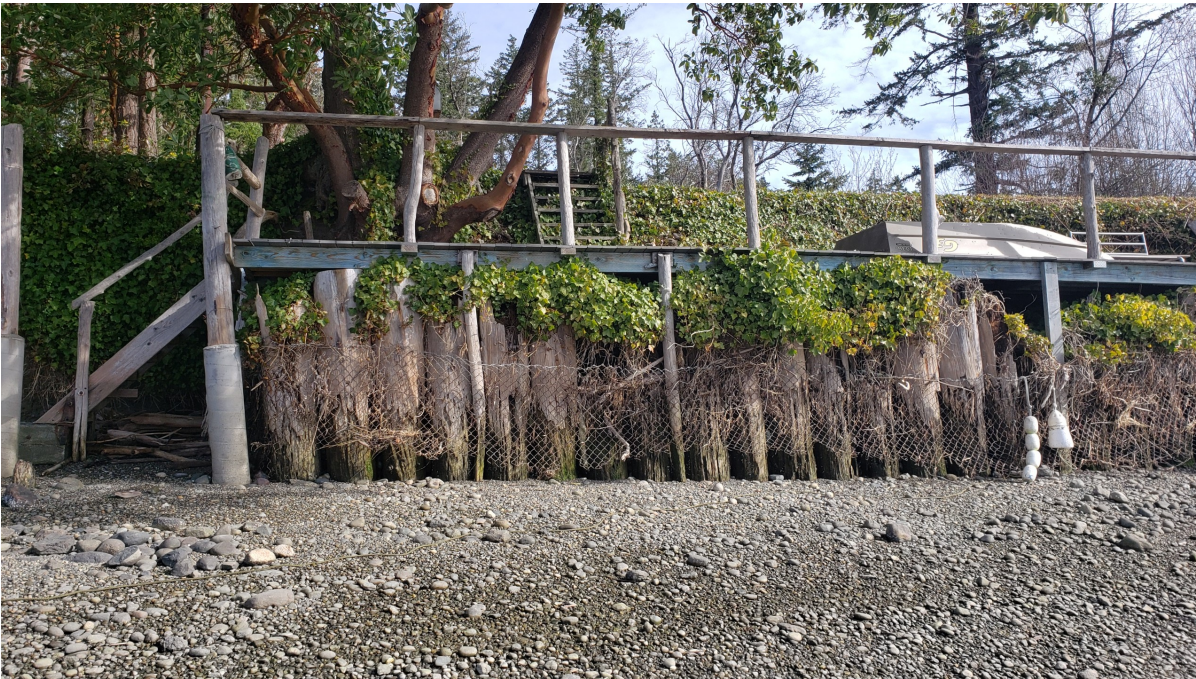
Photo 24: The steps and deck, looking north from Triangle Cove. The left (western) side of the deck and lower stairs could be encroaching on the western neighbor's property. Photo taken looking north.

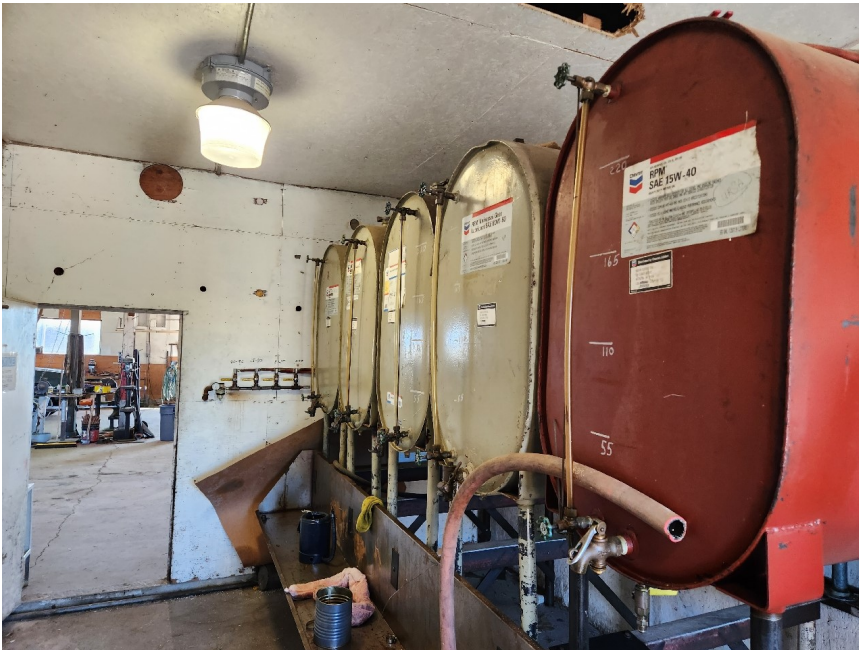
Photo 5: A storage room for various motor oils and hydraulic fluids. Each tank holds approximately 275 gallons. The floor was gently sloped to the west and with evidence of spilled oils and fluids. However, staff investigated soils on the western wall of this room (from the outside) and did not find any surface contamination. Map Photo ID: 45.2

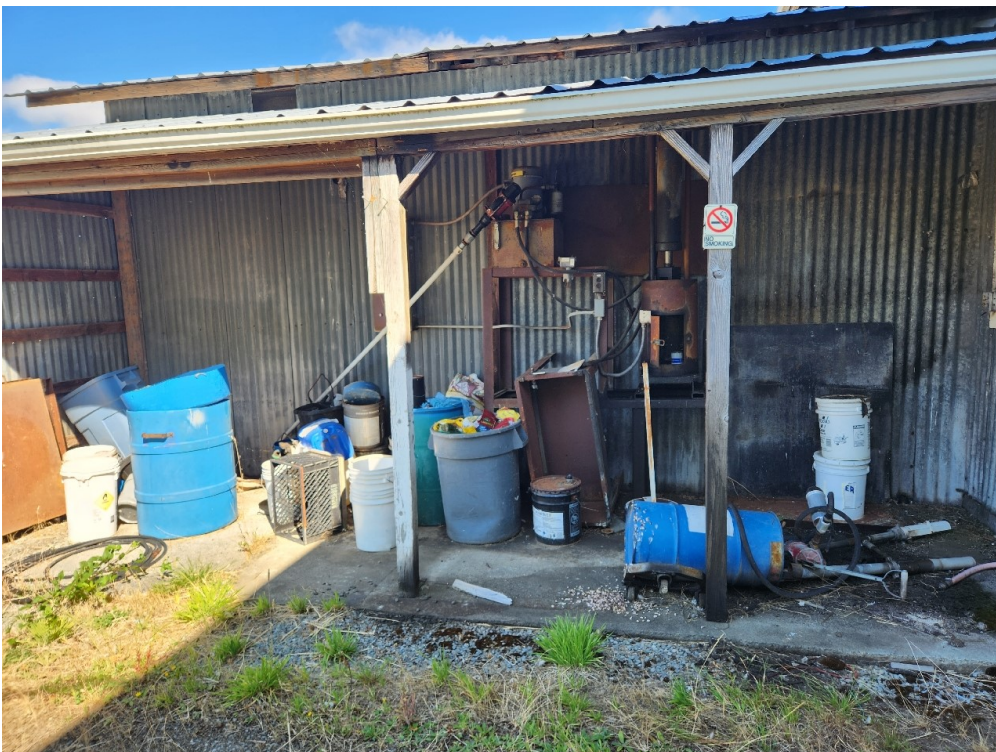
Photo 8: An oil filter recycling area. Twin City Foods staff utilized a hydraulic press to crush used oil filters and squeeze out any remaining oil. There were surface-level oil stains seen around the station. Steve Karcher (employee of TCF) said this recycling station hadn't been used in years, so a catch basin may have been used when in operation, but couldn't be determined during our survey. The oil/fluid storage room in the main shop is located on the other side of the wall pictured. Photo was taken looking north. Map Photo ID: 48

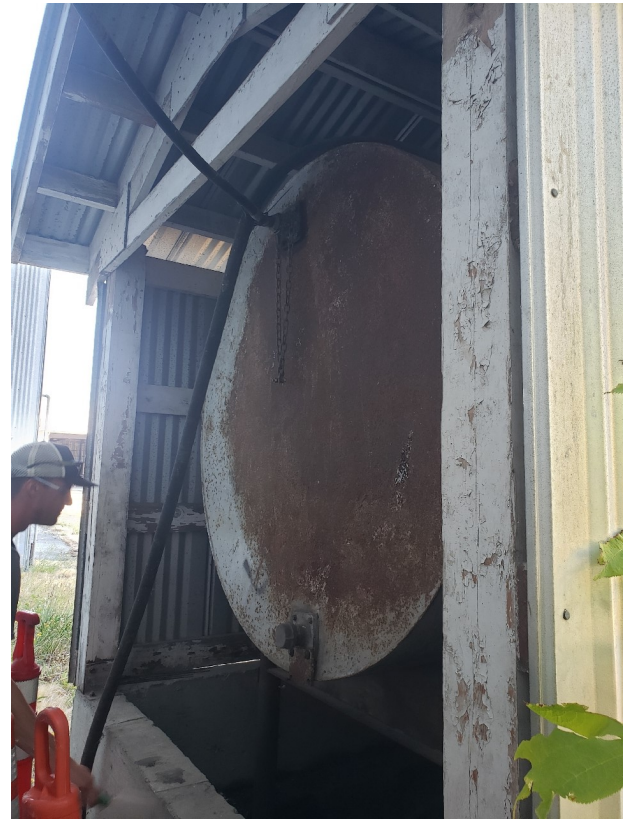
Photo 11: The backside of the [right] shed featured in Photo (6). A large, empty fuel/oil tank was found. This tank sat on top of a concrete 'tub', sealed on all sides, including the bottom. There was a small amount of hydrocarbon contaminated soils inside the concrete tub. Map Photo ID: 49.

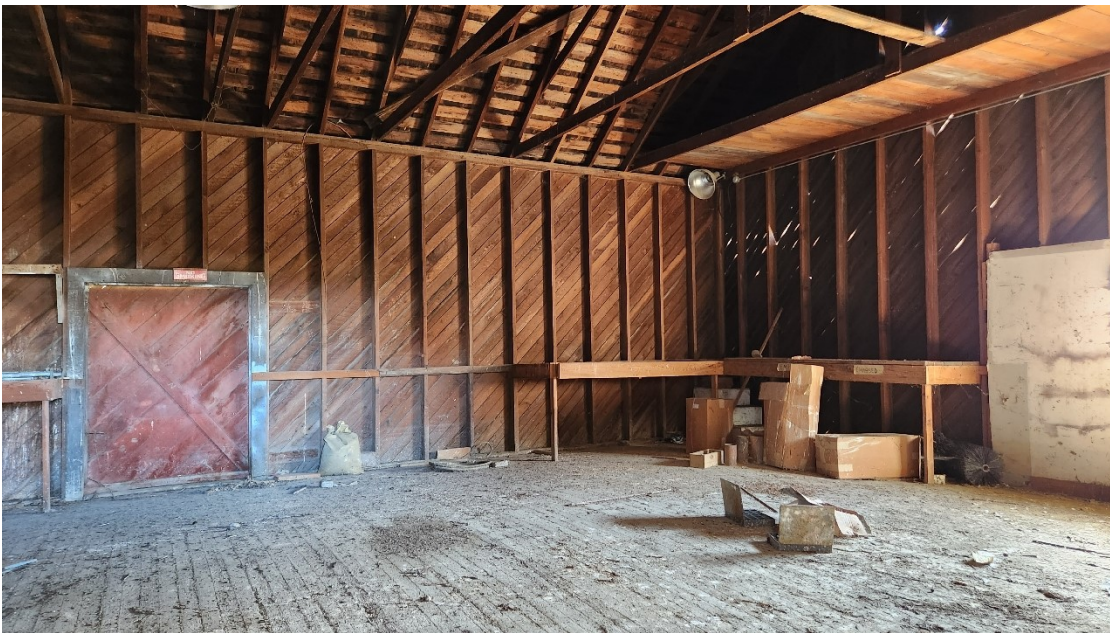
Photo 18: Inside the historic barn. Old desks, equipment, and refuse were found. Staff did not locate any HAZMAT. Map Photo ID: 35

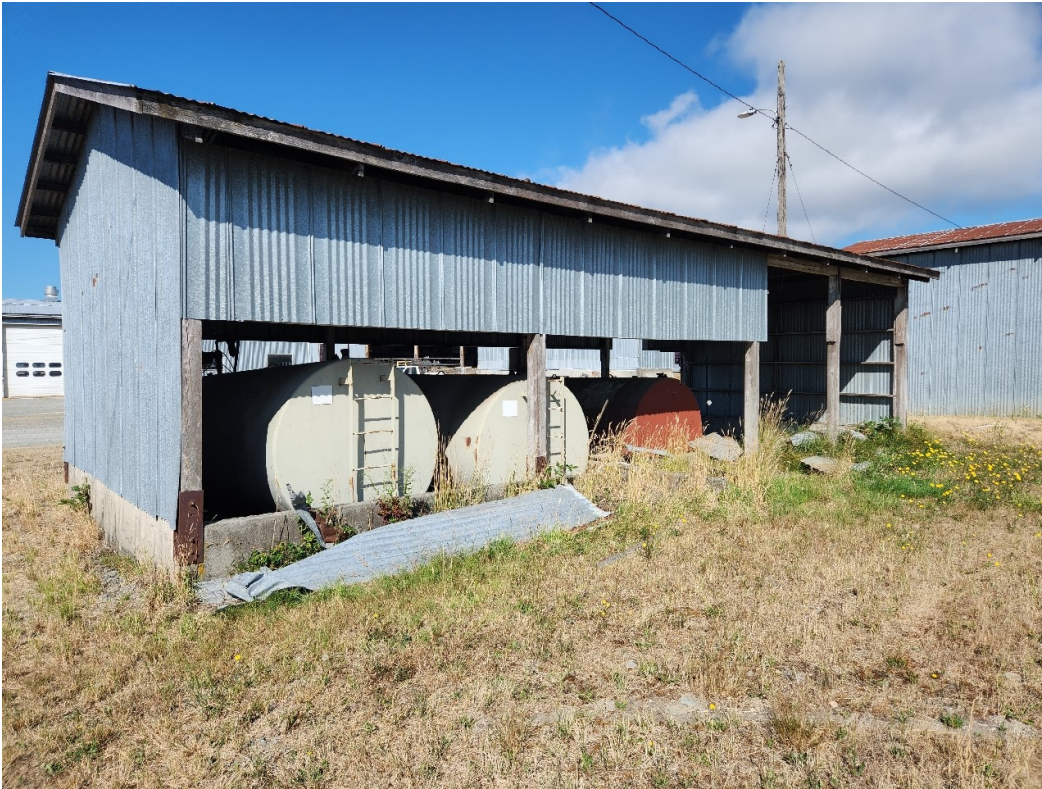
Photo 19: A large fueling shed for farm activities. At the time of survey all three tanks were empty. They historically contained red dye diesel (farm diesel), unleaded petroleum, and hydraulic fluid. The two bays not occupied were believed to have been used for other fuels and/or fluids. The tanks were inside a concrete tub and no apparent oil contamination was visible around the shed. This fueling shed is just to the south of the historic barn. Photo was taken looking northwest. Map Phone ID: 32

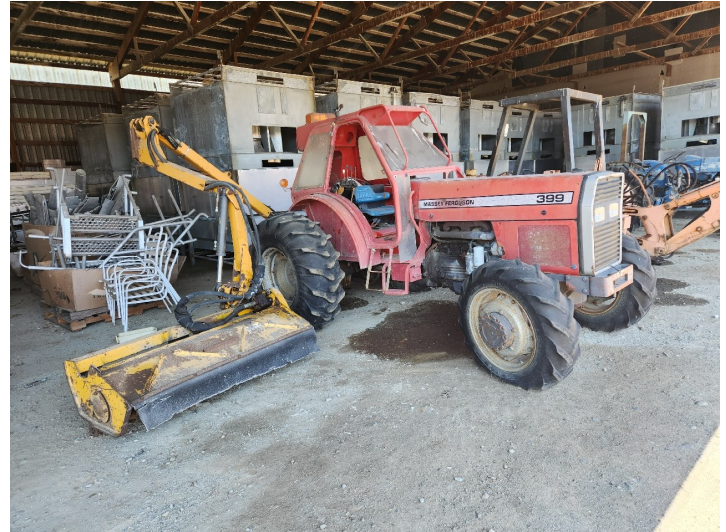
Photos 22-24: The gravel floor inside the pole barns had patches contaminated with oil and hydraulic fluids. These oiled/stained gravels were likely surficial, however standing pools were seen (like Photo (23) on the left). Map Photo IDs: 73, 75, and 76.

There are areas of surficial hydrocarbon contamination on the property (e.g. oil stains), limited to areas where equipment was housed, maintained, and fueled. There are also several areas where oil storage existed and refueling occurred—soil subsurface should be analyzed in these locations to ensure contamination is not present. The drainage systems from both sinks and storm drain should be investigated further, both in terms of what was put down the drains and where they drain to.
