Stillaguamish Tribal Response Program

Public Record Packet Summary

Lind Property Site Assessment

Assessment date: January 19, 2023

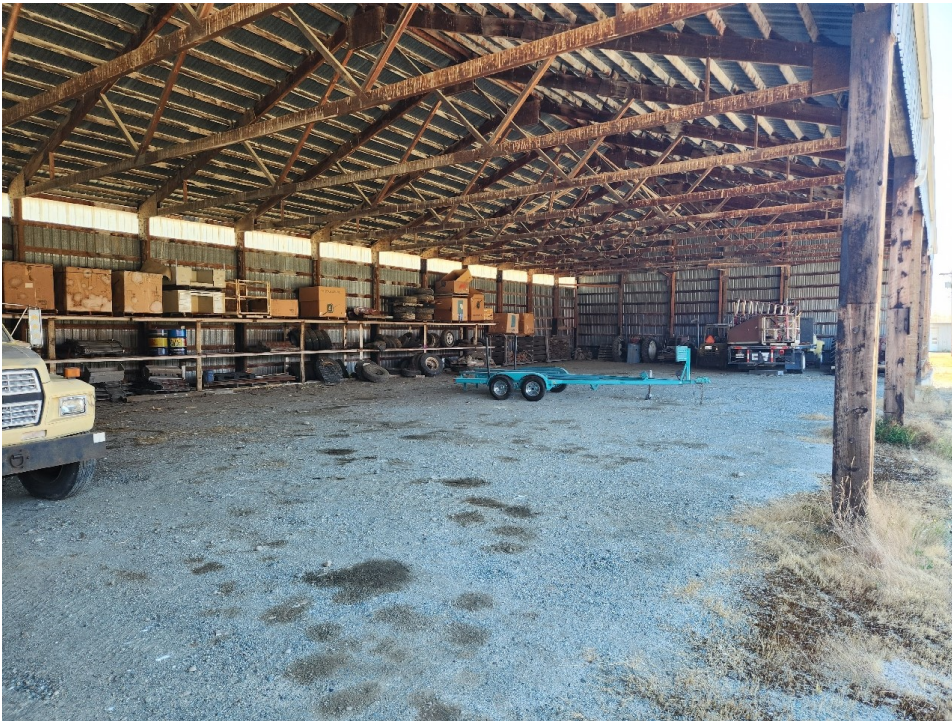
Photo 25: Another section of one of the two pole barns. More storage of equipment and vehicles can be seen, in addition to numerous oil stains. Map Photo ID: 82.

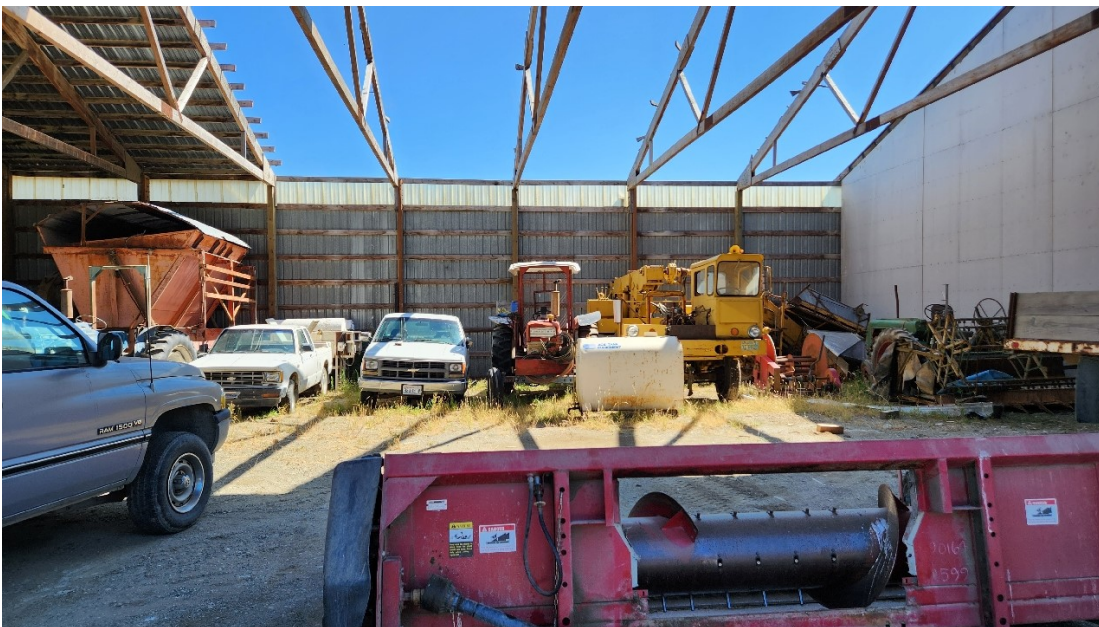
Photo 26: A section of the pole barn which lost its roof. More equipment and oil stained gravels were found here. Map Photo ID: 83.1

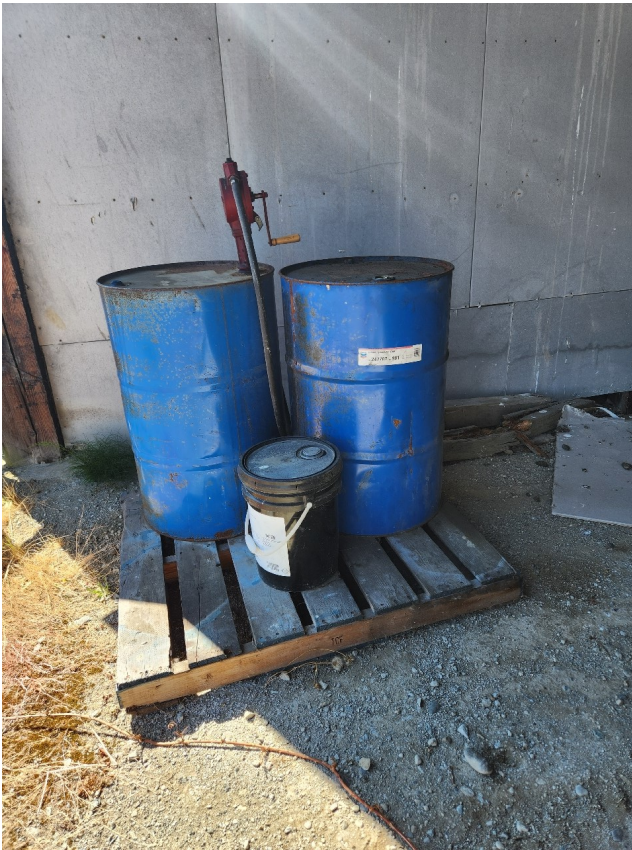
Photo 27: Within one of the pole barns, staff identified two 55-gallon drums which contained unleaded gasoline and/or red dye diesel. Staff did not identify oiled soils around this area. Map Photo ID: 78

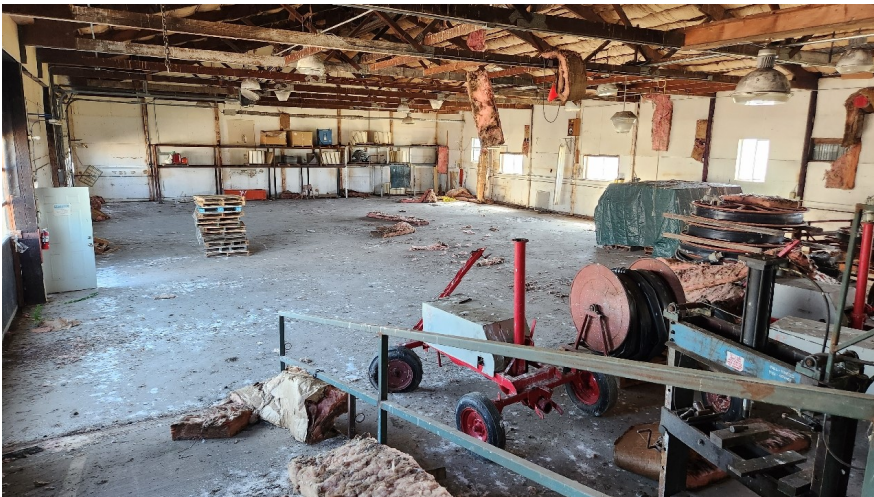
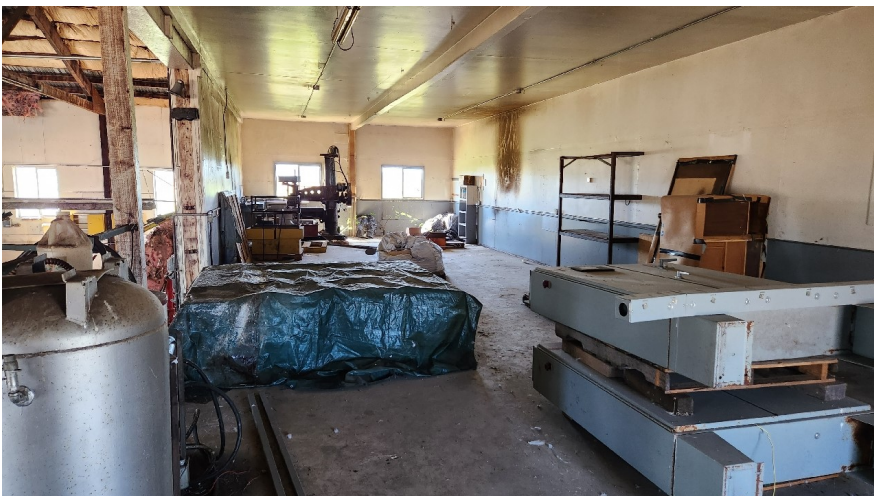
Photos 32-34: The eastern portion of the second shop. This area of the shop had loose and falling insulation, extensive bird and rodent feces, and oil stains on the concrete floor. It hadn't been used in years. Various large equipment, cabinetry, chemicals, were located, along with a second industrial sink (draining location unknown). Map Photo IDs: 68.2, 68.3, and N/A (sink).

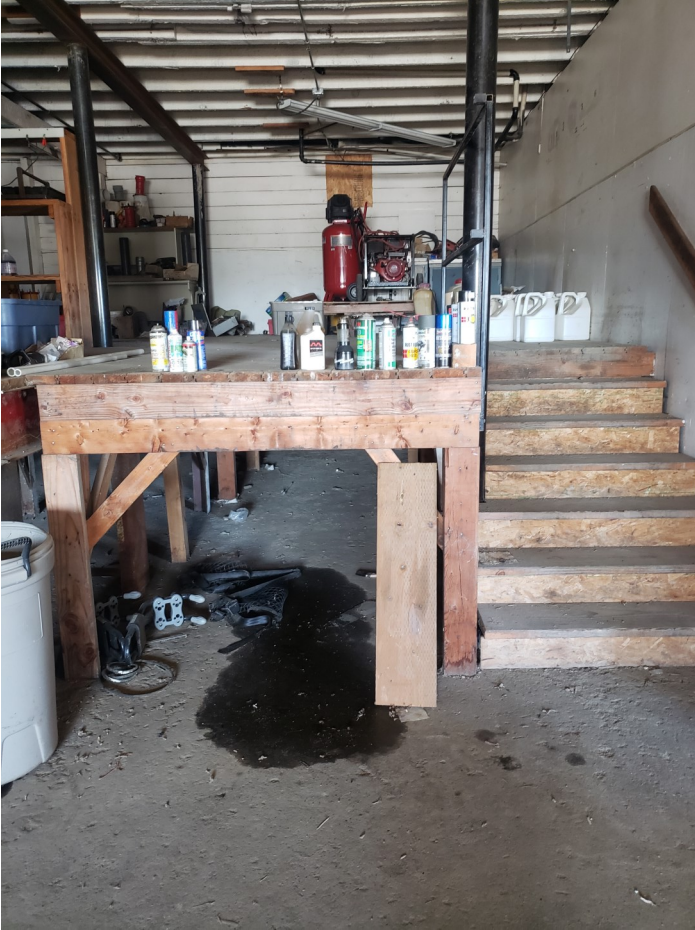
Photo 35: An oil stain, bottles of unknown fluids, aerosol cans, and an air compressor found in the second shop.

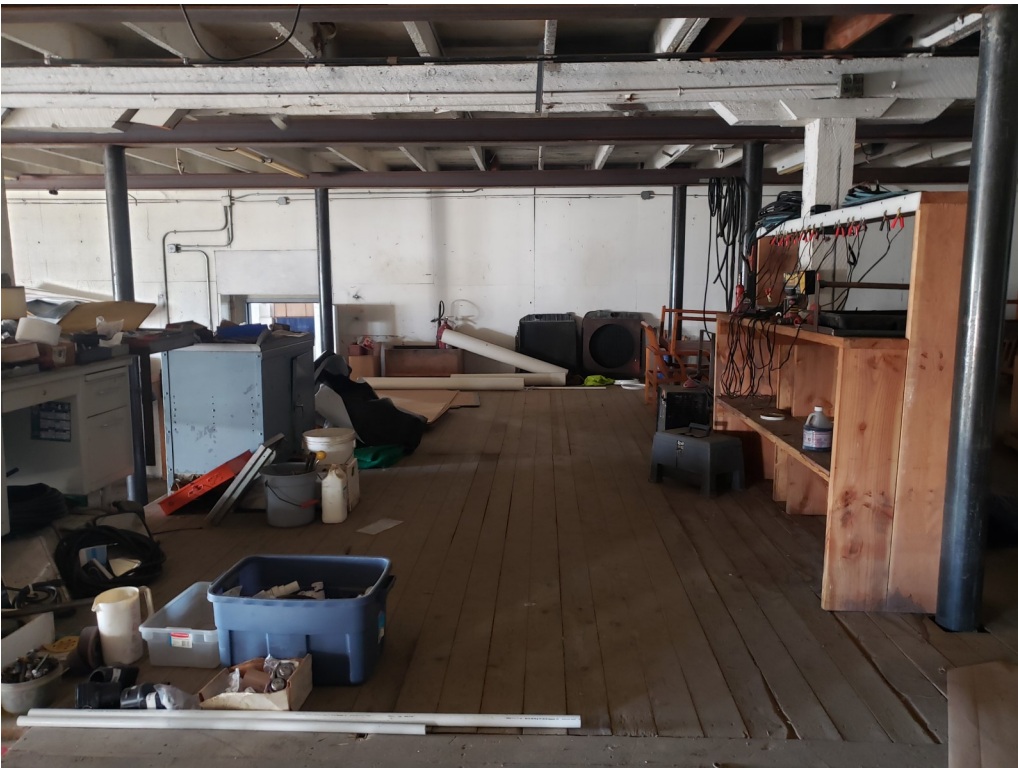
Photo 36: A battery charging station and refuse found in the second shop. Map Photo ID: N/A
