## Stillaguamish Tribal Response Program

### 2024 Public Record Packet Summary

# Local Brownfields Public Record Report

**Kunkel Property Site Assessment**

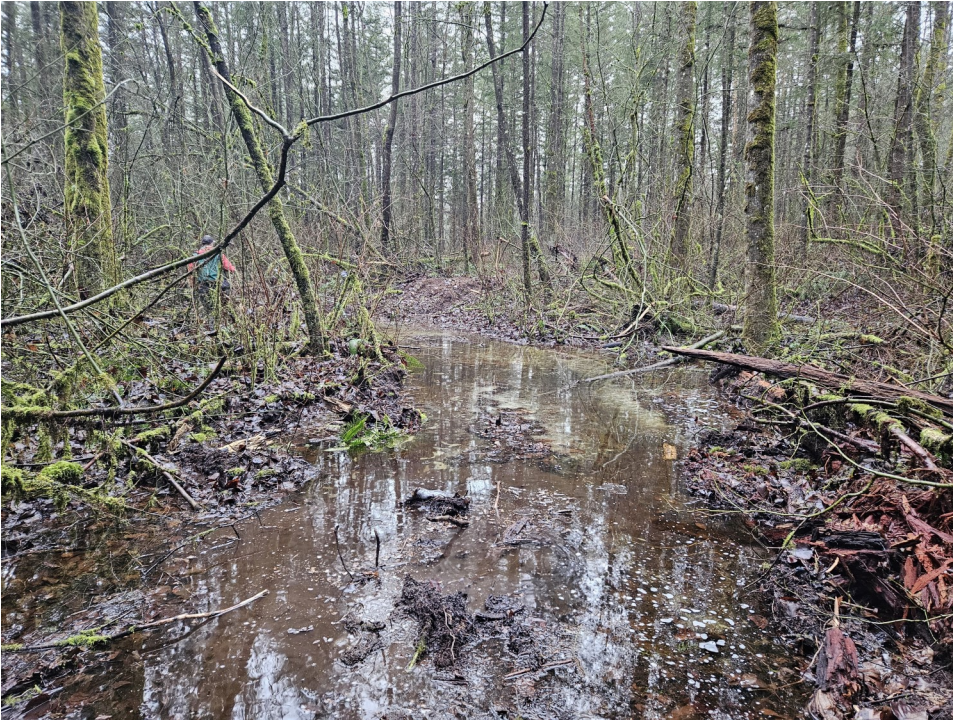
Photo 3: A flooded portion of the newly constructed trail. This area was generally level, with a very high water table. No flowing water was seen in this area. Tree composition (alder, cottonwood) indicates this area is usually saturated with water. Photo taken looking southwest, about 400' from the north-eastern property corner.

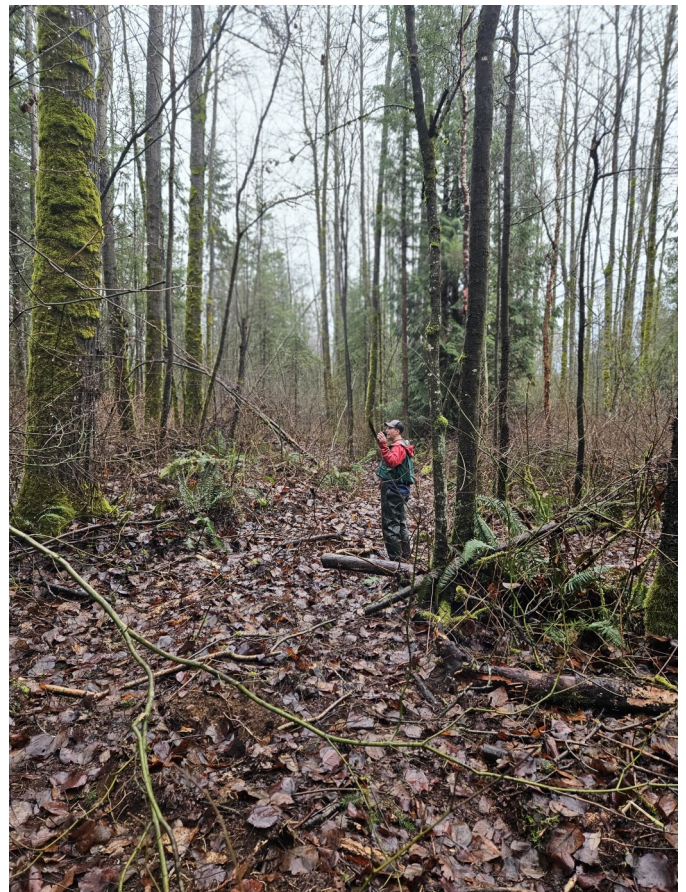
Photo 8: The new trail near the center point of the property, just south of the junction. Numerous percolation test pits (or evidence of) were located along this section of trail, maybe 10 in total.

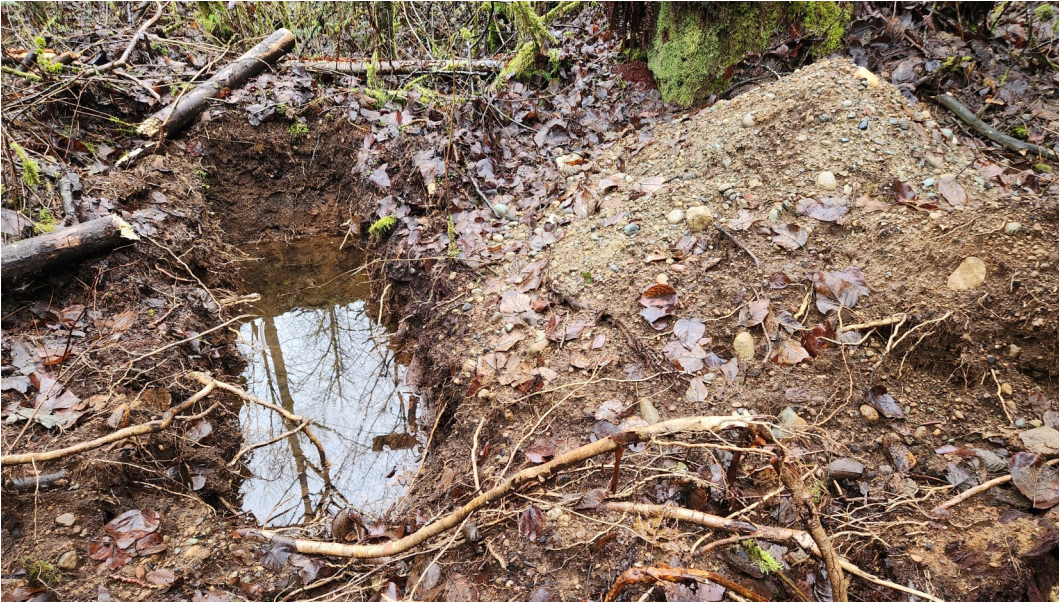
Photo 9: One of 8+ percolation test pits located along the newly constructed trail. Groundwater is seen just below surface level. Soils in some test pits had high levels of clay.

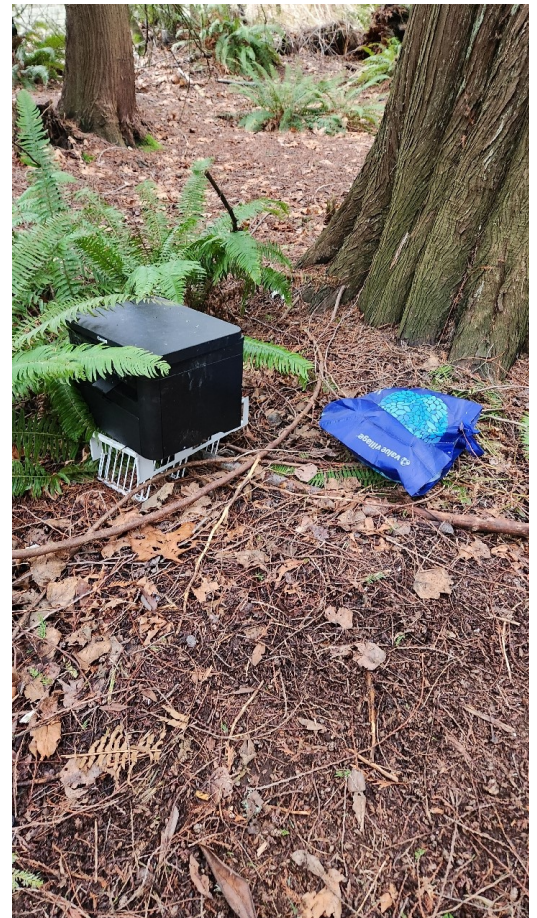
Photo 2 (Map point 111): An old printer and garbage just to the west of the driveway, near the entrance.

This property has a few areas that need attention to ensure contamination is not present or occurs during the move-out process. Both derelict vehicles should be carefully removed from the property to ensure hazardous liquids (e.g. antifreeze, oil, gasoline) don't contaminate the surrounding soils. The property was free of obvious signs of chemical storage and no overt soil staining was seen. The property was generally free of refuse and garbage. The Bergstrom Property has **Low Level of Risk that can be Mitigated.**

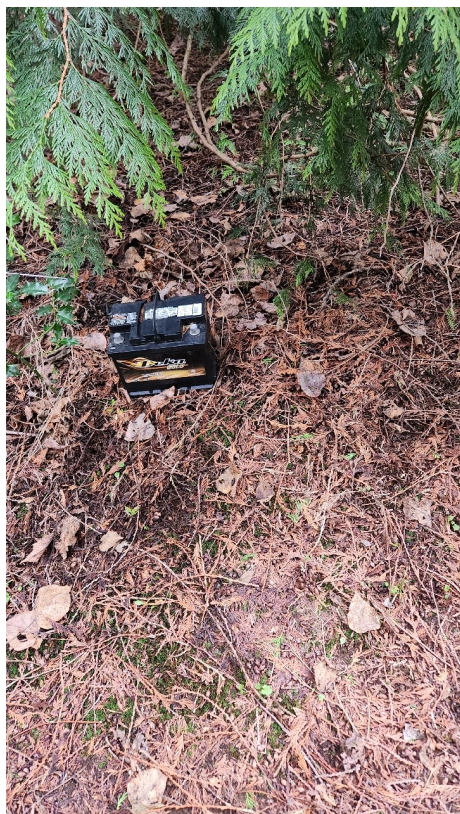
Photo 3 (Map point 112): An old battery just to the north of Photo (2).

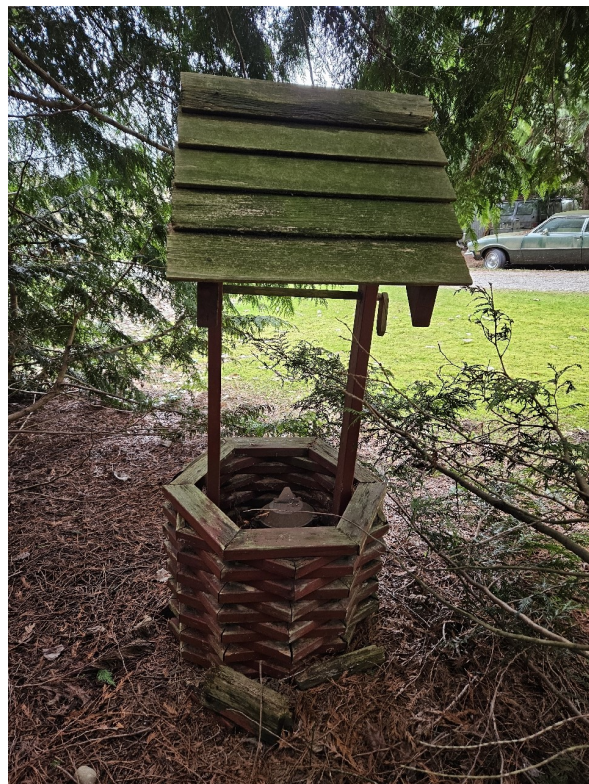
Photo 4 (Map point 113): Well head (drilled well) on the property, located about halfway down the driveway on the west side.

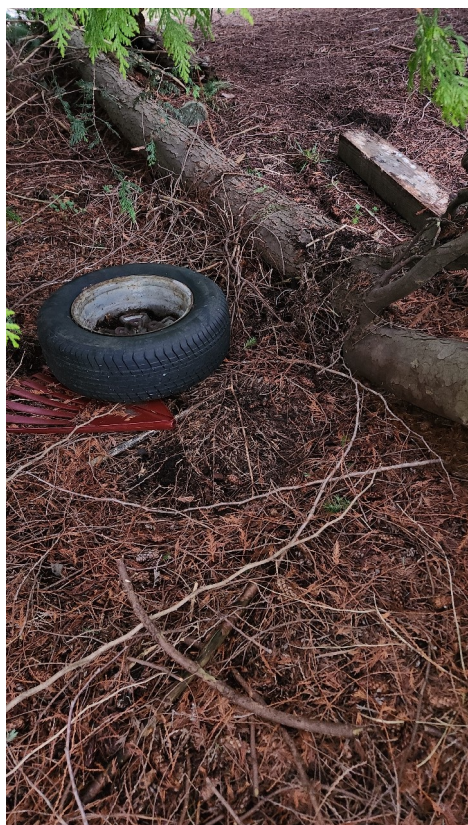
Photo 5 (Map point 101): An old tire located about halfway down the driveway, on the east side.

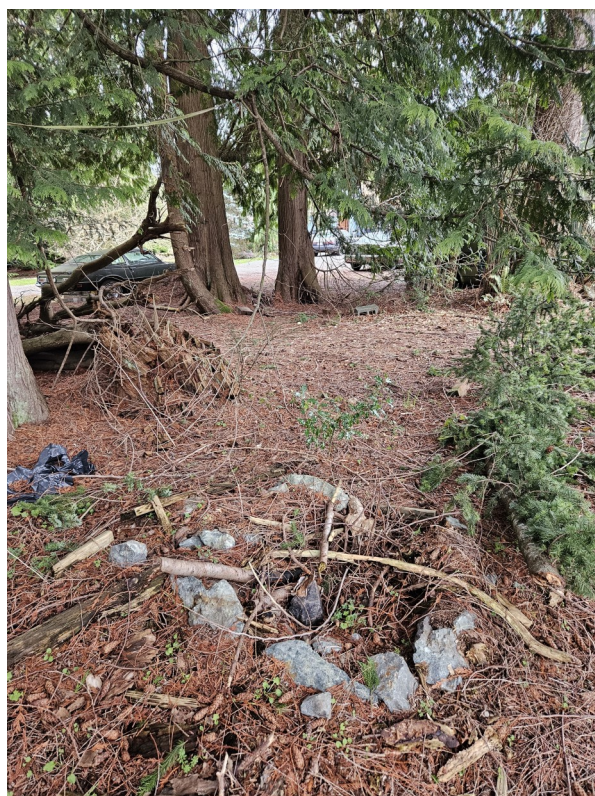
Photo 6 (Map point 100): A fire/burn pit on the east side of the driveway, about halfway down. No material was found in the pit.

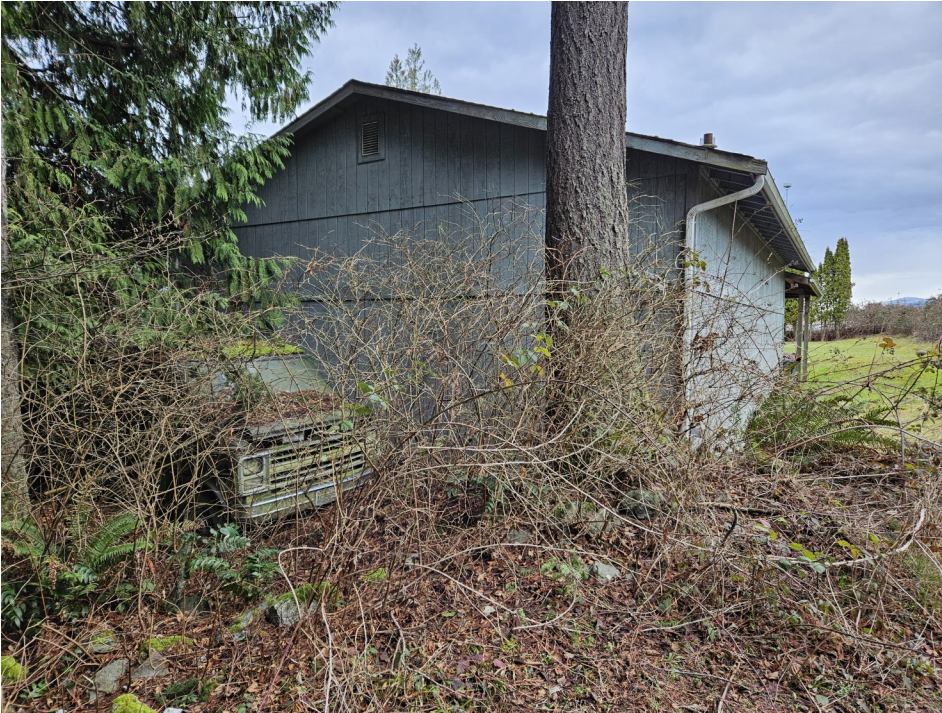
Photo 7 (Map point 102): A derelict van on the south side of the garage/shop on the property. Photo taken looking north towards Angel of the Winds Casino.

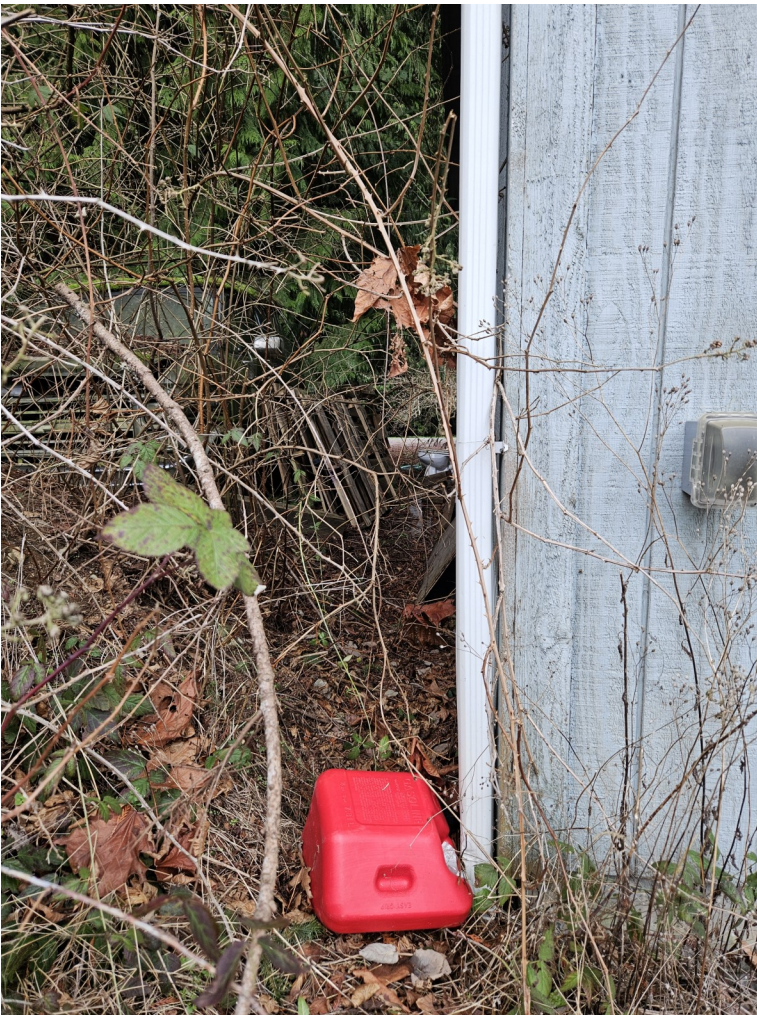
Photo 8: An empty gasoline can found along the south side of the garage/shed. The van from Photo (7) can be seen in the background.

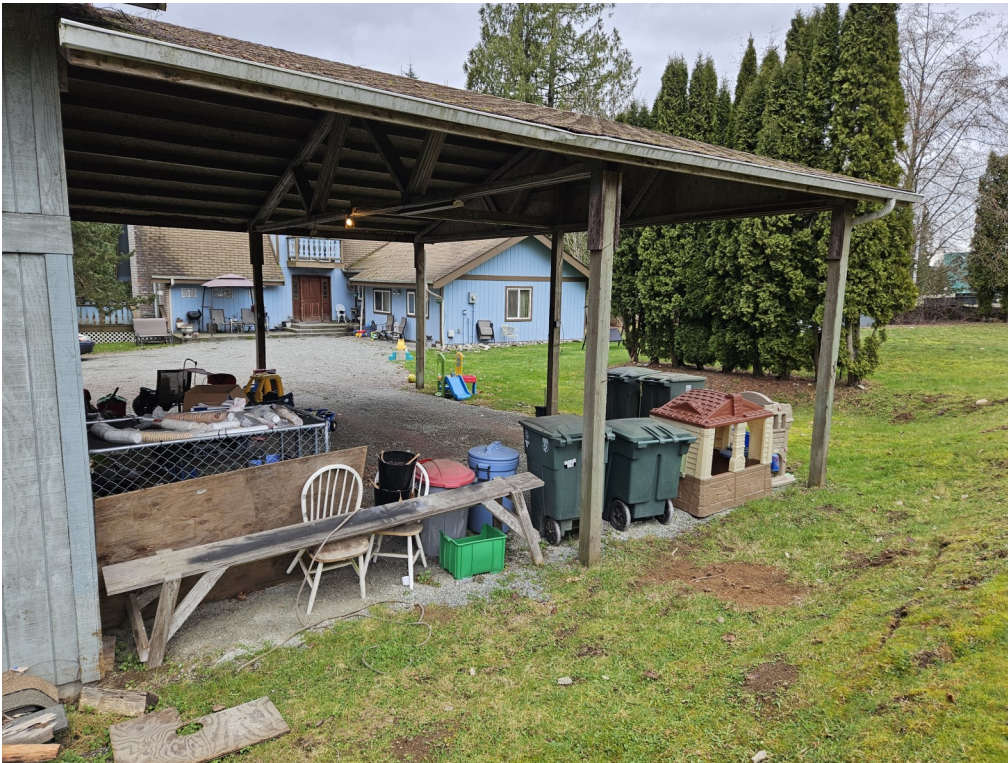
Photo 9: North side of the garage storing various home goods, trash bins, etc. No hazardous materials were seen stored here, nor evidence of large staining. The main residence can be seen in the background. Photo taken looking northwest.

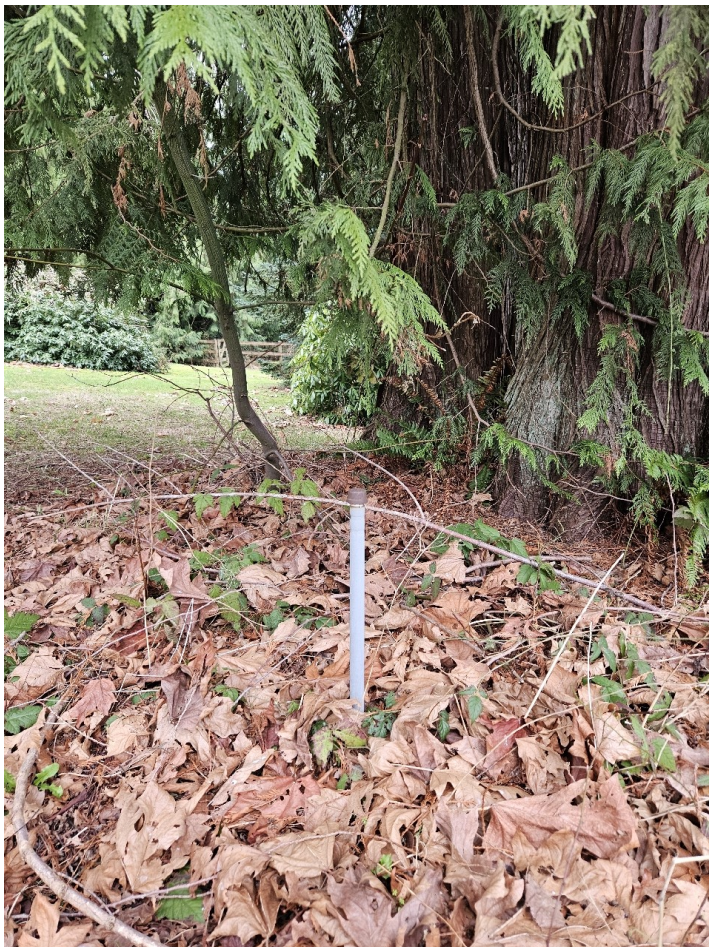
Photo 10 (Map point 103): A previous propane line to the main residence which attached to an above ground tank. The owner of the property says this propane tank was leased and removed by the propane company years ago.

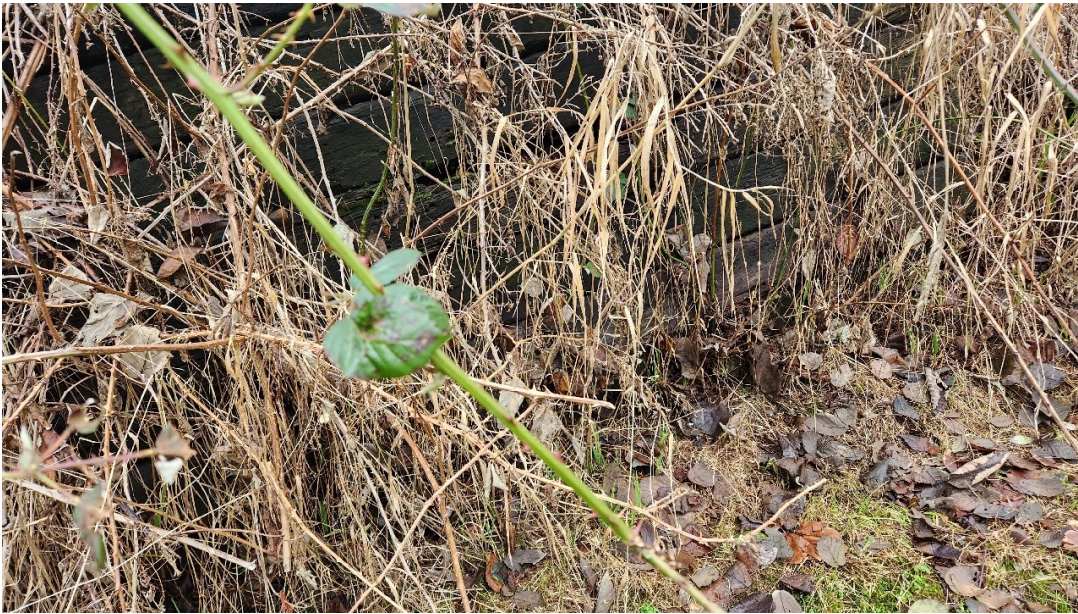
Photo 11 (Map point 105): A raised mulching bed, constructed out of railroad ties, located on the mid-point of the northern property line.

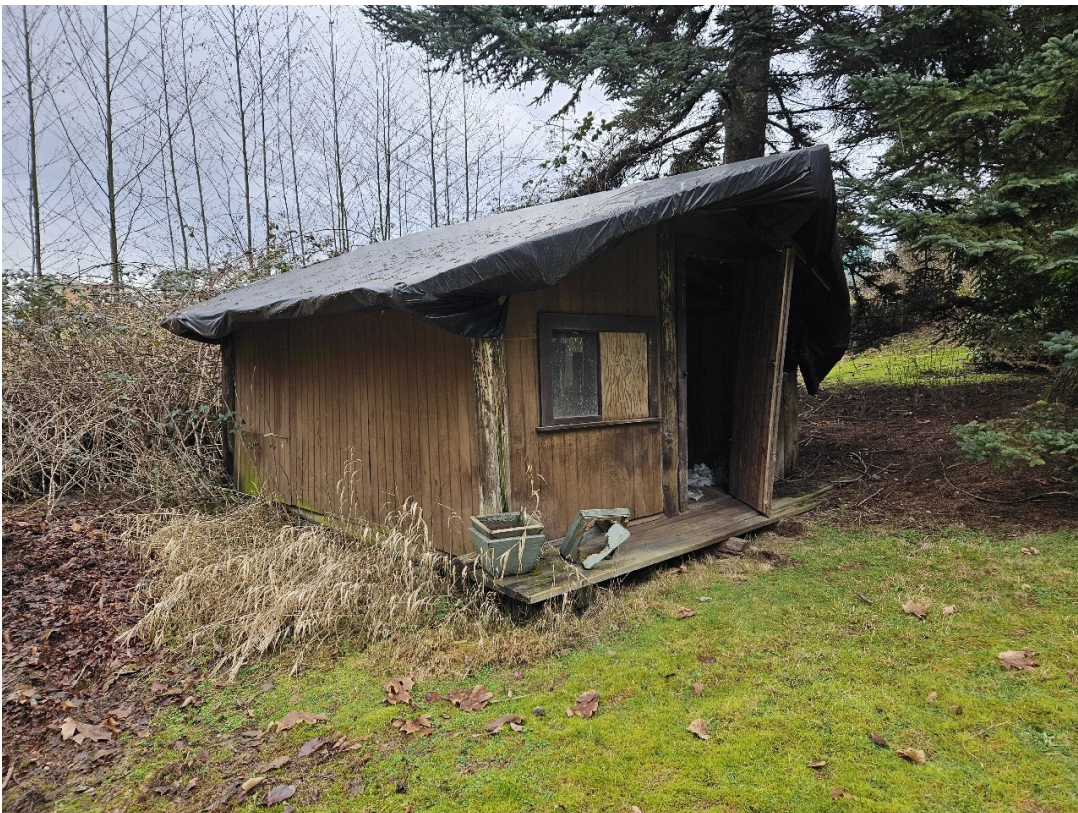
Photo 12 (Map point 104): A dilapidated shed located along the northern property line. Inside housed refuse and other garbage. No HAZMAT was easily identifiable.

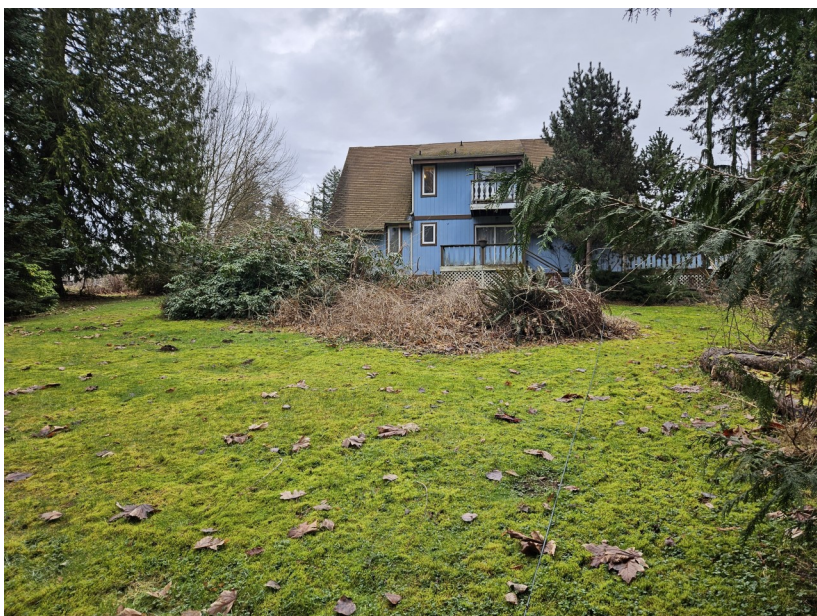
Photo 15: The backyard of the main residence, looking south. Staff were unable to locate the septic system, but this area is the presumed drain field.

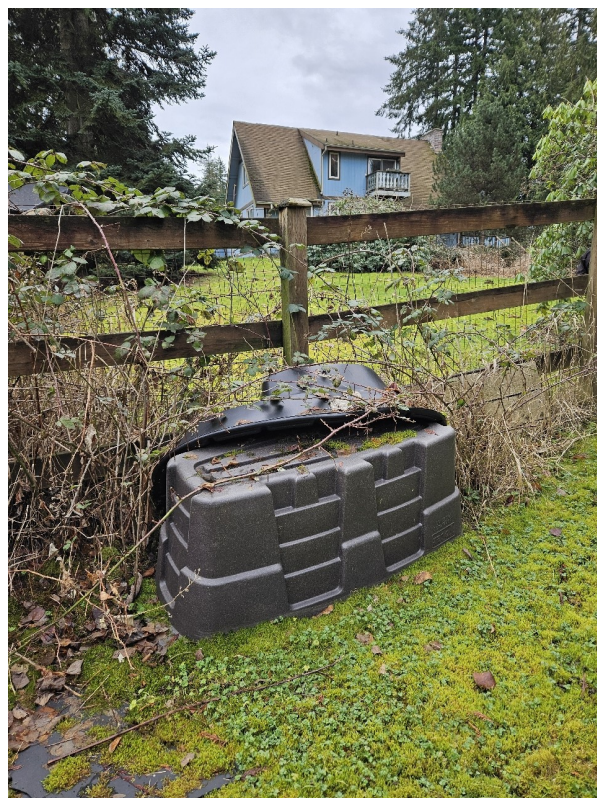
Photo 16 (Map point 106): A few large plastic totes along the fence line that runs north-south across the backyard.

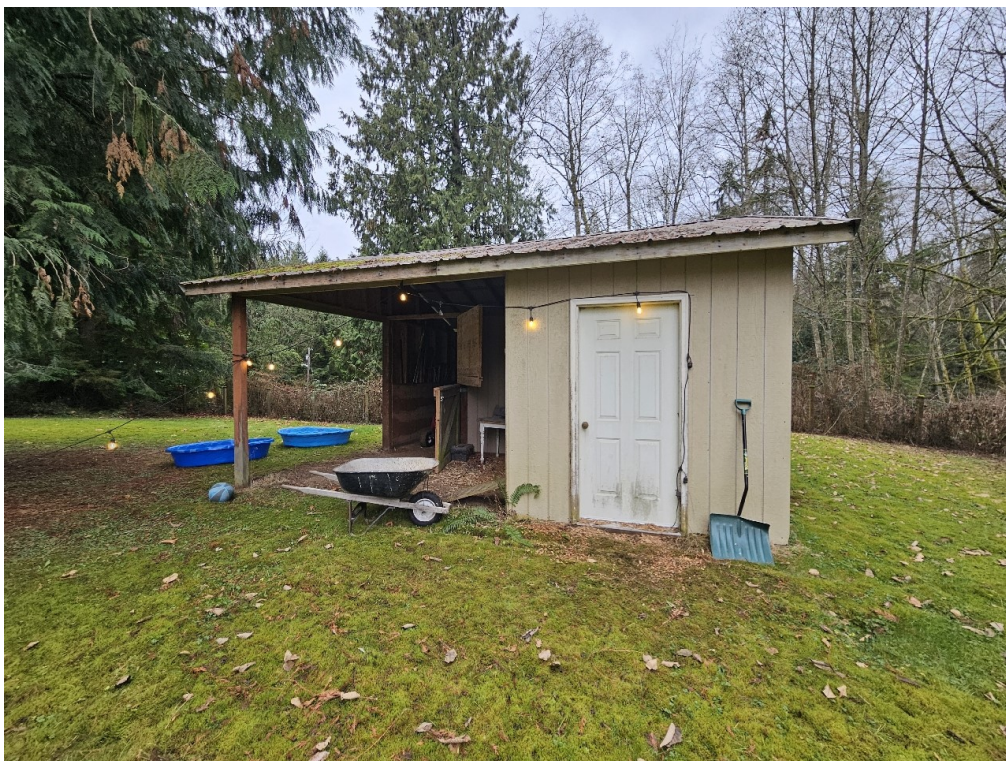
Photo 17 (Map point 107): A shed near the northwest corner of the property. No signs of HAZMAT storage or use were seen. Photo taken looking west.

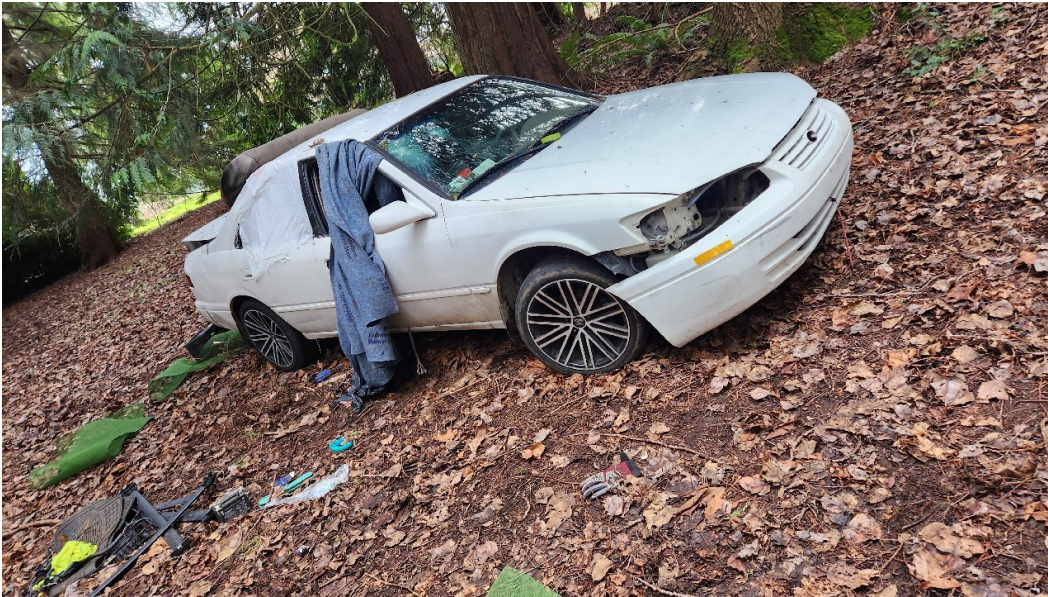
Photo 20 (Map point 109):  
A derelict car parked on the  
access road mentioned in  
Photo (18). The vehicle was  
filled with rubbish, which  
can be seen spilling out  
onto the surrounding area.  
No obvious signs of leaking  
were seen or smelled.

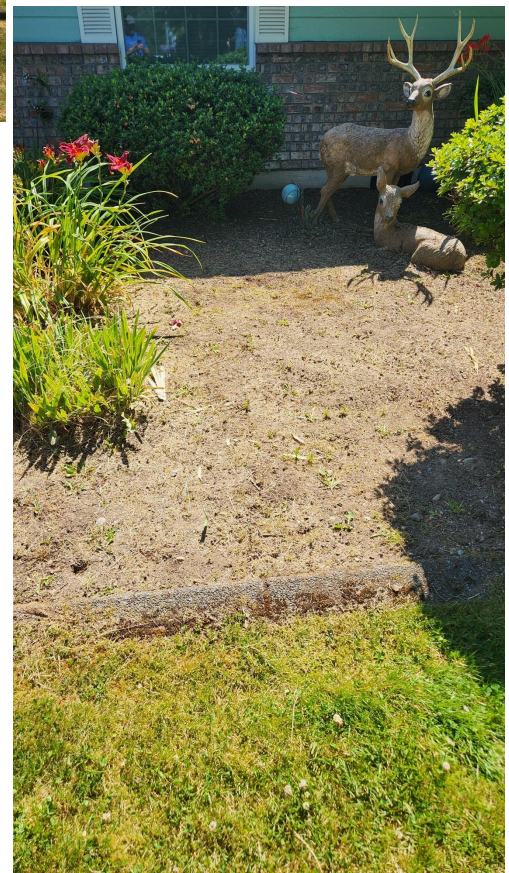
Photo 2: Location of Septic tank buried in garden by front door.

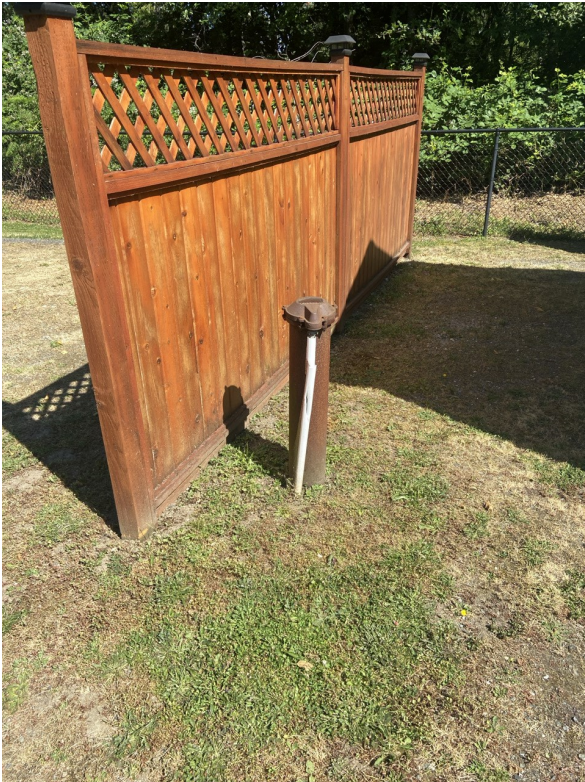
Photo 3: Eaton property well located behind fence at end of driveway.

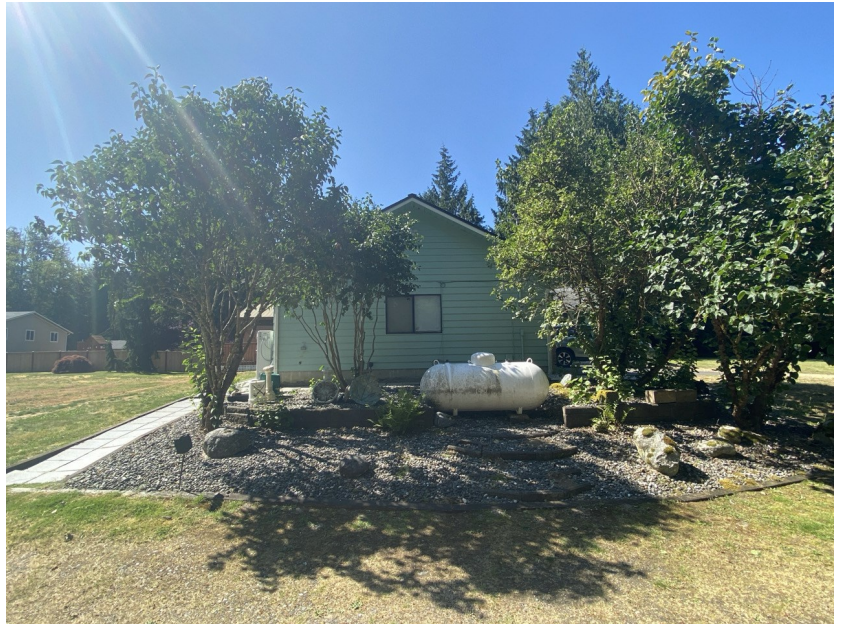
Photo 4: Eaton property propane tank located on northern end of house at end of driveway.

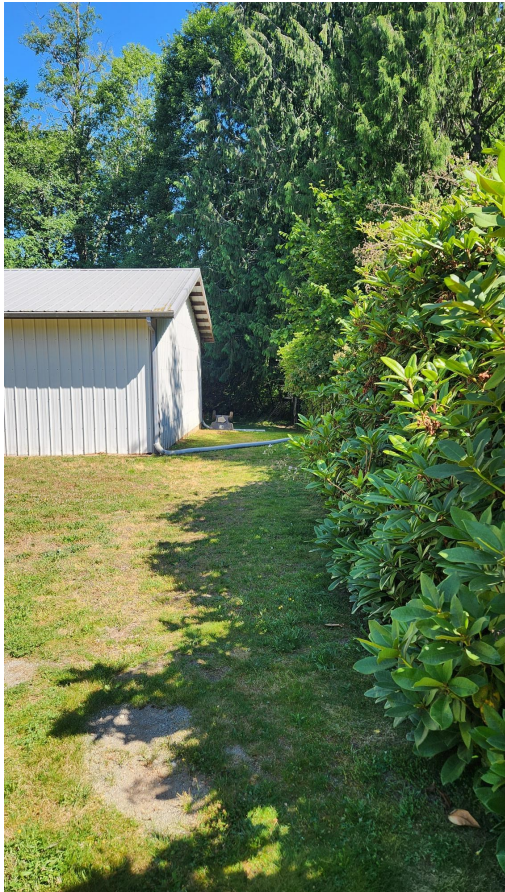
Photo 8: Eastern fence line looking north. Back of garage is seen. Garage gutters have two pipes directing water away from garage to under the fence line.

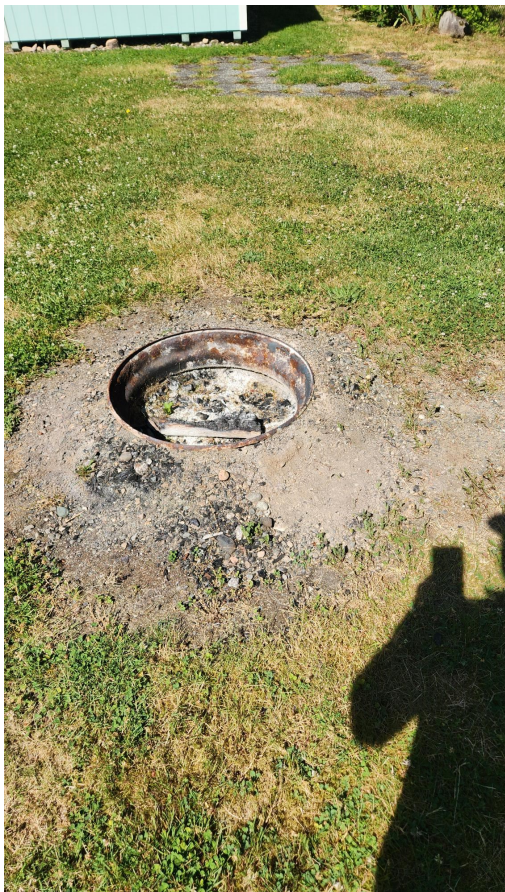
Photo 10: Eaton fire-pit mentioned in Photo 9, located to the north of garage.

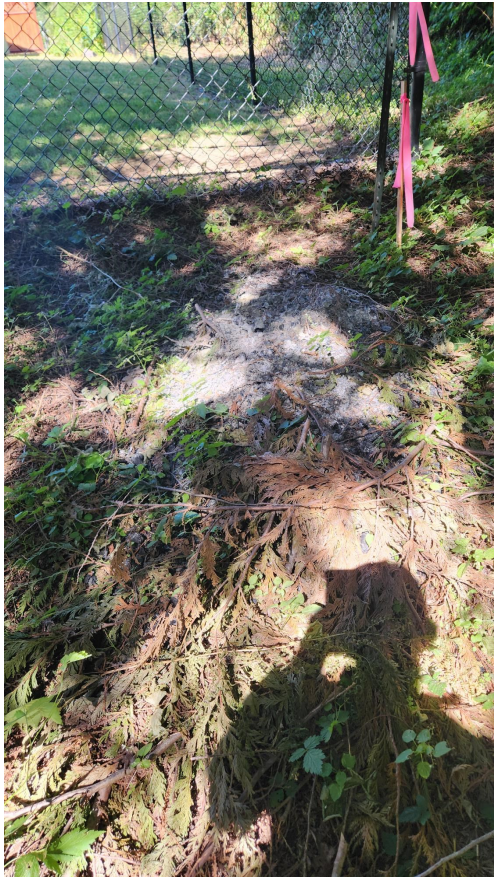
Photo 11: Eaton property in the north eastern corner of the fence line. Eaton's dump ash from fire-pit in Photo 10, over the fence into forested part of the property.

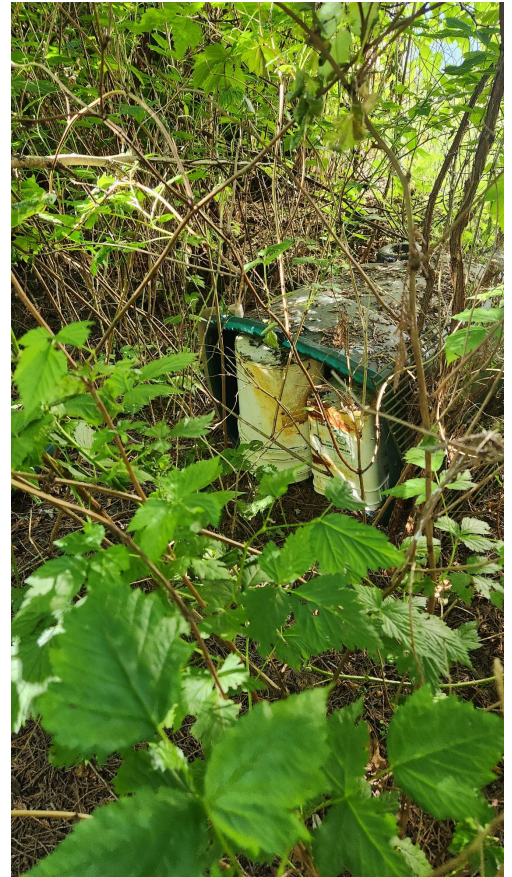
Photo 12: Green bin with old plastic buckets in forested part of property to the east of the fence line. Landowner said he will remove the bin.

This Eaton property does not have any real issues with it. We did not observe any contamination, burn pits, other than the fire-pit, dumps of trash or junk, or staining on the ground. The green bin on the west side of the fence should be removed although it looks fairly benign. The yard waste pile, also on the western side of the fence, looks benign, might be worth an inquiry of the landowner just to make sure it is of yard refuse. The property was free of refuse and garbage. The Bergstrom Property has **No Apparent Risk** associated with it.

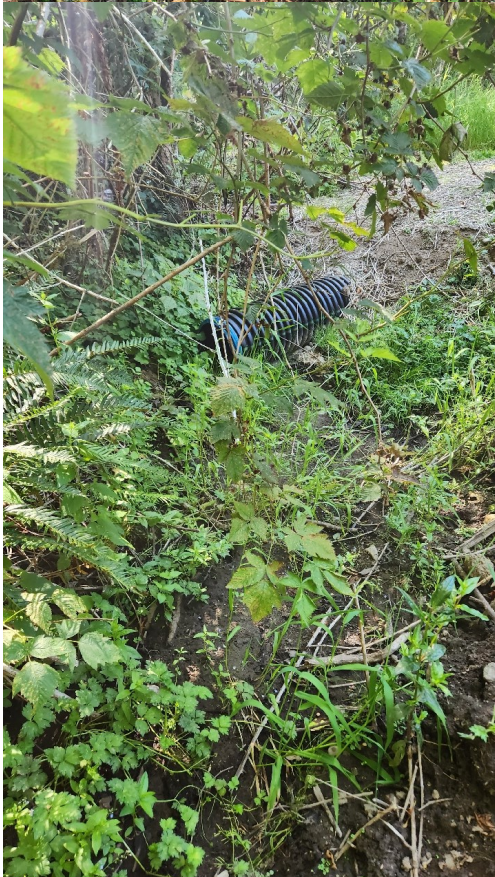
Photo 17: As mentioned in Photo 16, culvert under filled gravel from neighbor to the south. Culvert allows forested wetland to flow through Eaton and neighbors property. Forested wetland runs, north—south through forested section of the Eaton property.

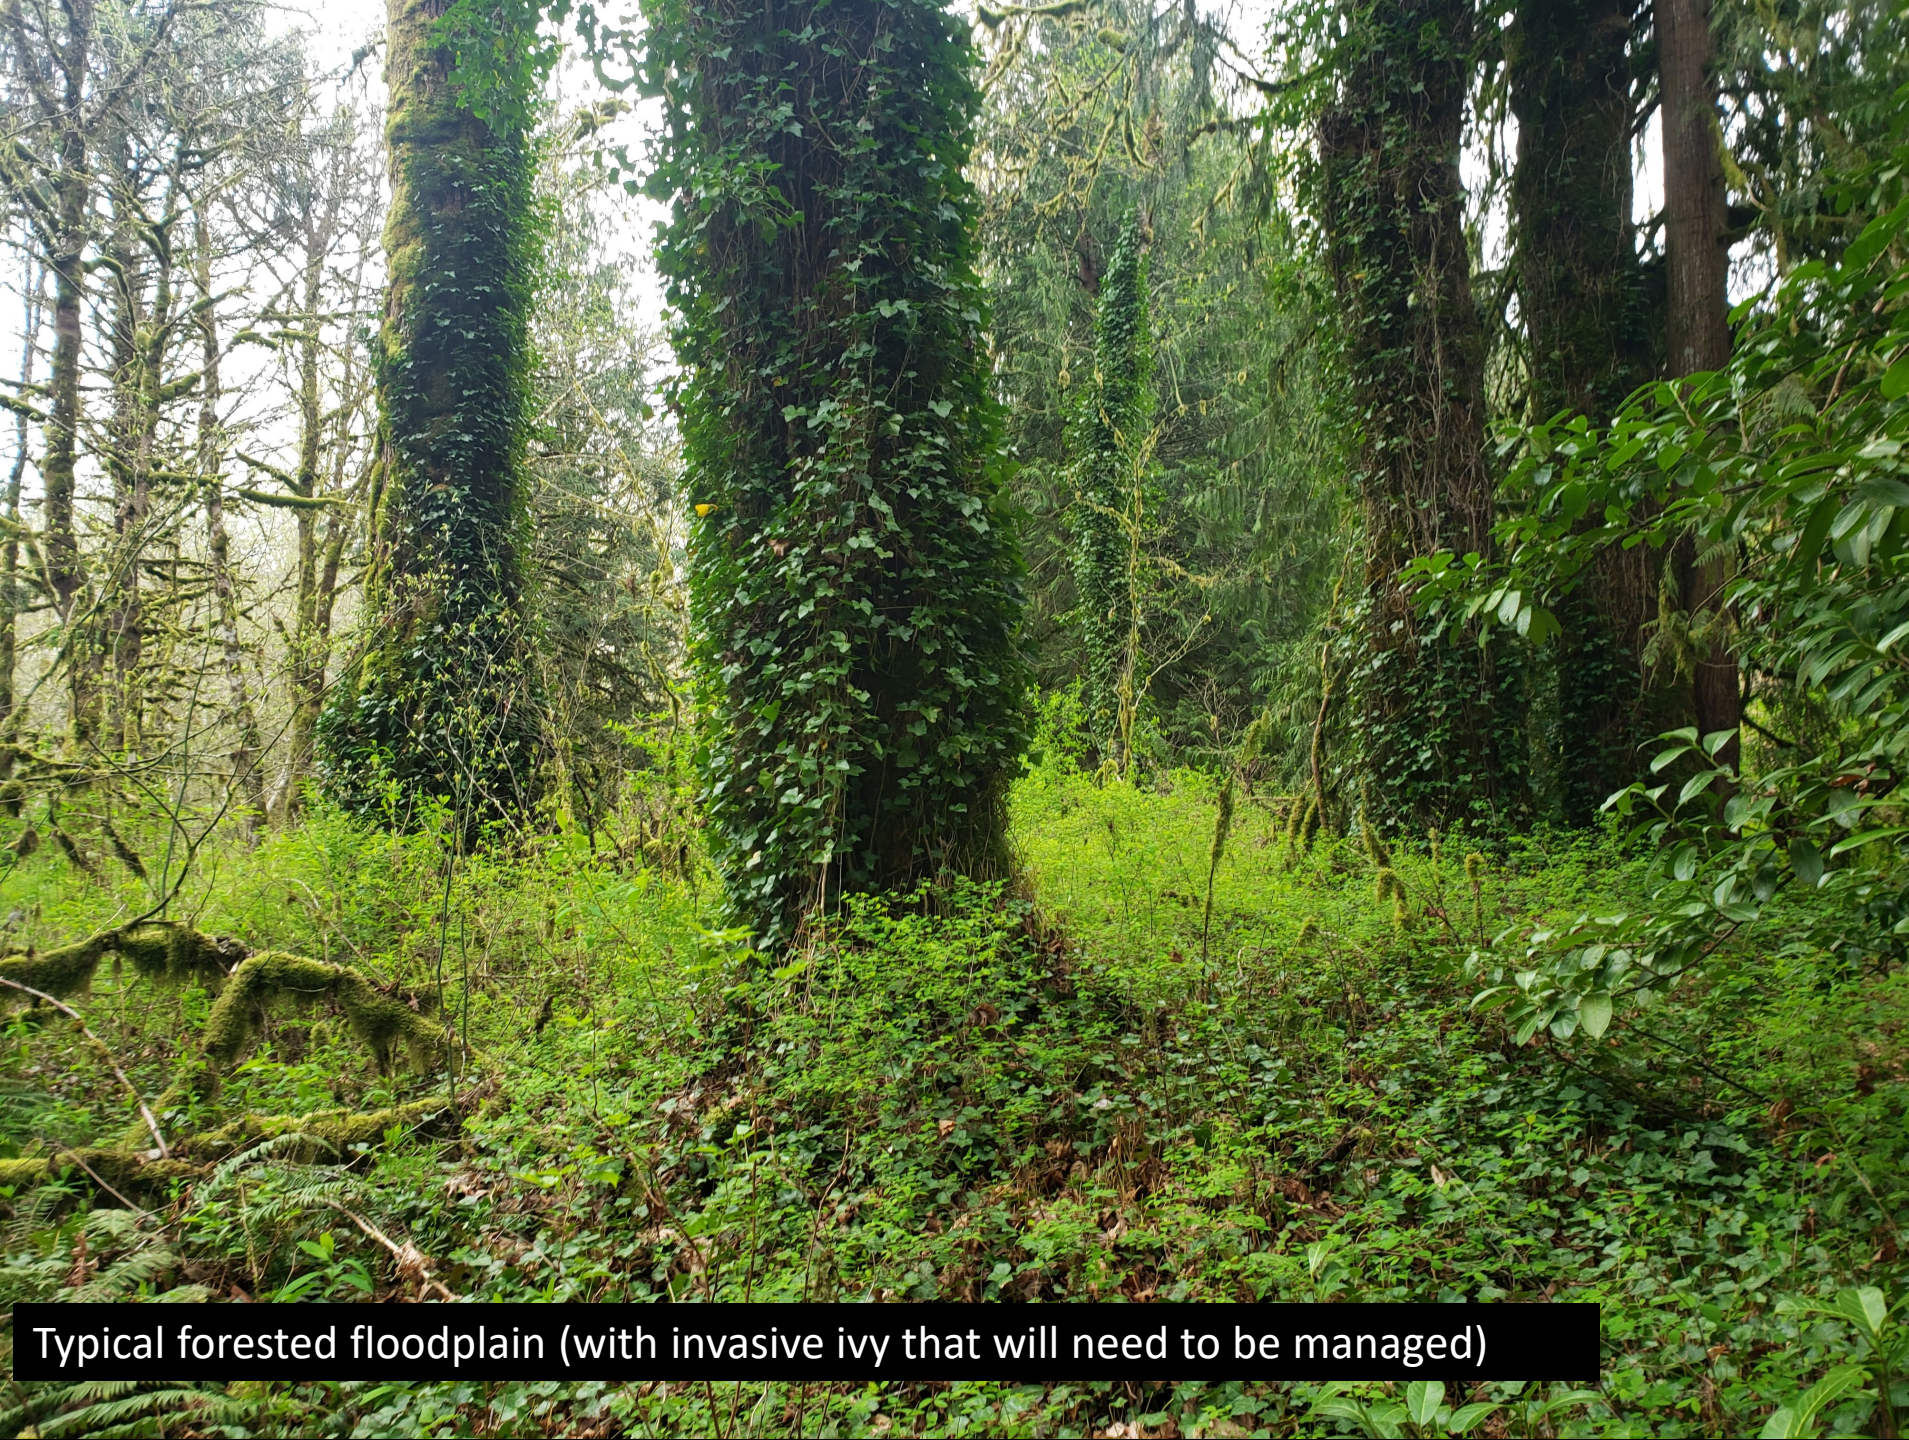
Typical forested floodplain (with invasive ivy that will need to be managed)
