**Stillaguamish Tribal Response Program**

**2025 Public Record Packet Summary**

**Schultz Clan Property Site Assessment (Parcel 1)**

Assessment date: 10/29/2024

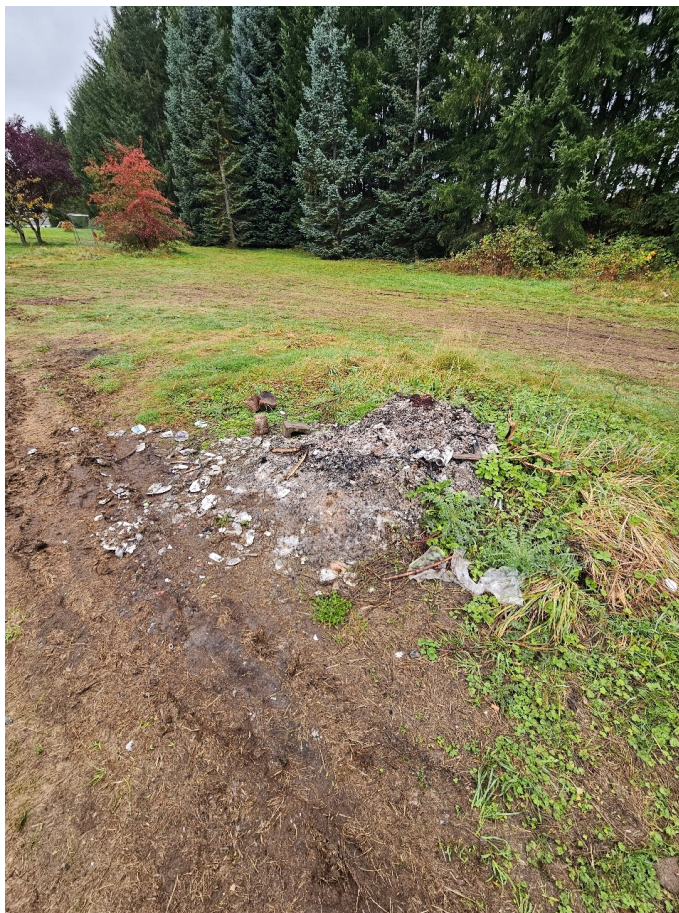
Photo 8 (Map Photo ID 146): A burn pile near the center of the property.

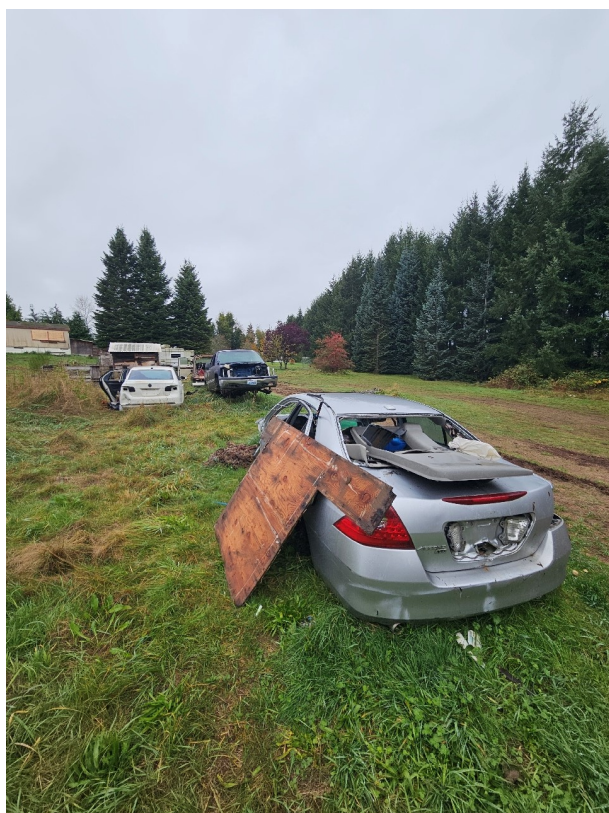
Photo 9 (Map Photo ID 145): Numerous ransacked, broken down vehicles, all filled with trash, bags of feces, needles, etc. Staff were unable to determine if there were fluid leaks (e.g. petroleum products), however, no fumes were smelled.

**Conclusion and Recommendation:** This parcel has high concentrations of garbage and tire piles, burn pits, stained soils, broken down vehicles, human feces, and dig and fill areas. All areas mentioned above need to be properly disposed and cleaned up. Many areas need further exploration to ensure contamination is not present. **Risk Needs Further Investigation.**

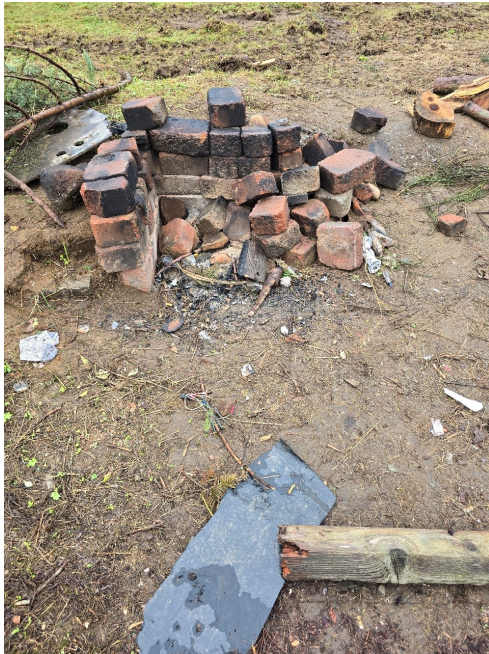
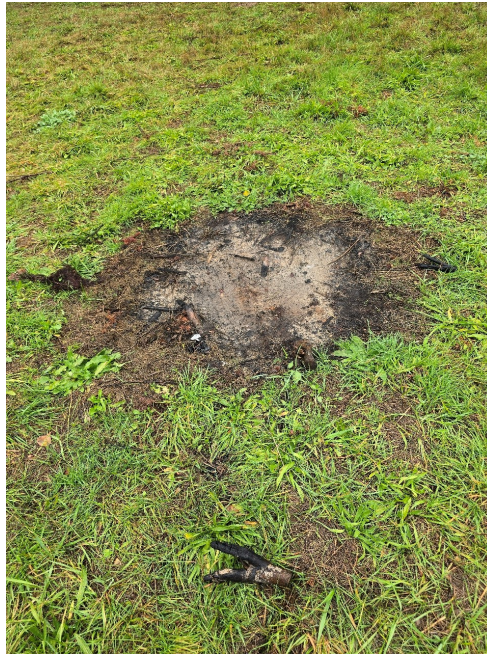
Photos 10 & 11 (Map Photo ID 143 & 144): Burn pits near the center point of the property. Garbage appears to have been burnt.

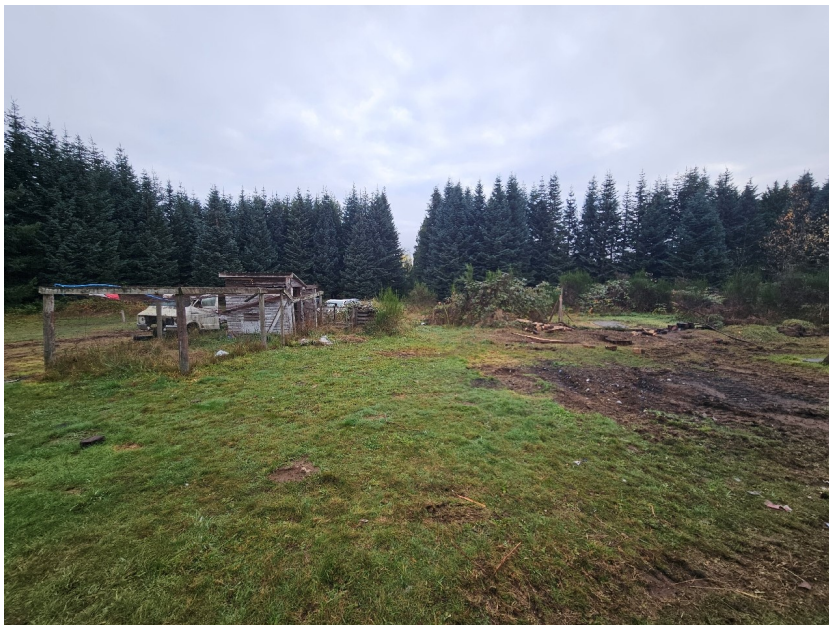
Photo 12 (Map Photo ID 141): An overview of the central/eastern portion of the parcel, looking east towards 19th Ave NE. An RV was previously removed from this area. Garbage, burn piles, human feces, and needles were spread throughout this area.

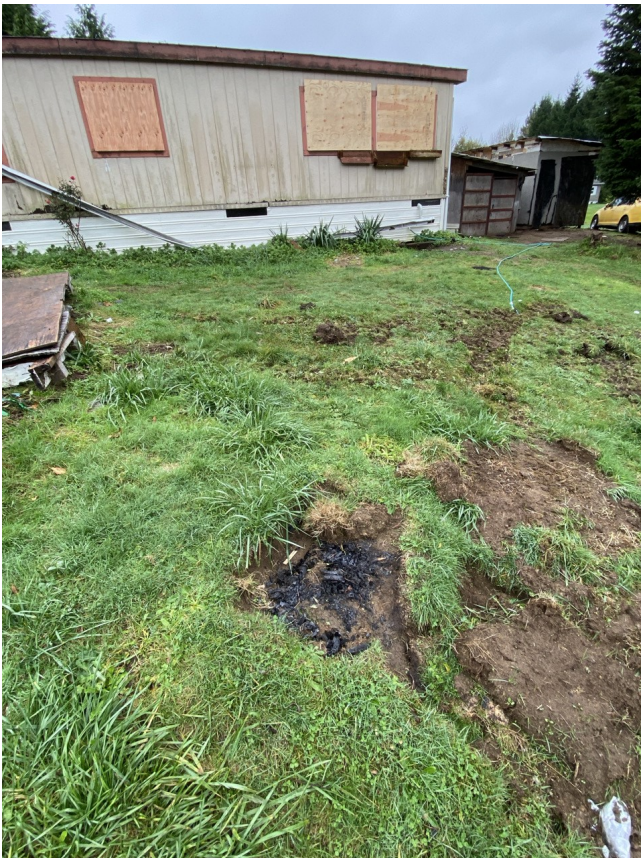
Photo 15 (Map Photo ID 139): Dig and fill areas and burn pits near boarded up mobile home.

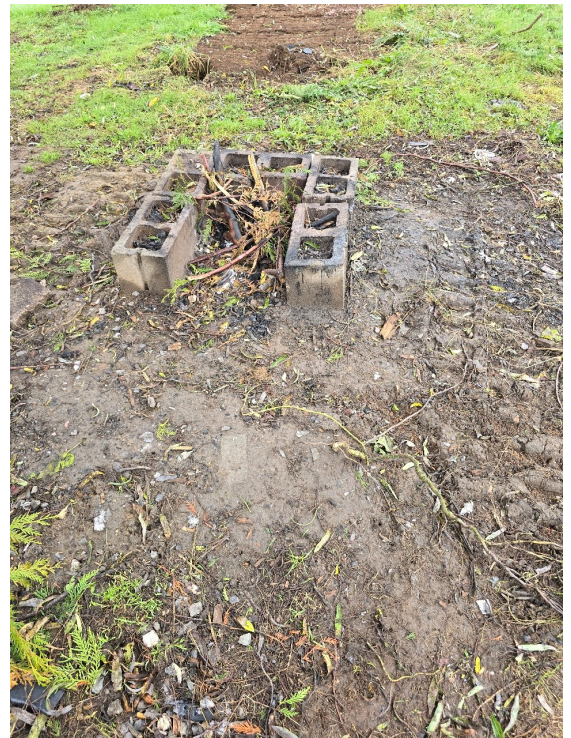
Photo 16 (Map Photo ID 134): Another burn pit near the mobile home.

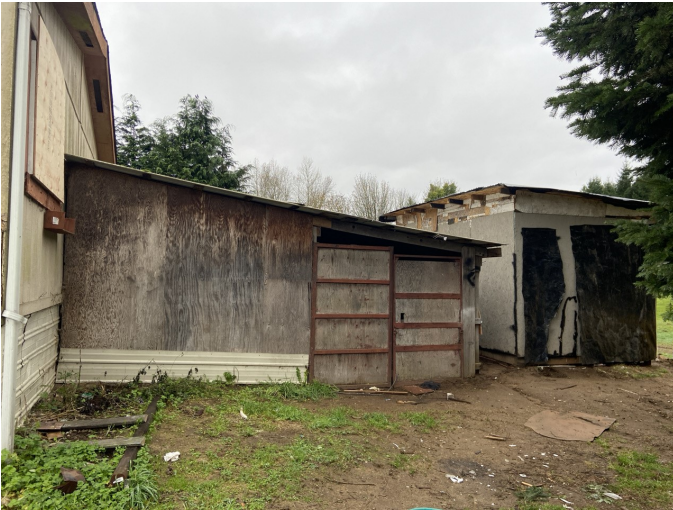
Photo 16 (Map Photo ID 142): Sheds on the north side of the mobile home. Garbage is spread throughout this area.

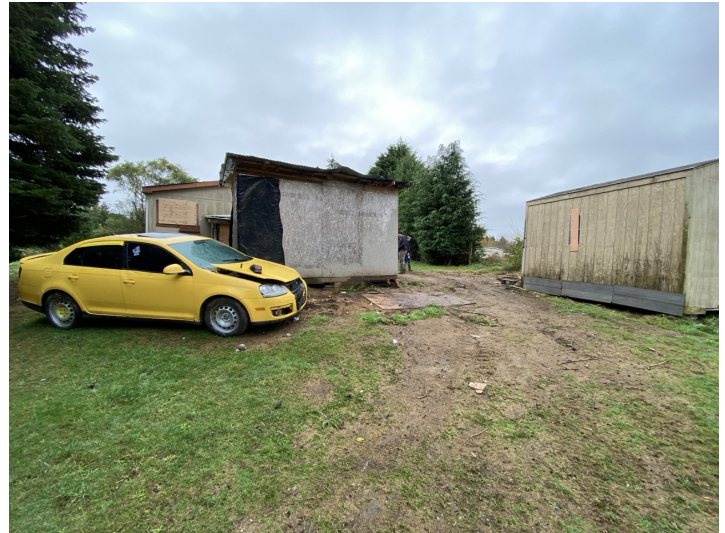
Photo 17 (Map Photo ID 147): Another view of the sheds, looking south. A stripped car filled with garbage was also found, no visible leaks were seen.

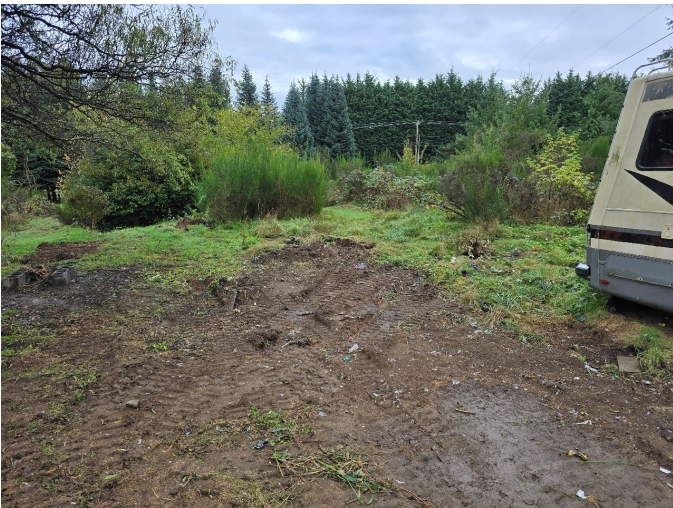
Photo 18 (Map Photo ID 138): Staff believe an RV was removed from this area (south side of the mobile home). Garbage was spread throughout this area.

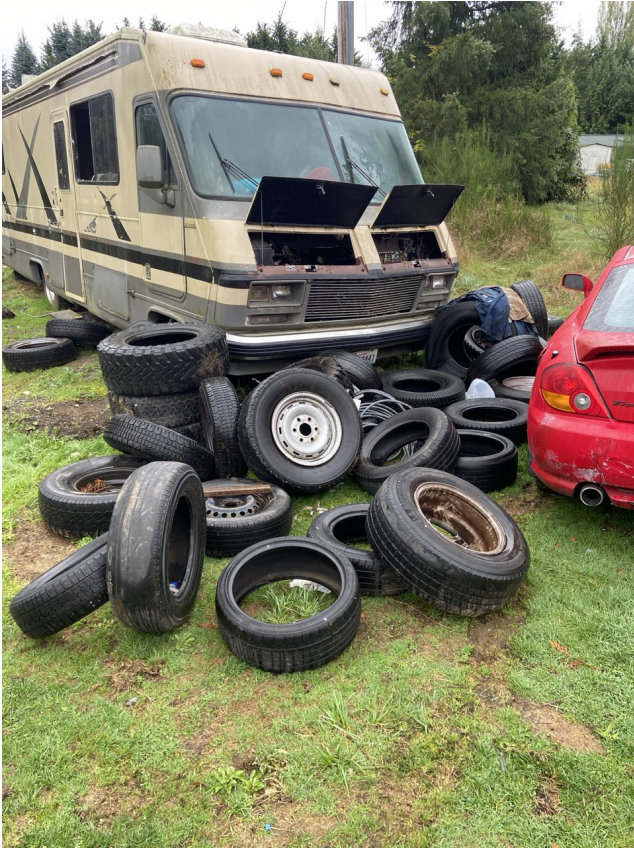
Photo 20 (Map Photo ID 135): Broken down and scrapped RV and car, with a pile of tires. Photo taken near southwest corner of the property. Trash was seen throughout this area.

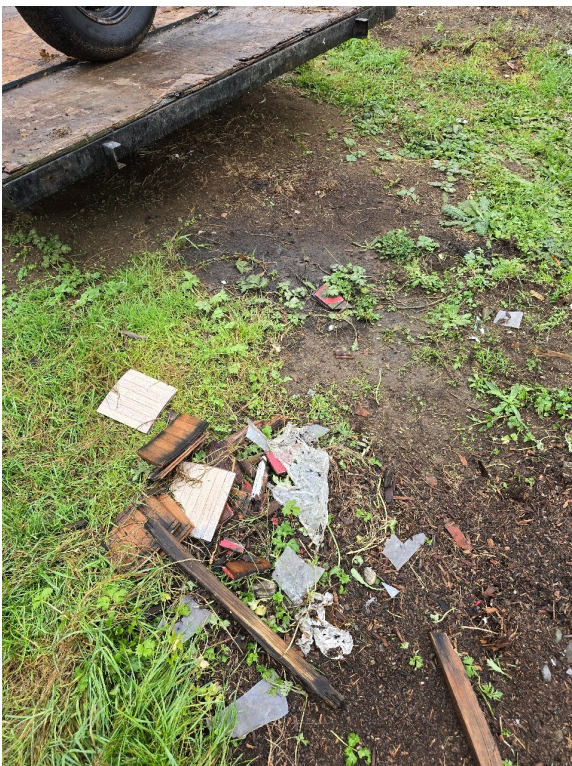
Photo 21 (Map Photo ID 132): Garbage, foil (drug paraphernalia) and potential stained soils near the Photo (20).

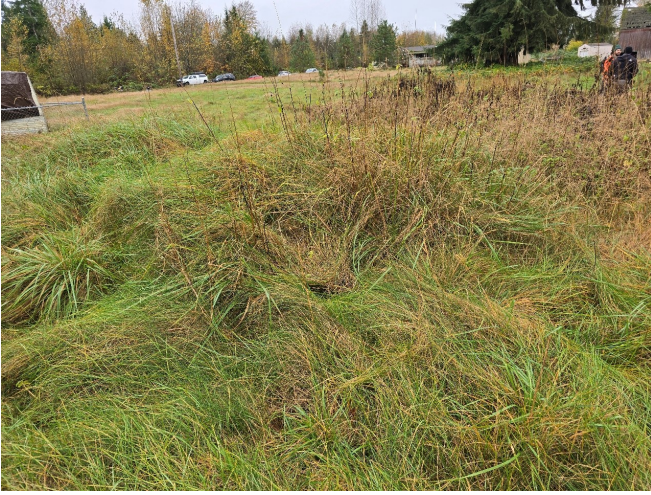
Photo 3 (Map Photo ID 125): Mounds were seen covered by long grass. This area should be explored further to ensure materials aren't buried here. Photo taken looking south.

**Conclusion and Recommendation:** This parcel was mostly clean and doesn't appear to have any significant environmental concerns. The two trailers should be investigated for soil contamination, the trash piles should be cleaned up, and the old chimney pipe should be investigated to ensure its not connected to a subsurface pile of unknowns. **Low Level of Risk that can be Mitigated.**

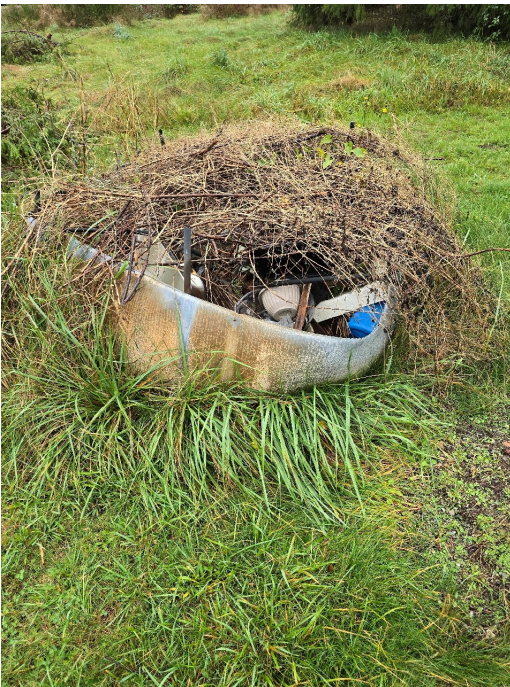
Photo 6 (Map Photo ID 120): Burn pile and garbage near the northwestern corner of the parcel.

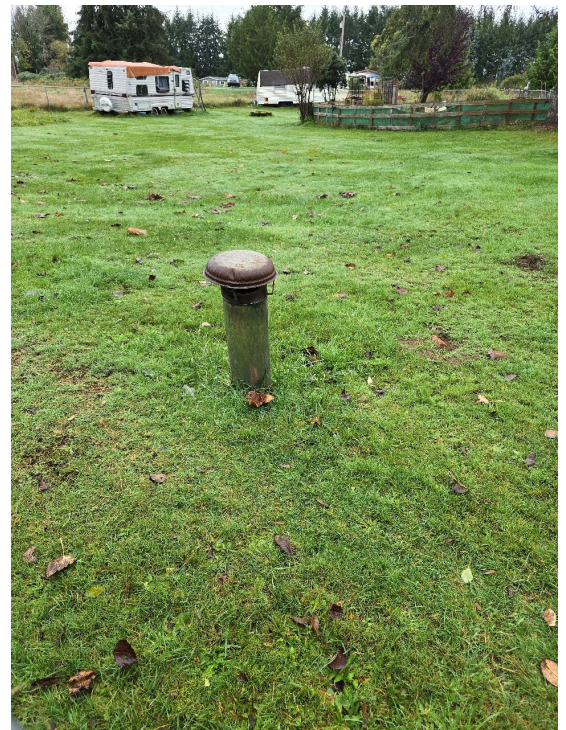
Photo 7 (Map Photo ID 118): Old chimney pipe that appears to be stuck in the ground. This was inside the fenced backyard and staff were unable to investigate further. Two old trailers can be seen, as well.

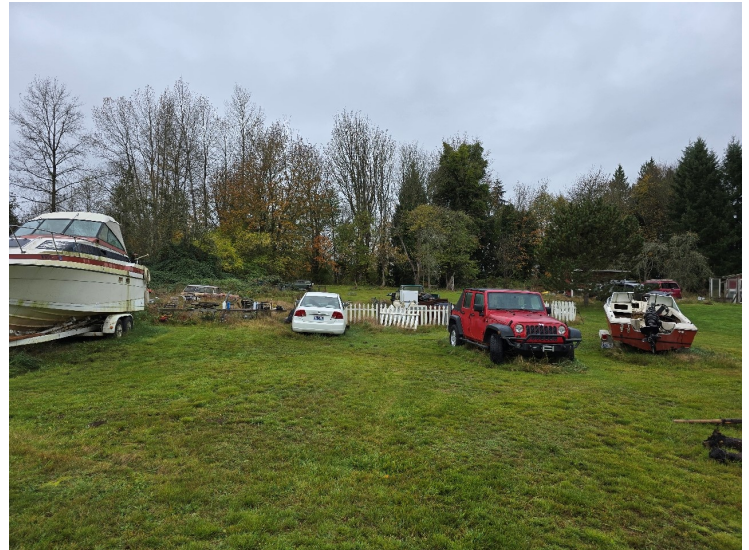
Photo 4 (Map Photo ID 150): Cars, boats, and other junk. No apparent signs of leaking were apparent, but further investigation would be wise post-removal.

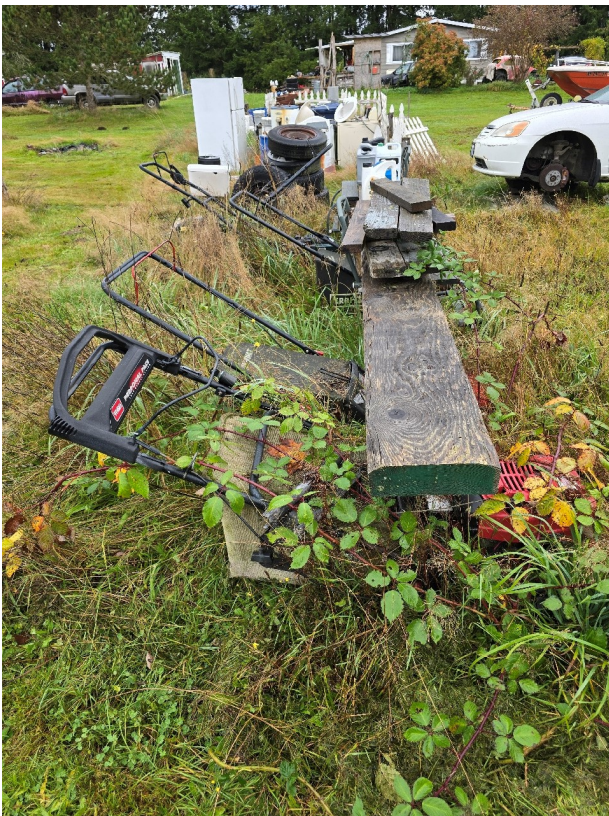
Photo 5 (Map Photo ID 153): A large pile of junk including lawn mowers, fridge, tires, and other household items.

**Conclusion and Recommendation:** This parcel was mostly clean and doesn't appear to have any significant environmental concerns. All piles of junk should be removed and investigated for soil contamination, especially the areas with household appliances, chemicals, and paint cans. **Low Level of Risk that can be Mitigated.**

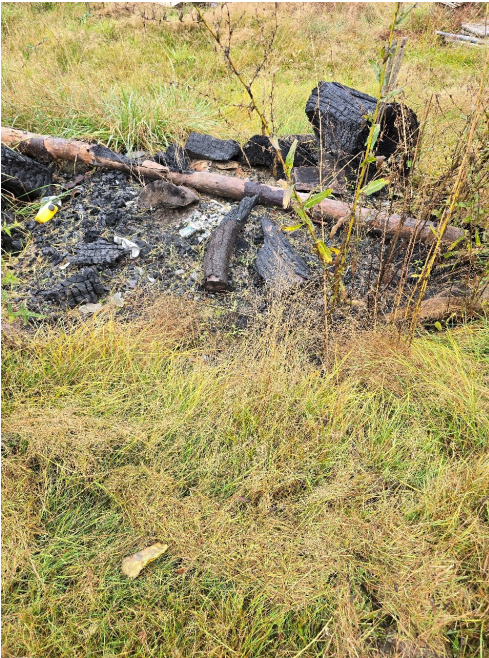
Photo 7 (Map Photo ID 161): A burn pit near the southern property line and next to the piles of junk from Photos (5 & 6).

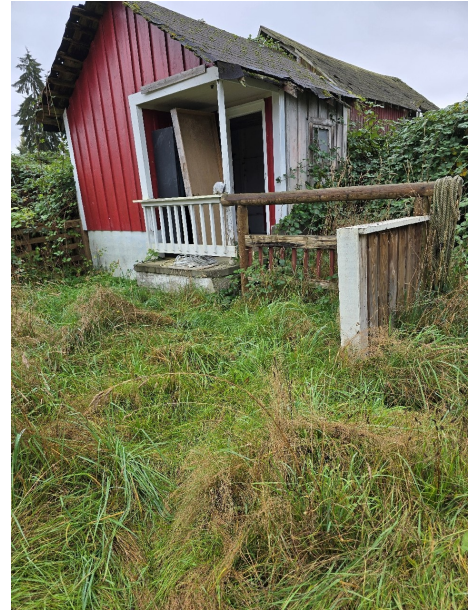
Photo 8 (Map Photo ID 165): An old storage shed near the southern edge of the property. This likely needs to be torn down, as its highly compromised.

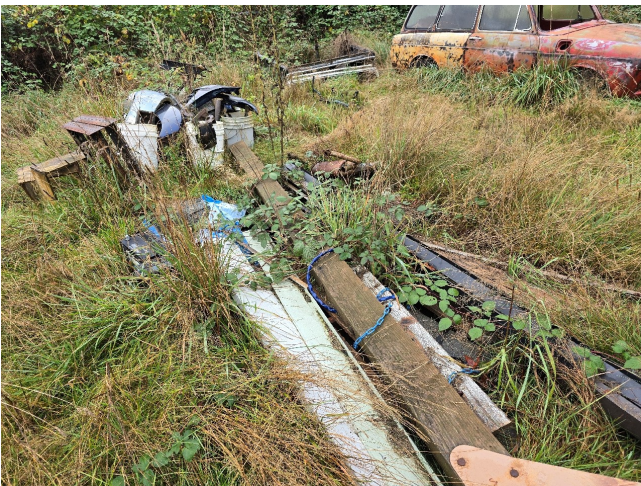
Photo 9 (Map Photo ID 163): Another pile of junk, including dimensional lumber, and a broken down vehicle. Seen along the southern property line.

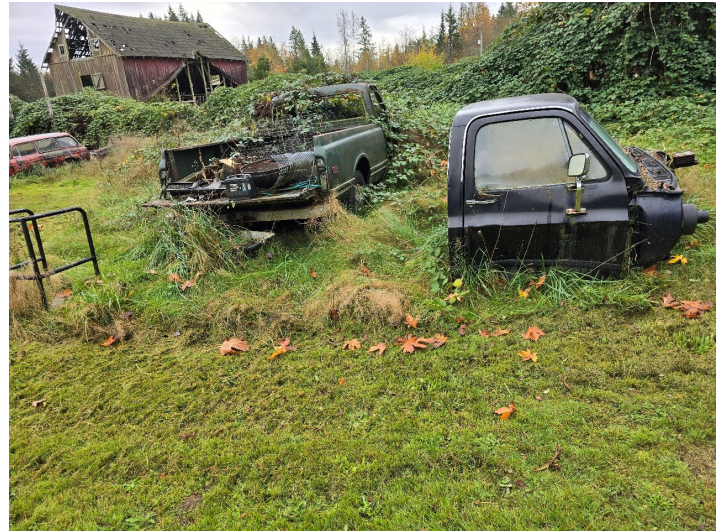
Photo 12 (Map Photo ID 173): Broken down and parted out trucks, near the southwest corner of the property.

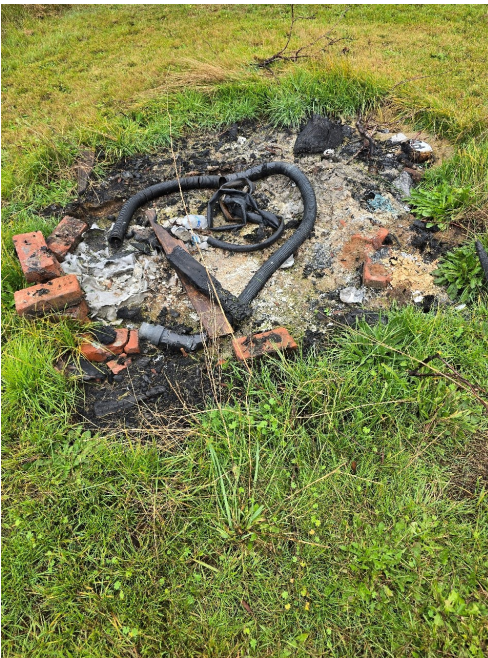
Photo 13 (Map Photo ID 159): Another burn pile, with garbage present, near the southern property line.

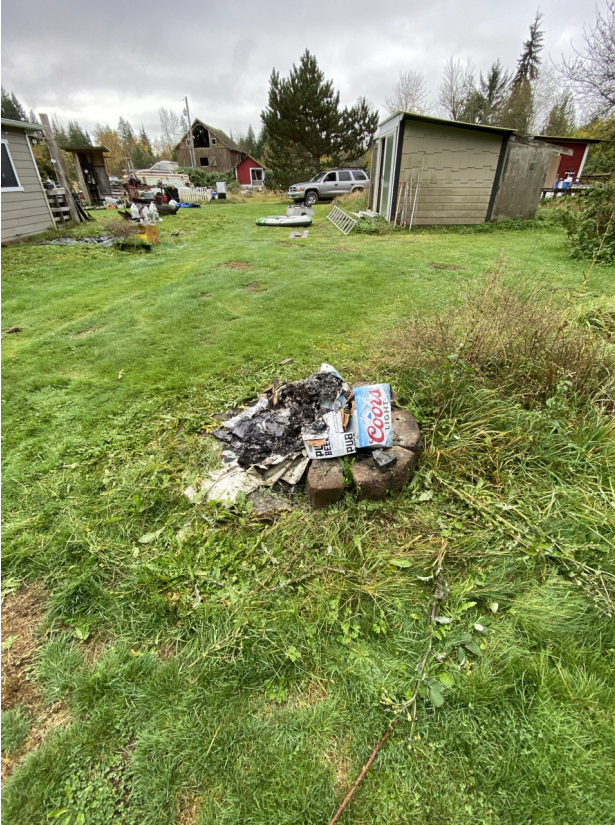
Photo 19 (Map Photo ID 162): A burn pit on the west side of the house.

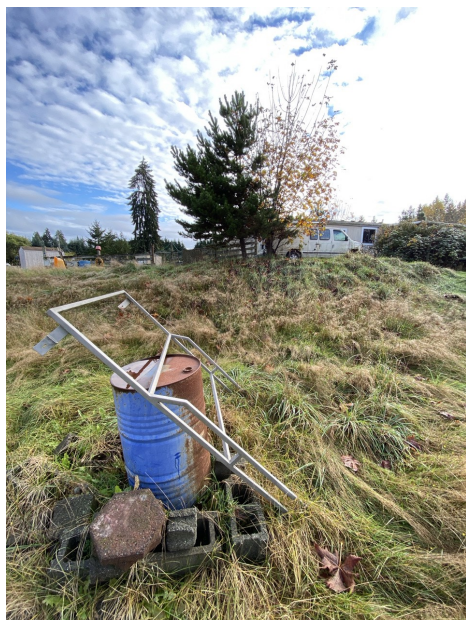
Photo 5 (Map Photo ID 206): A chemical drum located just south of the house. The cap of drum seemed compromised, with possible rainwater intrusion. The drum was partially full, but no apparent leaks.

**Conclusion and Recommendation:** This parcel was mostly clean and doesn't appear to have any significant environmental concerns. All piles of junk should be removed and investigated for soil contamination, especially the areas with household appliances and chemicals. **Low Level of Risk that can be Mitigated.**

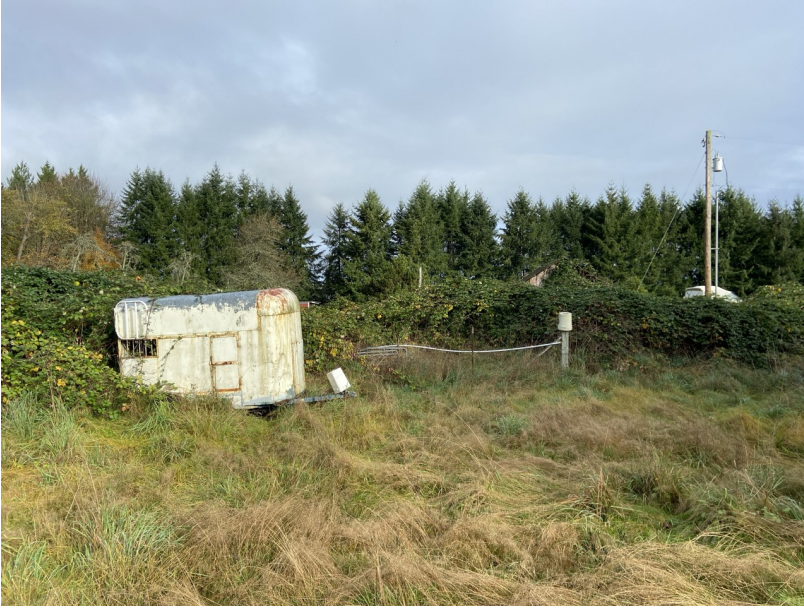
Photo 15 (Map Photo ID 199): An abandoned livestock trailer found northwest of the barn.

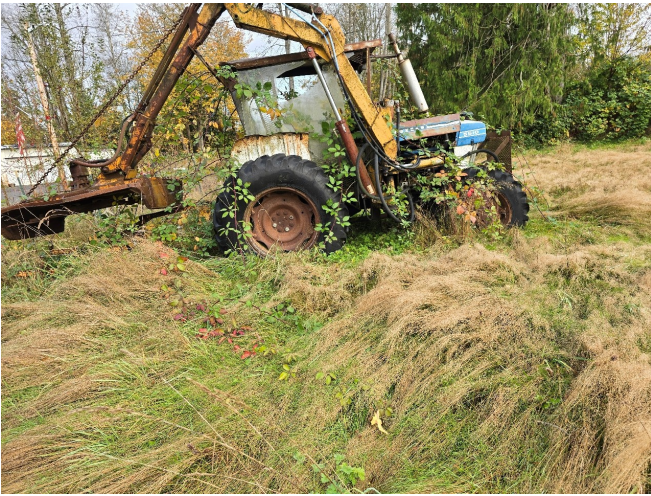
Photo 3 (Map Photo ID 189): Derelict tractor just east of the driveway entrance, no smells (petroleum products) were apparent.

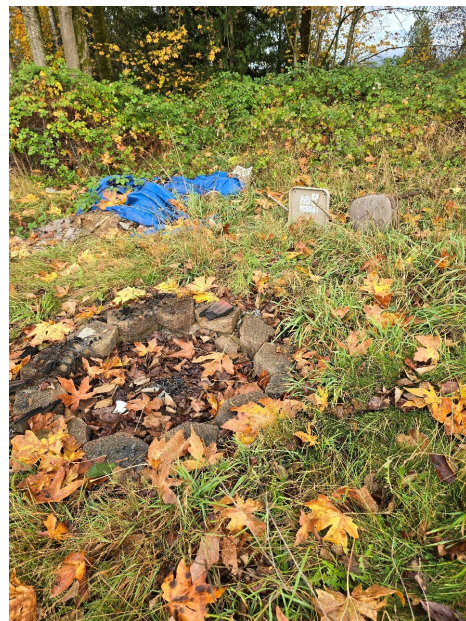
Photo 9 (Map Photo ID 184): Another burn pile and/or firepit located just east of the garage/shop and next to Photo (8).

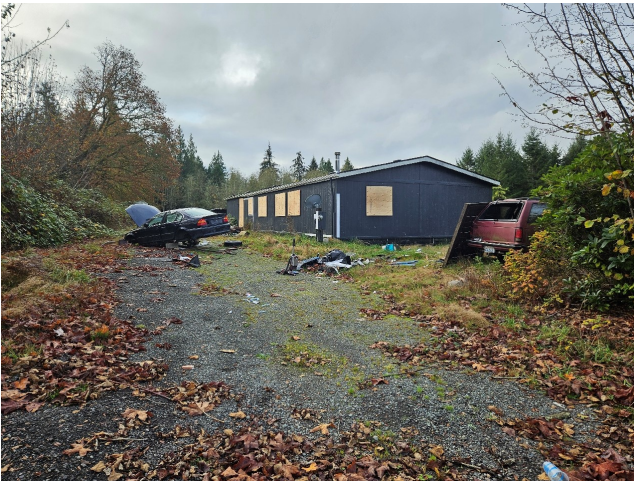
Photo 1 (Map Photo ID 209): Overview of the property as viewed from the driveway entrance off 246th St NE. Broken down cars and piles of junk can be seen.

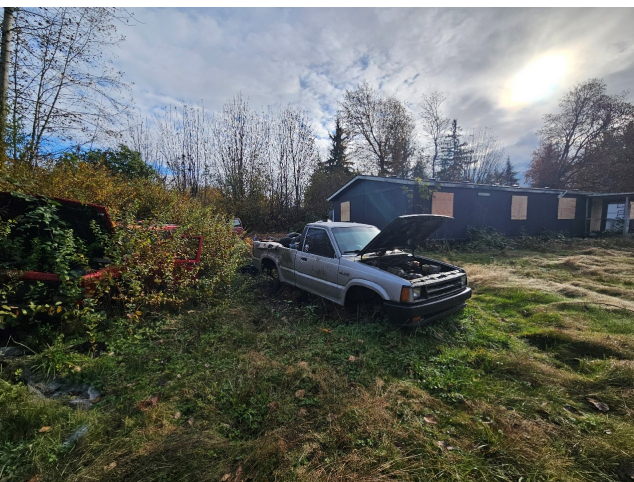
Photo 2 (Map Photo ID 210): Northside of the property , just west of Photo (1). More broken down cars and junk were present. No obvious signs of contamination were present around the vehicles.

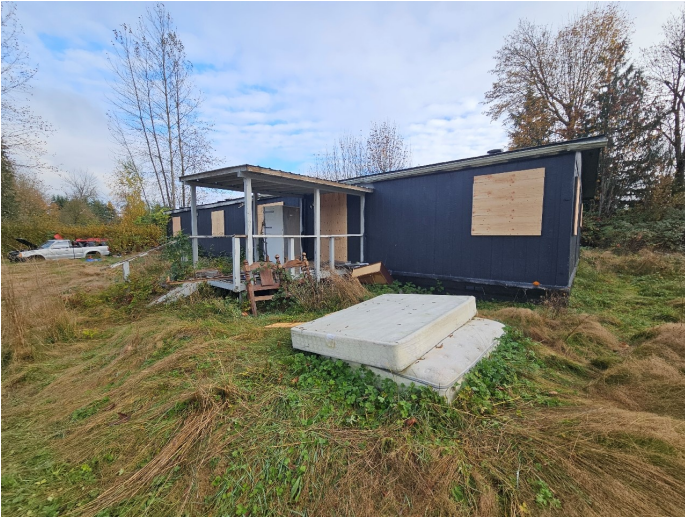
Photo 3 (Map Photo ID 212): West side of the house, with more piles of junk and mattresses.

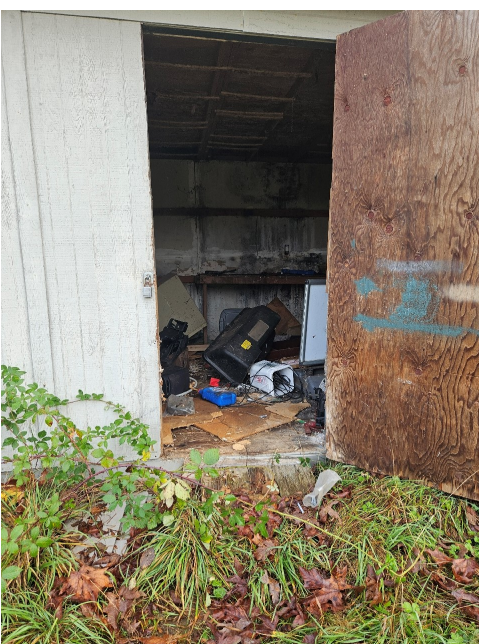
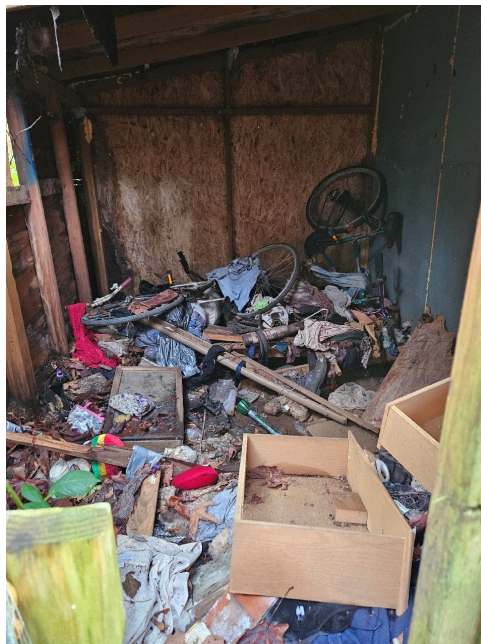
Photos 4 (Map Photo ID 216 & 217): Inside the storage sheds from Photo (4). They were filled with junk, chemicals, clothes, etc. Staff were unable to investigate inside the sheds due to their condition.

**Conclusion and Recommendation:** This parcel was filled with broken down cars, junk, and general refuse. All broken down cars should be removed and checked for soil contamination. The sheds should be cleaned out and checked for contamination. The wellhead should be check that the leak was fixed and not just covered up. **Risk need Further Investigation.**

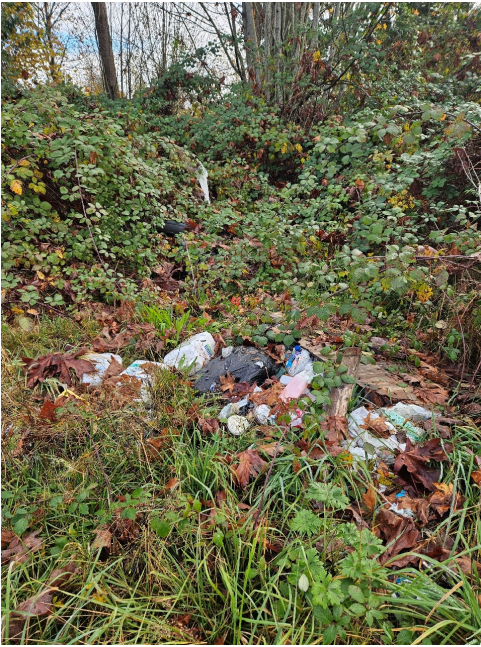
Photos 5 (Map Photo ID 214): A pile of trash just behind (east) of the two storage sheds.

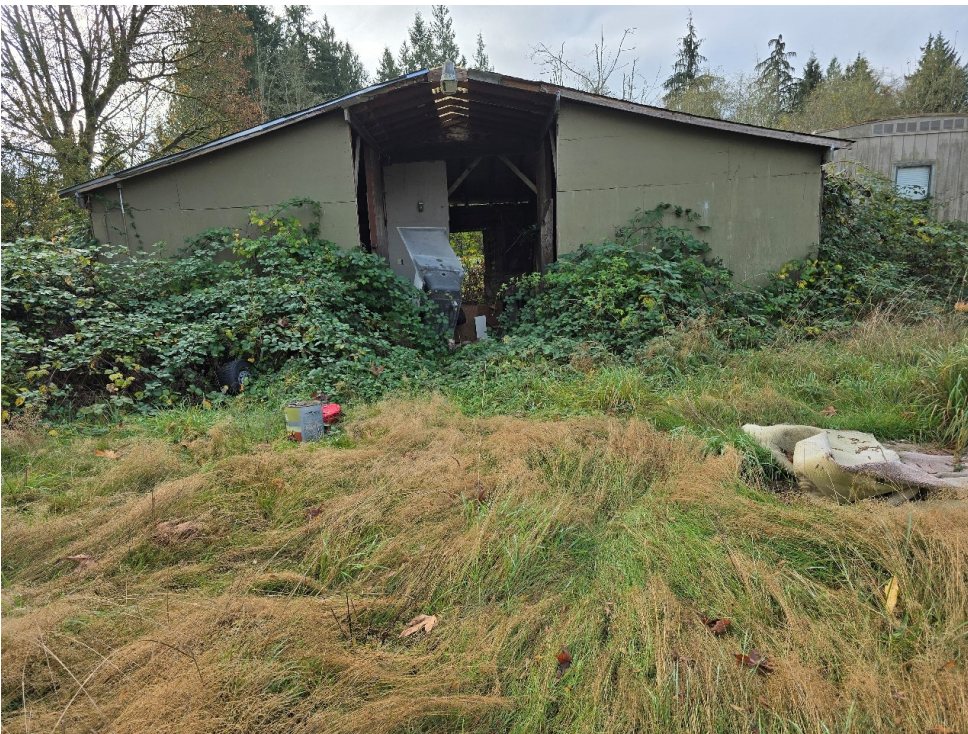
Photos 7 (Map Photo ID 207): An old barn filled with tires, carpets, bath tubs, chemicals, and various junk (both within and around). Located on the southern portion of the parcel.

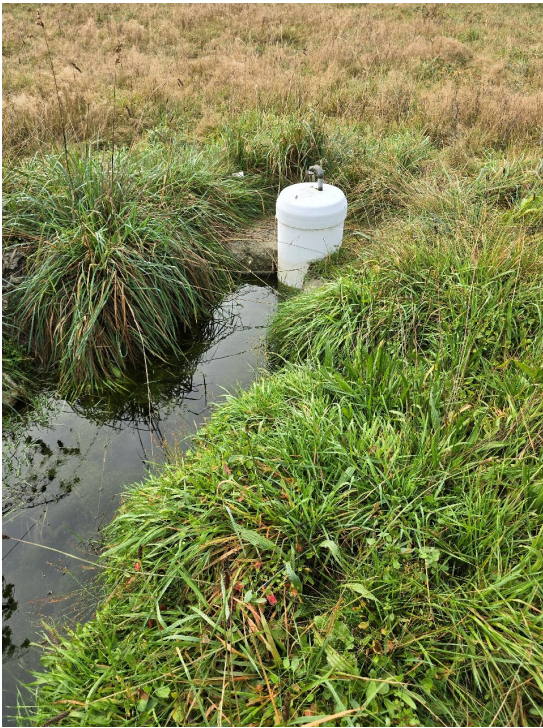
Photos 8 (Map Photo ID 196): Well which services all parcels part of the Schultz Clan Property. A pipe runs from here, north to the new Well House. Previous tenants had broken the pipe, creating a serious leak, as surface water can be seen pooled around the wellhead.

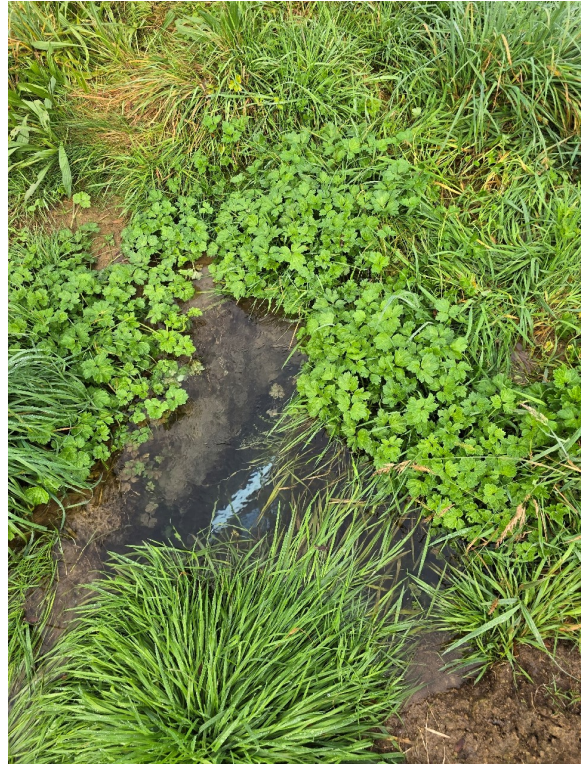
Photos 9 (Map Photo ID 194): A closer look at the location of the leak (10-15 feet away from the well head). Well company working on the new pump house were to fix this in the coming days. A follow-up should be completed to ensure this leak is fixed, as the water is not safe to drink in its current state.

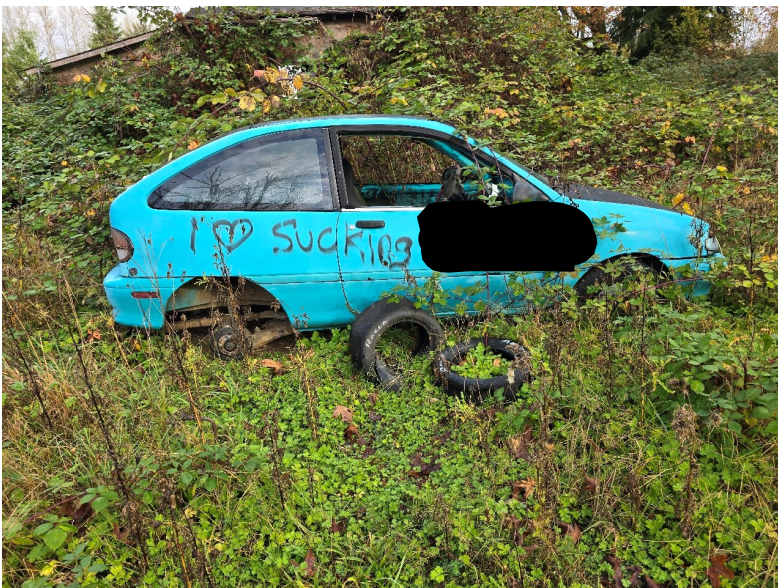
Photos 10 (Map Photo ID 201): A broken down car spray painted with vulgar language, located behind the barns. Obvious signs of contamination were not seen.

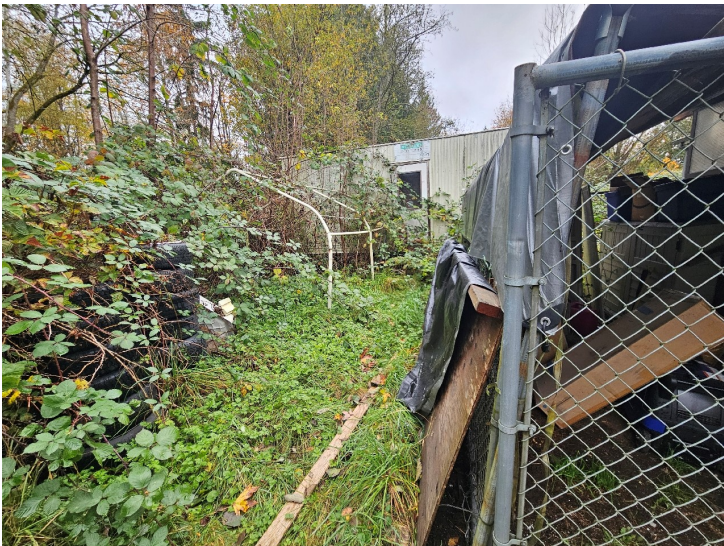
Photo 5 (Map Photo ID 234): The backyard of the house (west) as seen from the corner of the covered patio, filled with junk and lawn care equipment. Tires and junk were found also located in the blackberry bush on the left side of the photo.

**Conclusion and Recommendation:** This parcel had broken down cars and smaller concentrations of junk and general refuse. All broken down cars should be removed and checked for soil contamination. Blackberry bushes should be further investigated to ensure more junk, cars, etc. aren't hidden. All other junk should be properly disposed. Overall, this property has a **Low Level of Risk that can be Mitigated.**

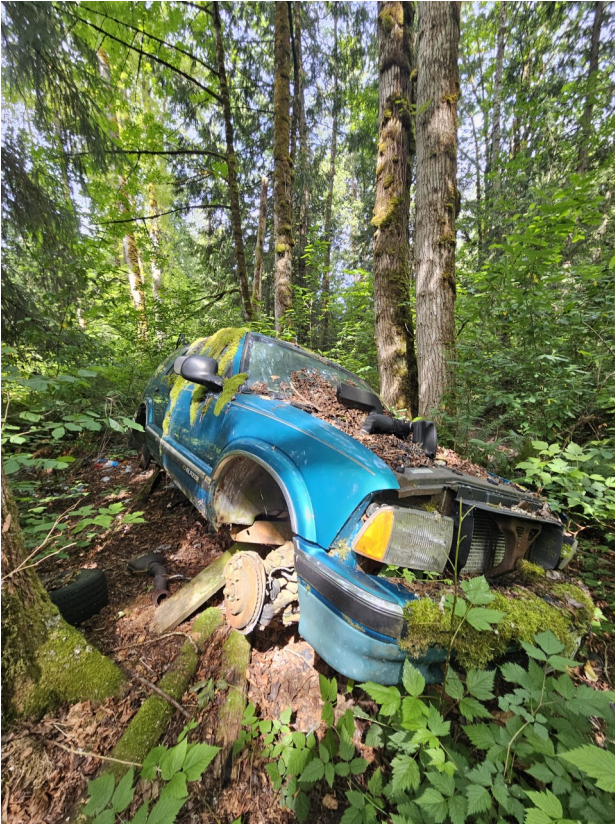
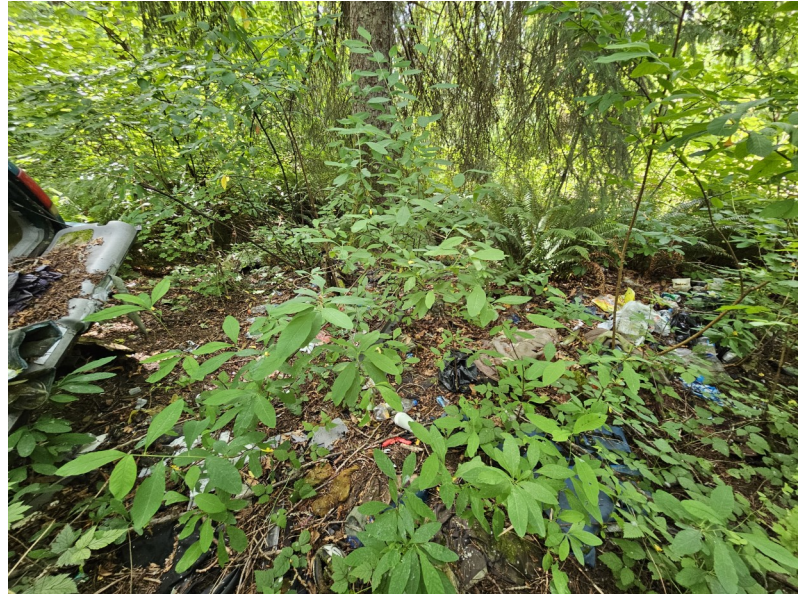
Photos 17 and 18: A broken down SUV surrounded by garbage. No petroleum smells were observed. Vehicle was found near the northwest corner of the property, west of the BP Olympic Pipeline about 75 feet.
