Property Assessment Checklist for Hazardous Substances Certification

Zoe Property Site Assessment

Address: 22732 19th Dr. NE, Arlington, WA 98223

Hoback Property Site Assessment

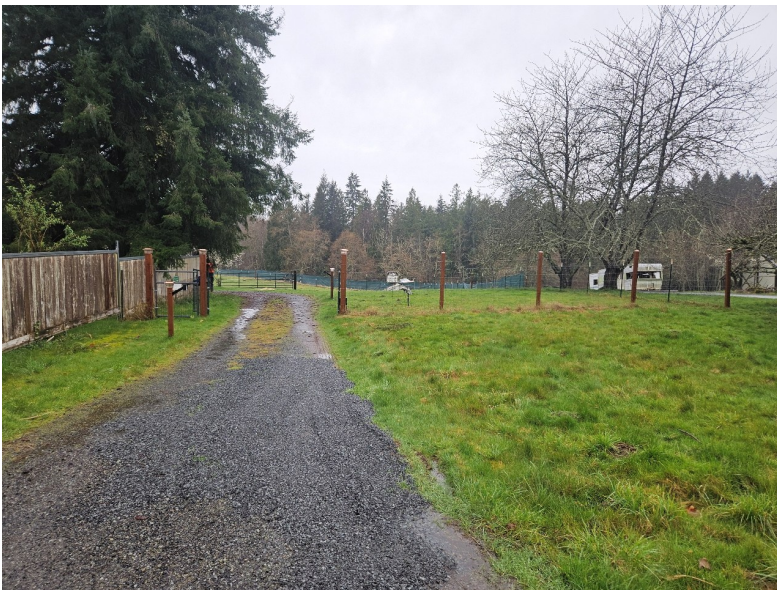
Photo 1 (Map Photo ID 277): Entrance to the property off 19th Dr. NE.

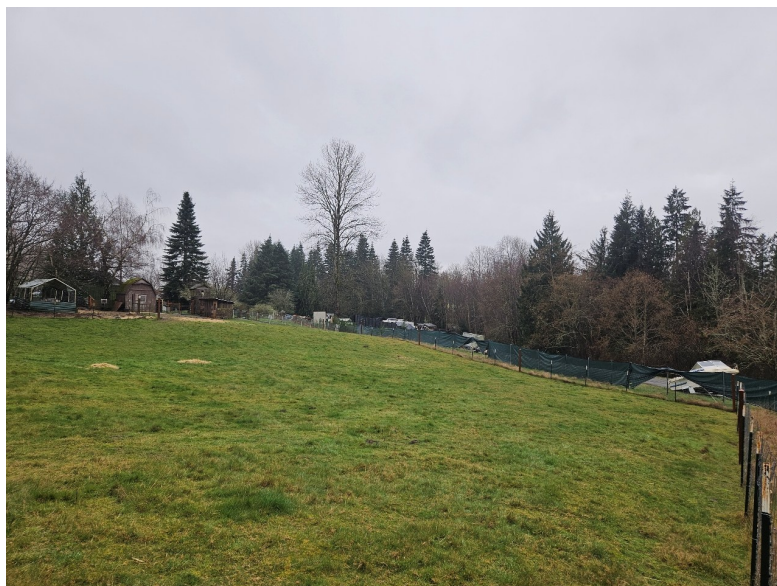
Photo 2 (Map Photo ID 279): Front yard looking towards the western property line.

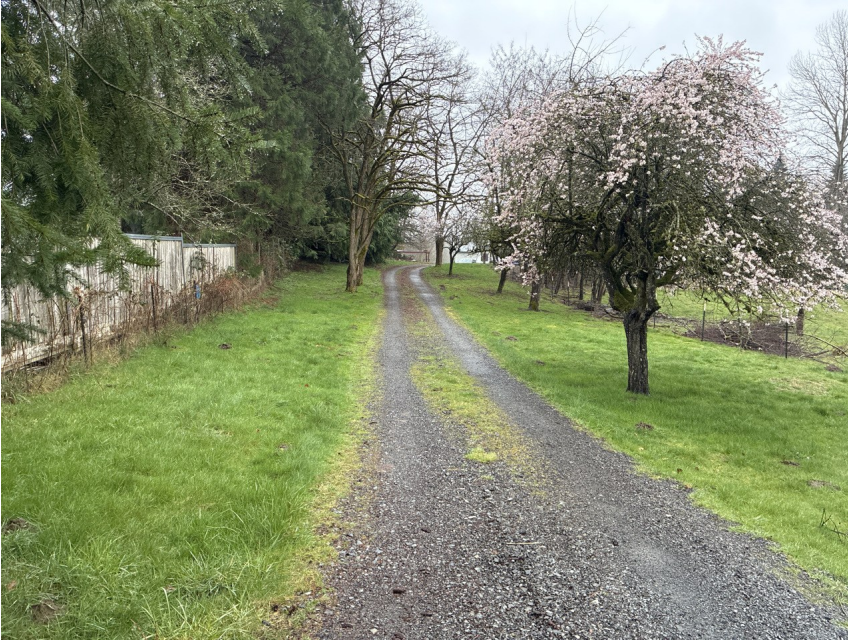
Photo 3 (Map Photo ID 278): Looking down the driveway from 19th Dr. NE which runs parallel to the eastern property line (fence on the left side of the photo).

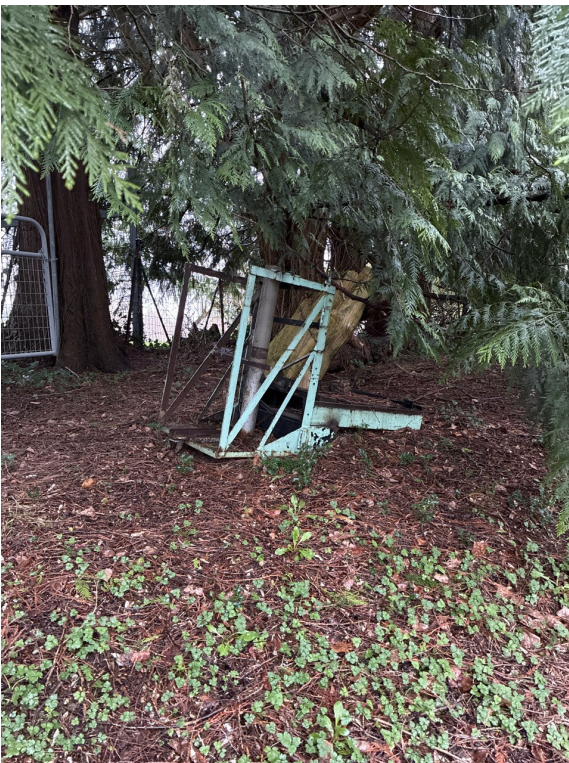
Photo 4 (Map Photo ID 280): Equipment and trash along the east fence.

Conclusion and Recommendation: This property was found to have no visible signs of environmental hazards or risks. It is a well maintained and cared for property. A few piles of rubbish should be cleared prior to closing. **No Apparent Risk.**

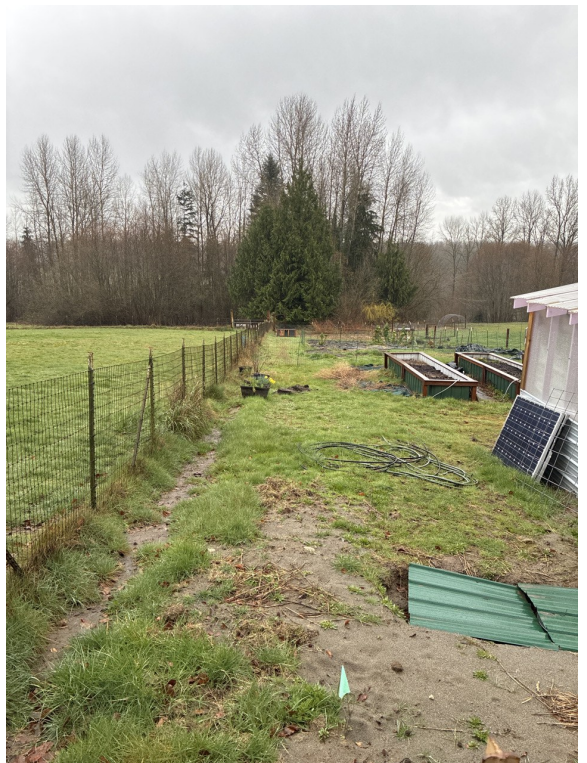
Photo 5 (Map Photo ID 285): Looking south down the eastern property line. The covered hole is used for composting vegetables grown on the property.

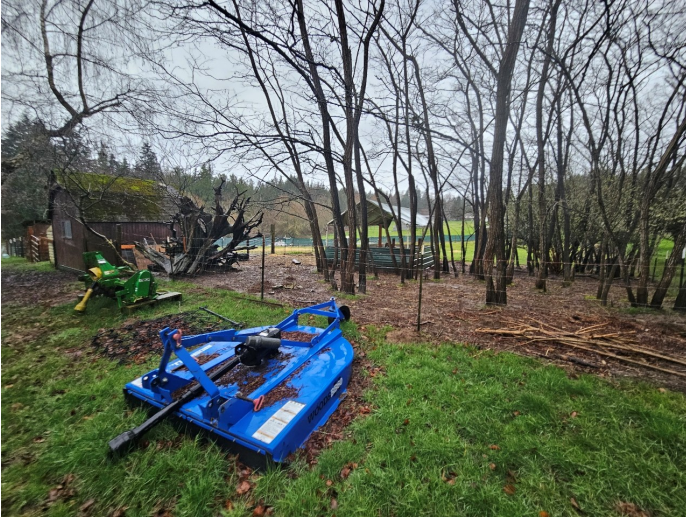
Photo 6 (Map Photo ID 281): Yard equipment next to livestock area in the northern portion of the property.

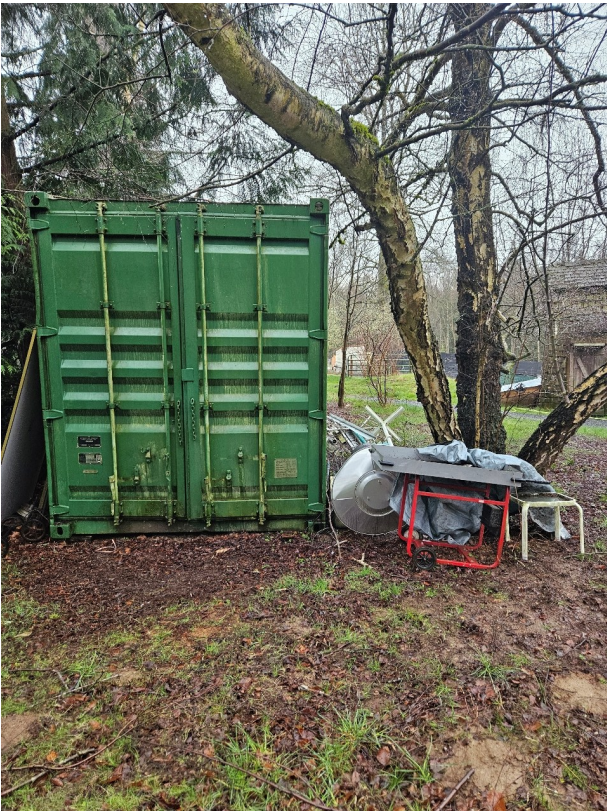
Photo 7 (Map Photo ID 283): Conex box with a pile of metal, including a propane tower heater.

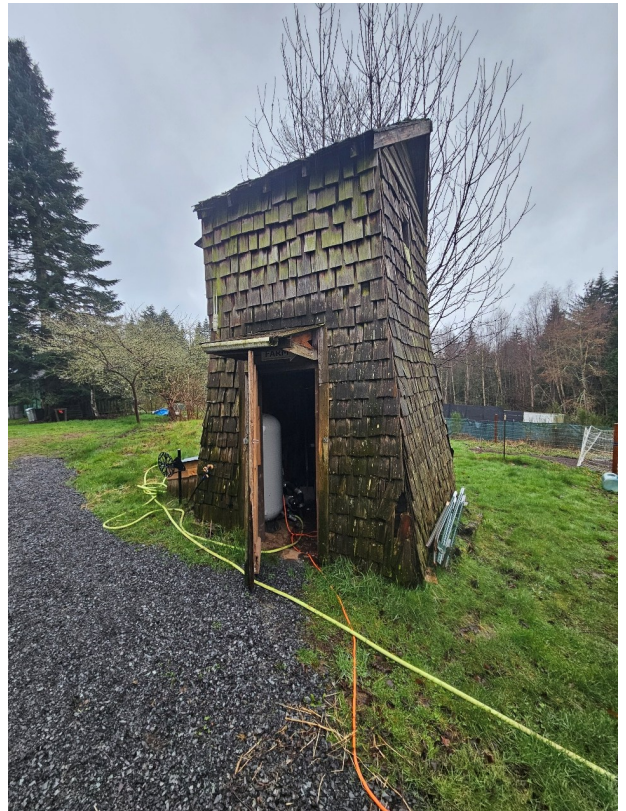
Photo 8 (Map Photo ID 284): Well house, covering well equipment and a dug well.

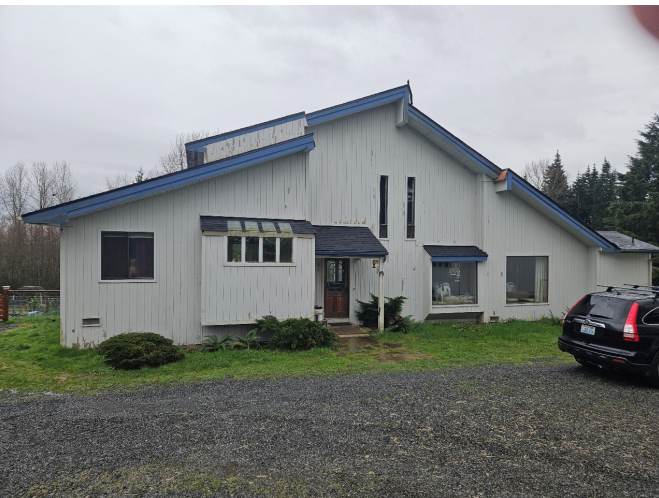
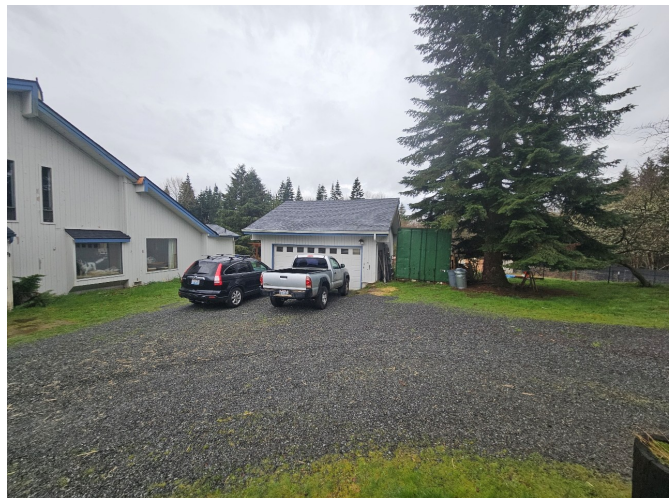
Photos 11 & 12 (Map Photo ID 301): Main residence and garage, looking south. A creosote retaining wall was located just behind Photo 12.

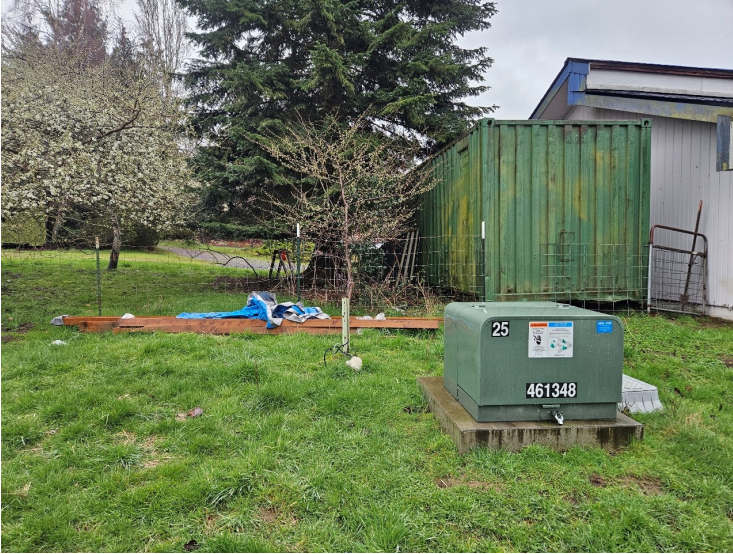
Photo 13 (Map Photo ID 288): Transformer box on the north side of the garage.

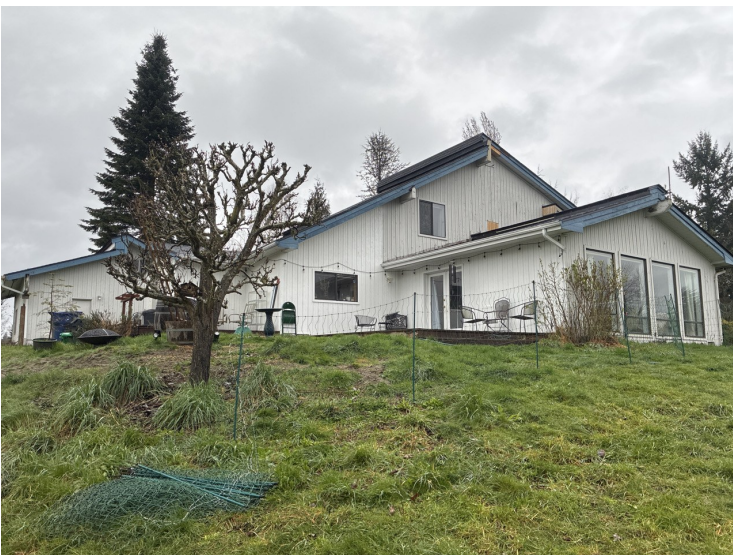
Photo 15 (Map Photo ID 291): Southern side of the main residence. From here, the property slopes south to the Stillaguamish River. Septic field is just downhill and right (east) of this photo. Septic access is buried.

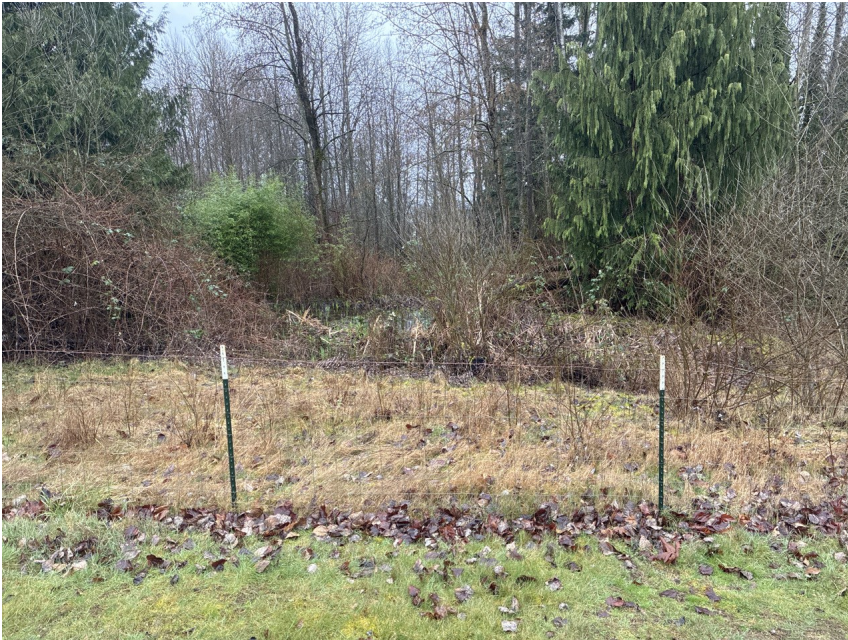
Photo 16 (Map Photo ID 292): Small pond (400 square feet) along the eastern property line, looking east.

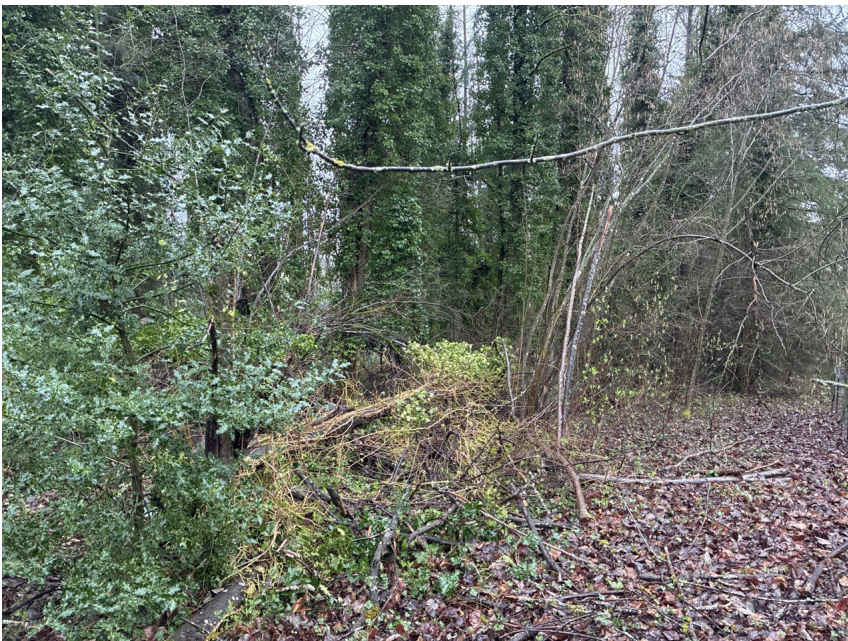
Photo 17 (Map Photo ID 300): Invasive plants in timber section along the eastern fenceline down to the river. No pond outlet was seen, however there were saturated soils to the south of the pond. Neighboring property has a ravine running south to the river.

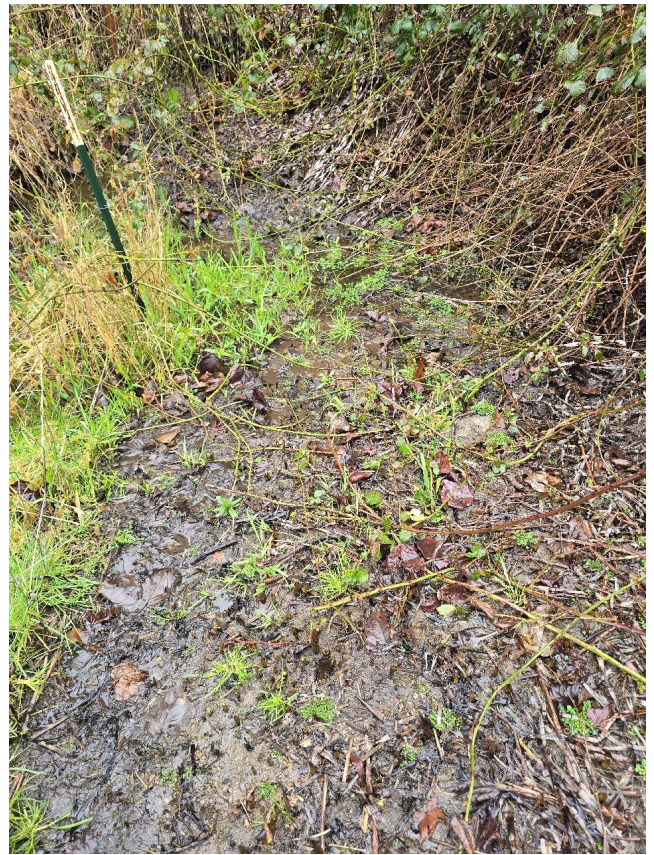
Photo 19 (Map Photo ID 298): Water seepage/spring near the western property line, about halfway down the hill. Water flows through a ravine down to the river.

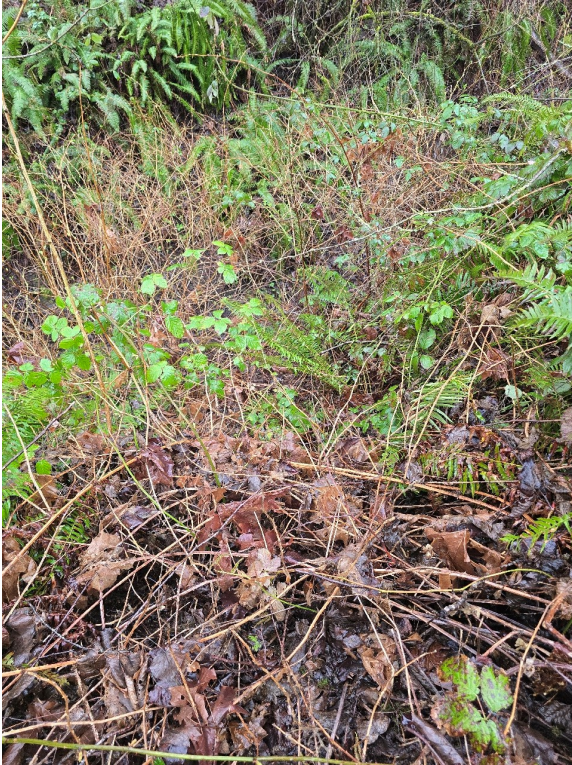
Photo 21 (Map Photo ID 294): Deep ravine near the western property line. Water originates from the seepage/spring uphill.

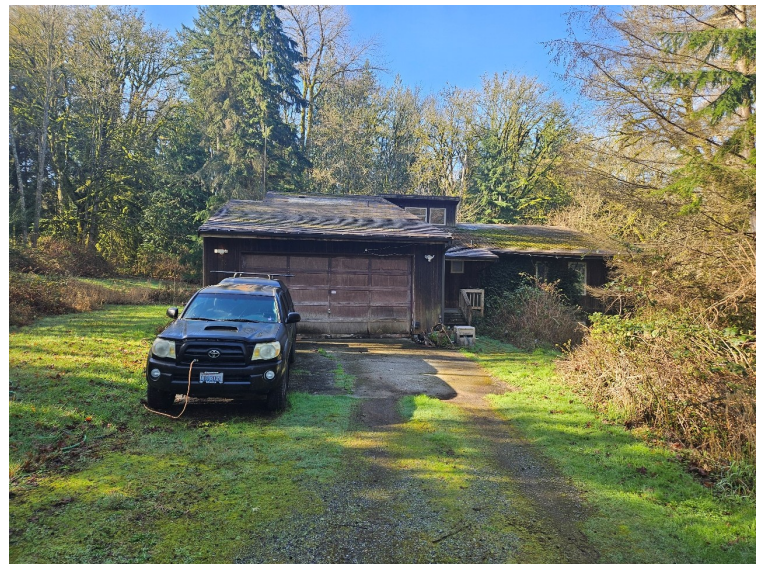
Photo 2 (Map Photo ID 303): Residence on the property. Ivy was seen growing up the north side of the house.

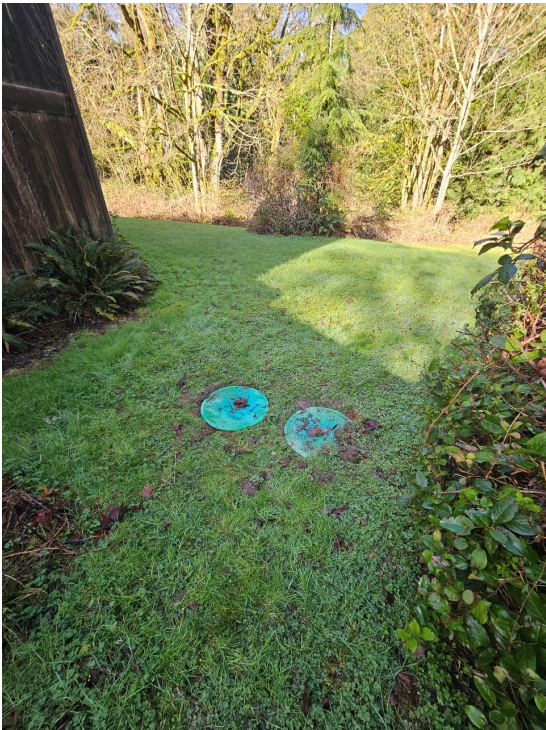
Photo 3 (Map Photo ID 304): Septic tanks on the west side of the house—the caps look new.

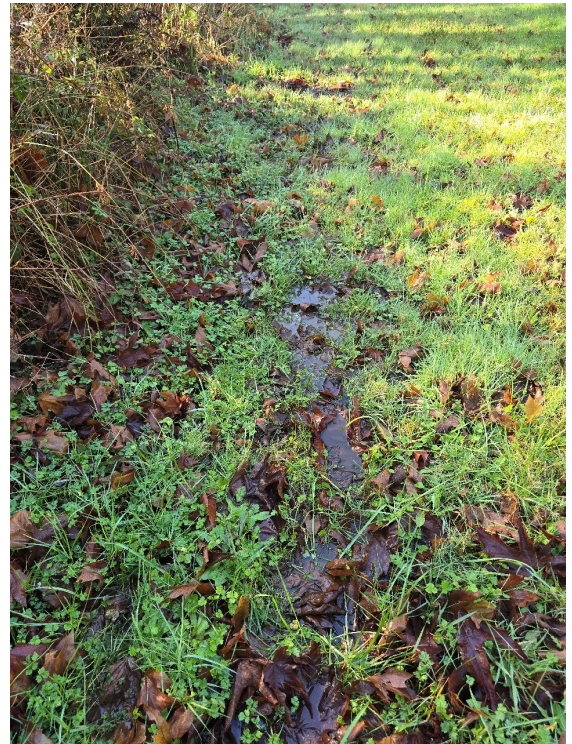
Photo 4 (Map Photo ID 305): Saturated lawn on the east side of the residence.

Conclusion and Recommendation: This property was found to have no visible signs of hazardous substances risk. However environmentally, saturated soils were seen surrounding the house, particularly the east and south side. Drainage issues will continue to be an issue at the property during wet periods of the year. Overall, the property is well maintained. A few piles of rubbish should be cleared prior to closing. **No Apparent Risk.**

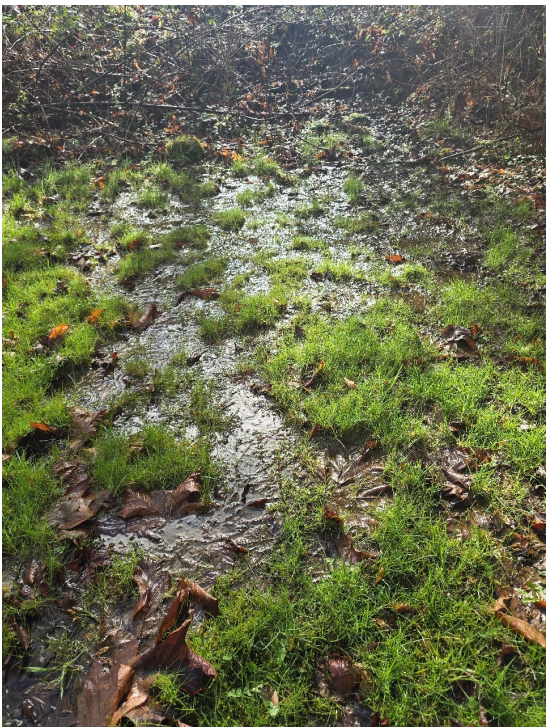
Photo 5 (Map Photo ID 315): More saturated lawn on the southwest side of the residence.

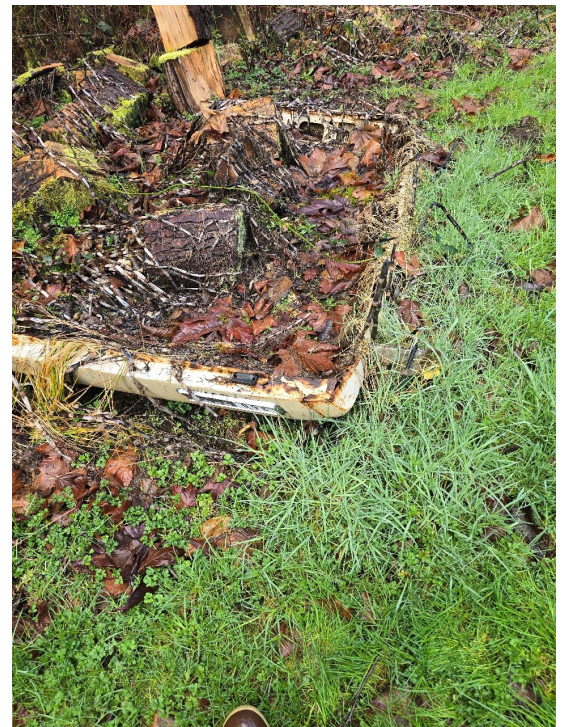
Photo 6 (Map Photo ID 313): The hood of a vehicle on the edge of the south lawn.

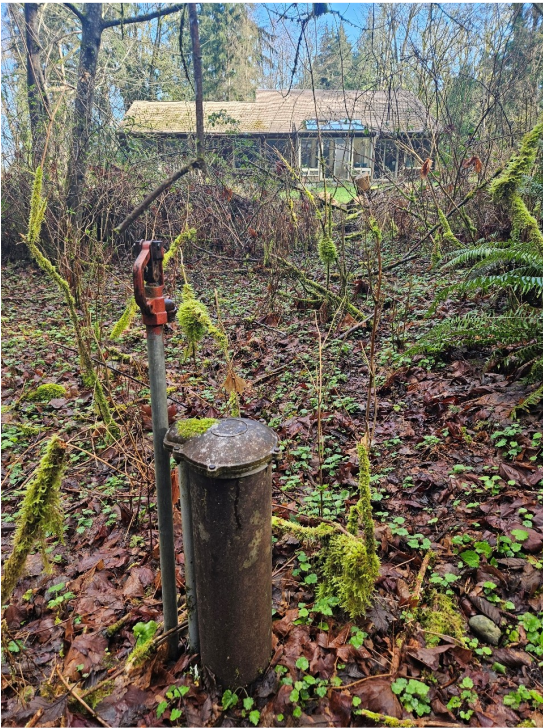
Photo 7 (Map Photo ID 314): Drilled well head and spigot south of the residence. No well tag was present. Just to the south of the well head there is a small wetland.

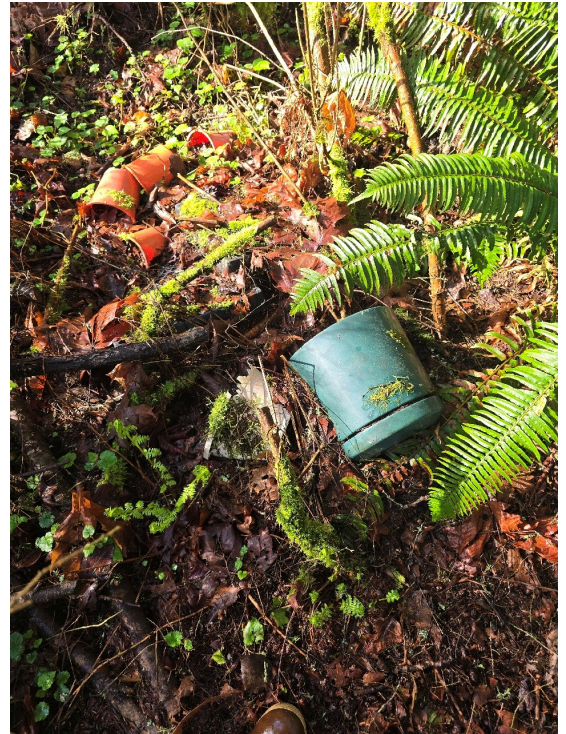
Photo 7 (Map Photo ID 312): Old plant pots found in the forested, southeast section of the property.

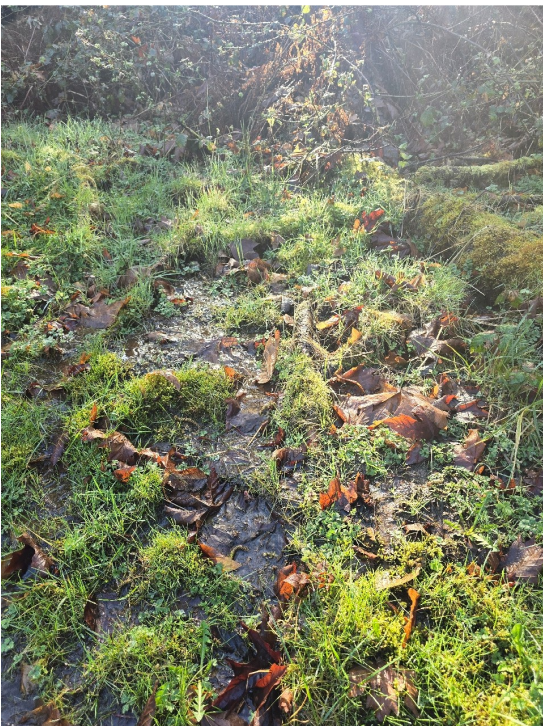
Photo 7 (Map Photo ID 312): More saturated lawn in the southeast section of the property.

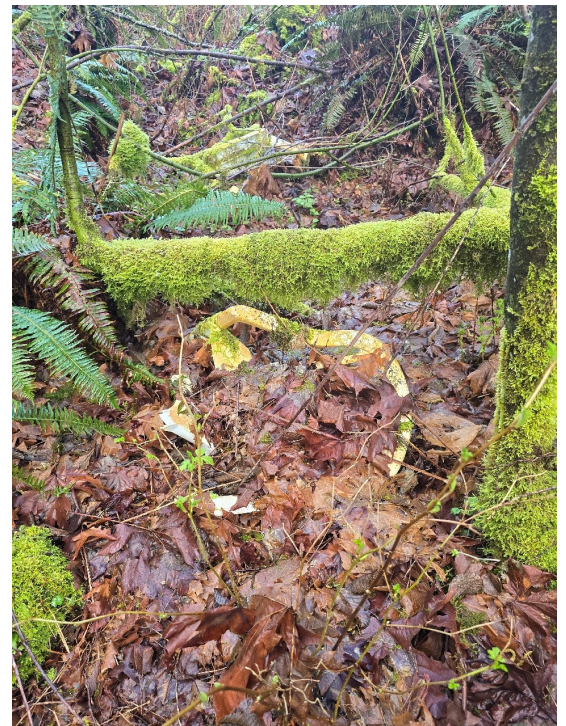
Photo 8 (Map Photo ID 310): Old plastic lawn chairs in the southeast section of the property.

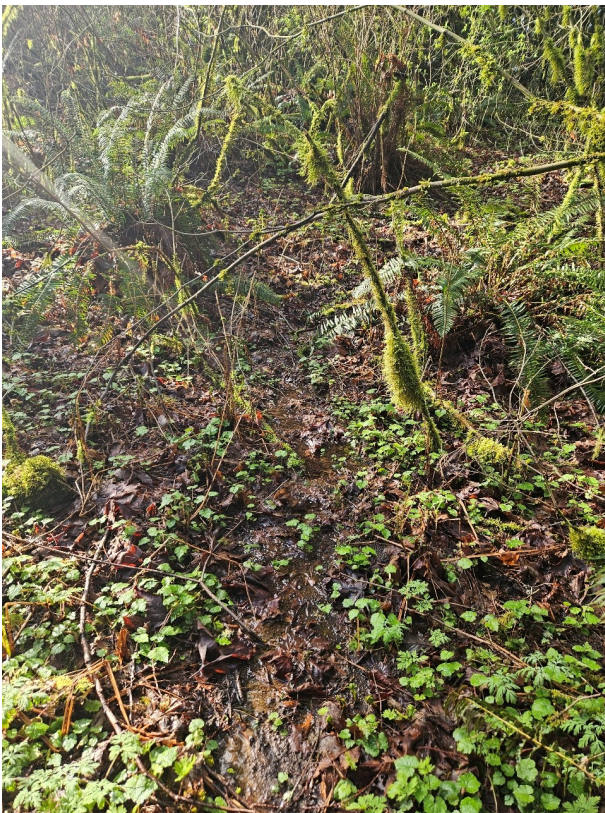
Photo 10 (Map Photo ID 309): Saturated soils near the northwest corner of the property.
