Stillaguamish Tribal Response Program

Public Record Packet Summary

Lind Property Site Assessment

Assessment date: January 19, 2023

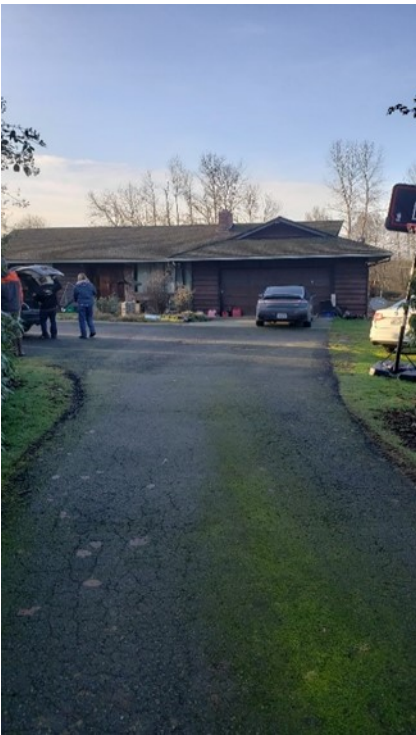
Photo 1: One of two residences on the property. For purposes of this report, this residence will be called the ‘main residence’. Photo taken looking west from the southern driveway off 15th Ave.

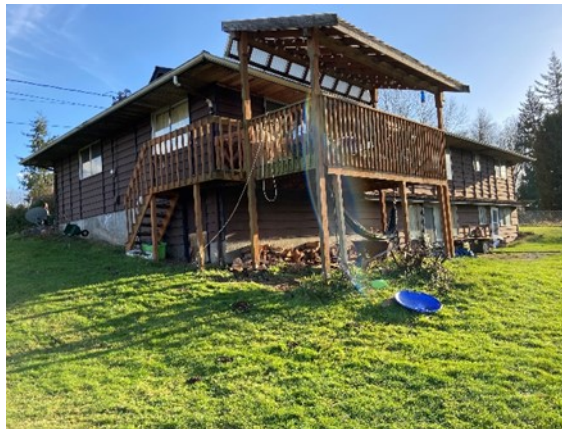
Photo 2: The main residence from the backyard. The water treatment infrastructure is located under the stairs—water filter, conditioner, etc. can be found in this room. Photo taken looking south-east, towards 15th Ave.

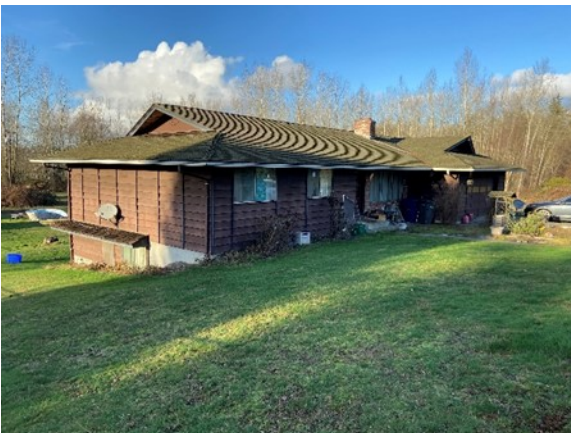
Photo 3: Another angle of the main residence. Photo taken looking northwest, close to the southeastern corner of the property.

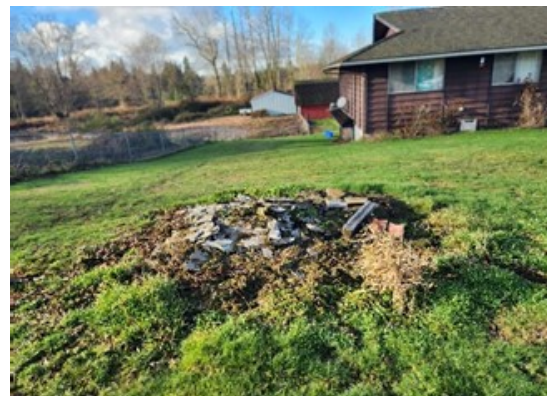
Photo 4: A small pit, and/or burn area near the southeastern corner of the main resi-

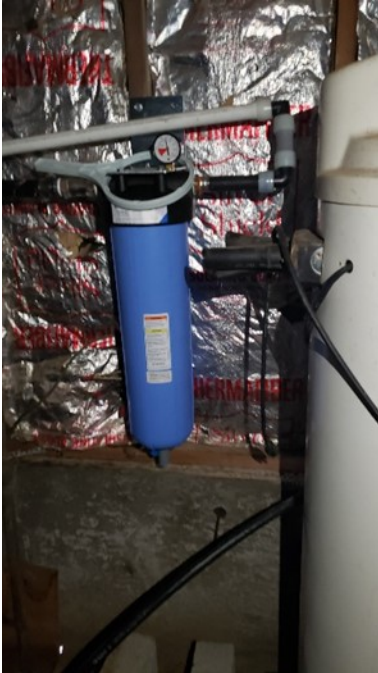
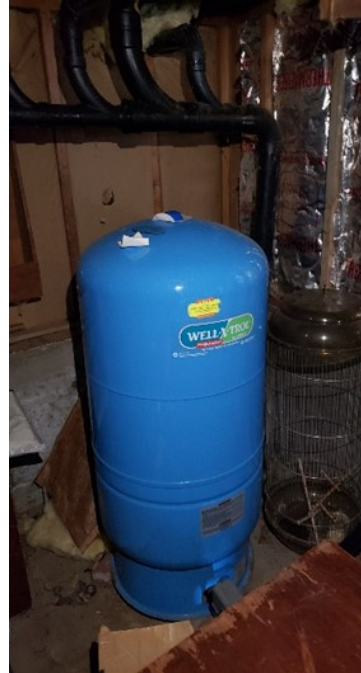
Photo 5 and 6: Inside the room under the deck stairs which houses the well/water infrastructure. Everything seems new and up-to-date. This services both dwellings on the property.

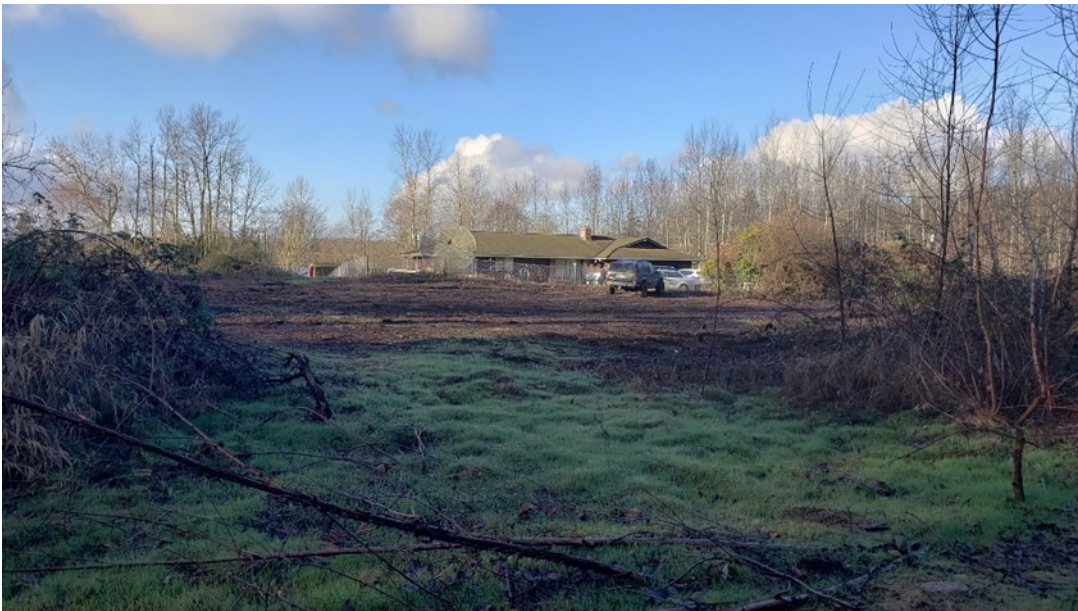
Photo 7: View from the southeastern corner of the property. This field is regularly mowed and apparently used as an off-roading course. This field was clean and free of garbage.

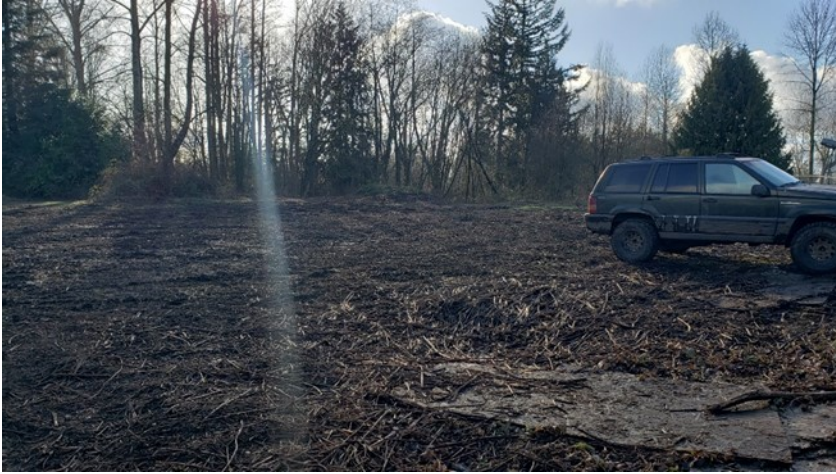
Photo 8: Another photo of the south-eastern field, looking south towards the property line (the tree line in the photo)

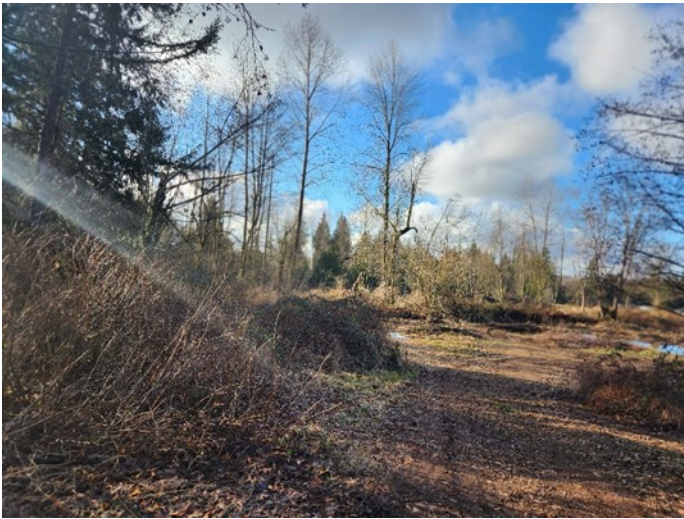
Photo 9: Looking down the southern property line, looking towards western property line that borders Interstate 5. The open field above slopes into this lower field.

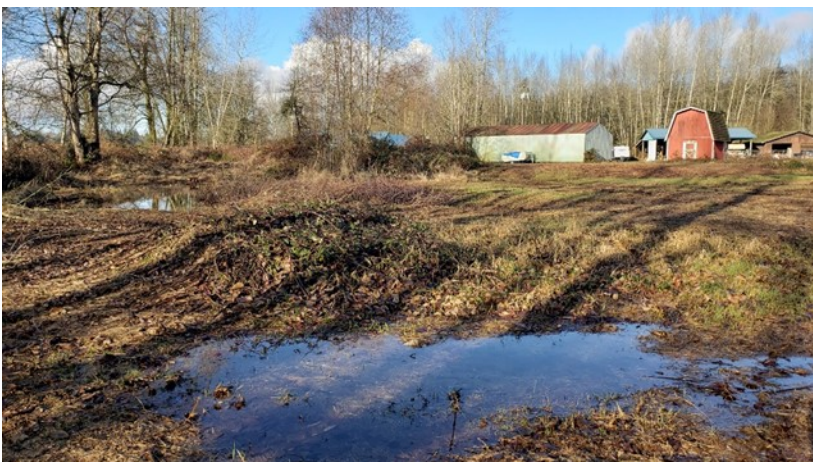
Photo 10: From the lower field bordering the western property line. Areas of standing water were seen, presumably from rainwater. This field looks like it was also used for off-roading. Buildings in the background were used for cedar shingle/shake manufacturing

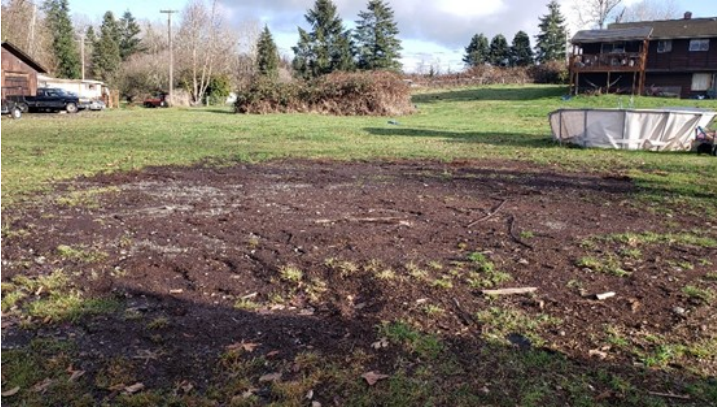
Photo 11: According to the previous tenants/mill operators, this area (center of the deforested portion of the property) was used to cut cedar poles before milling them. Substrate was composed of gravel and a few inches of sawdust, no oils were seen or smelled in this area.

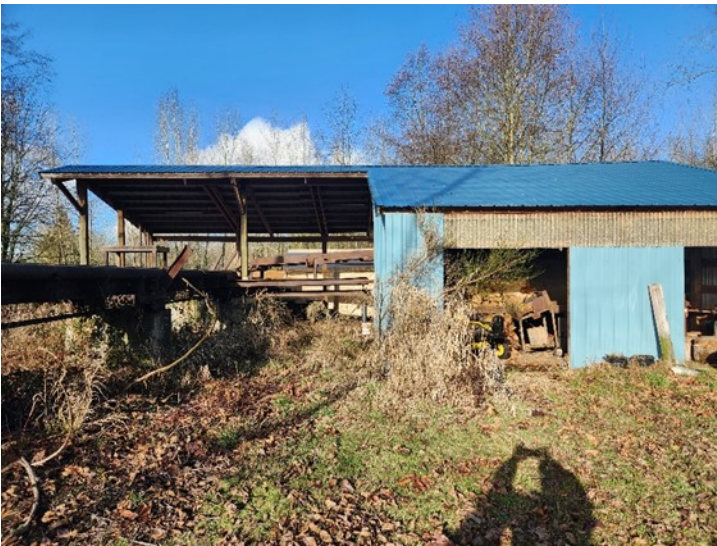
Photo 12: The cedar shake/shingle mill. This building was the main location for this operation; logs were cut and shaped here. The mill was converted to electric during the 1990s. Prior to that they used hydraulic pumps to operate the mill. The mill is located along the western border of the property. Photo taken looking north.

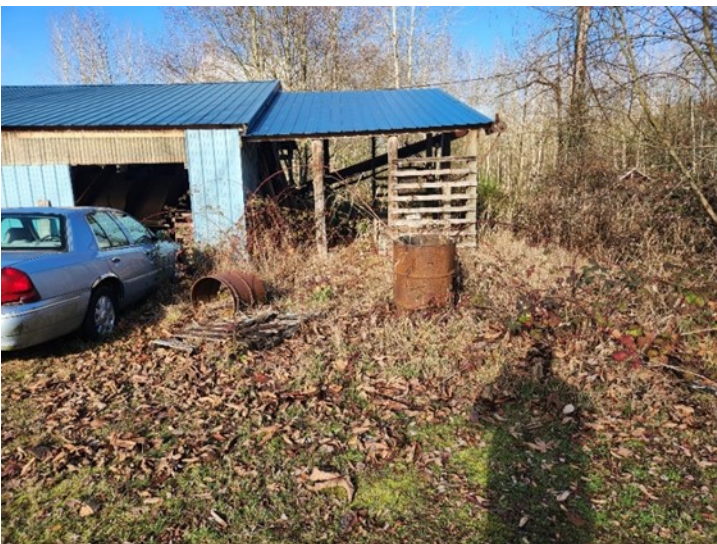
Photo 13: The eastern side of the mill. Trucks were backed in along the edge of this building and were loaded with sawdust and cuttings. This loading ramp is now mostly filled in and overgrown.

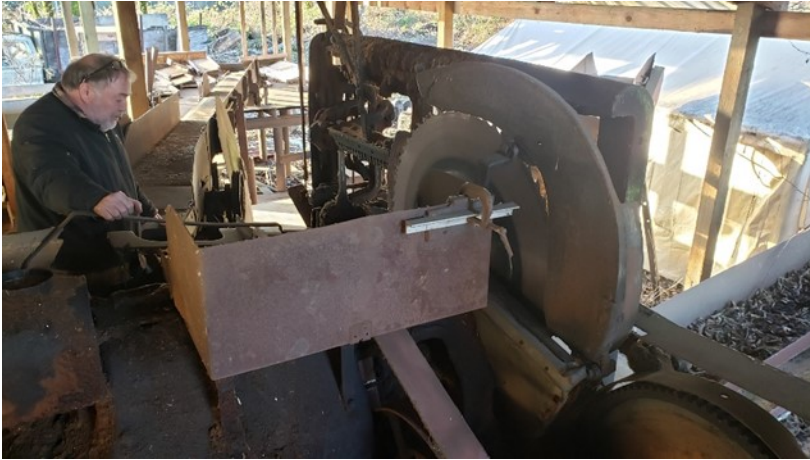
Photo 14: The saw used to cut cedar shake and shingles—A 1916 saw manufactured by Sumner Iron Works in Everett, Washington. The conveyor belt carrying sawdust away can be seen in the bottom right of the photo. The sawdust was carried to an incinerator just to the north of the mill.

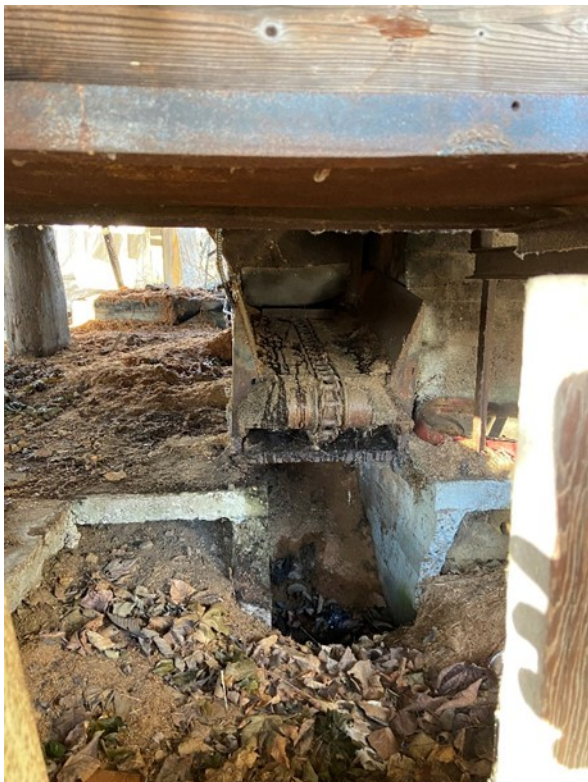
Photo 15: Chain return trough for the conveyor belt seen above. Upgrades have been made to the mill apparatus that have made the trough irrelevant. Before, the trough was approximately 3-4 feet deep. Simple soil sampling confirmed no obvious signs of hydrocarbon contamination.

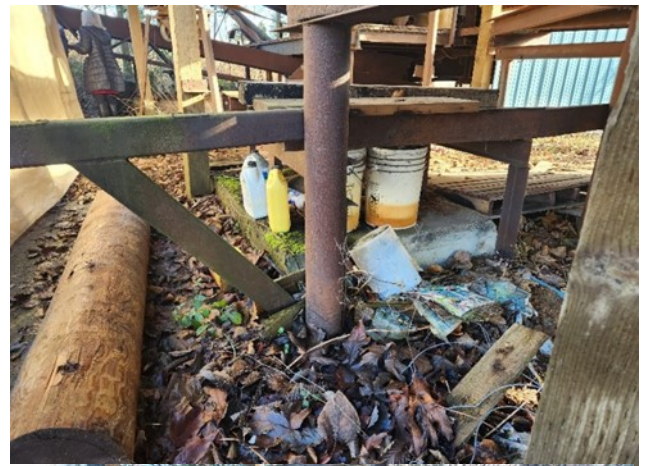
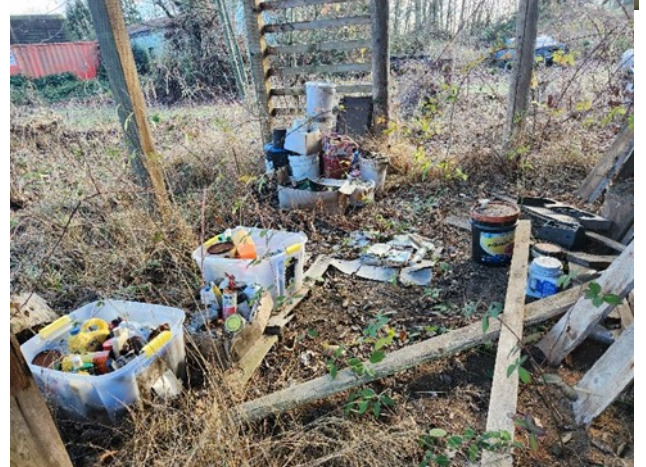
Photos 16 & 17: Various buckets and containers of grease, oils, and other chemicals underneath the mill.

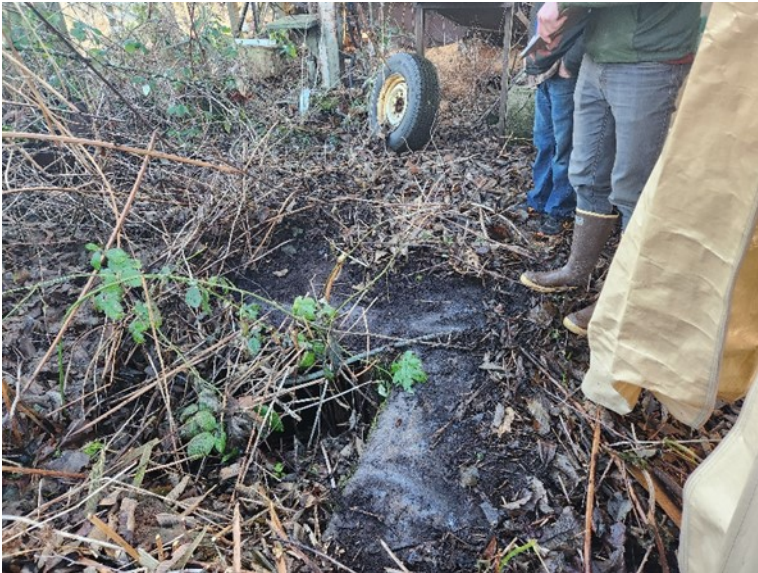
Photo 18: Previous area where an Above Ground Storage Tank (AST) was located (the northwest corner of the mill). After removing a top layer of deposited soil and sawdust, an oil sheen could be seen. It is unknown when the AST was removed from the property. It previously contained used hydraulic fluid.

Staff believe this property does not pose significant environmental risk; however, there are some risks that should be further investigated and/or mitigated. There are some signs of slight hydrocarbon contamination surrounding the previous location of the Above Ground Storage Tank—extent of contamination is unknown. The property also has an Underground Storage Tank that should be pressure tested to check for tank integrity (to understand if leaking could have occurred), pumped out if product is present, and ultimately removed from the property. There are various broken down vehicles and machinery surrounding the mill, many of which are near or inside thick blackberry bushes. These areas could harbor some localized hydrocarbon contamination, but staff determined there were no obvious signs of contamination. Additionally, many of these blackberry bushes contained piles of garbage, electronics, and used chemical containers, and other waste that should be removed and properly disposed. **Risk needs Further Investigation.**

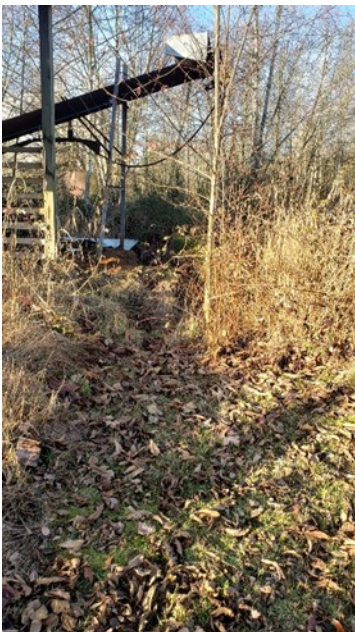
Photo 19: Filled in sawdust loading ramp previously discussed in Photo (13).

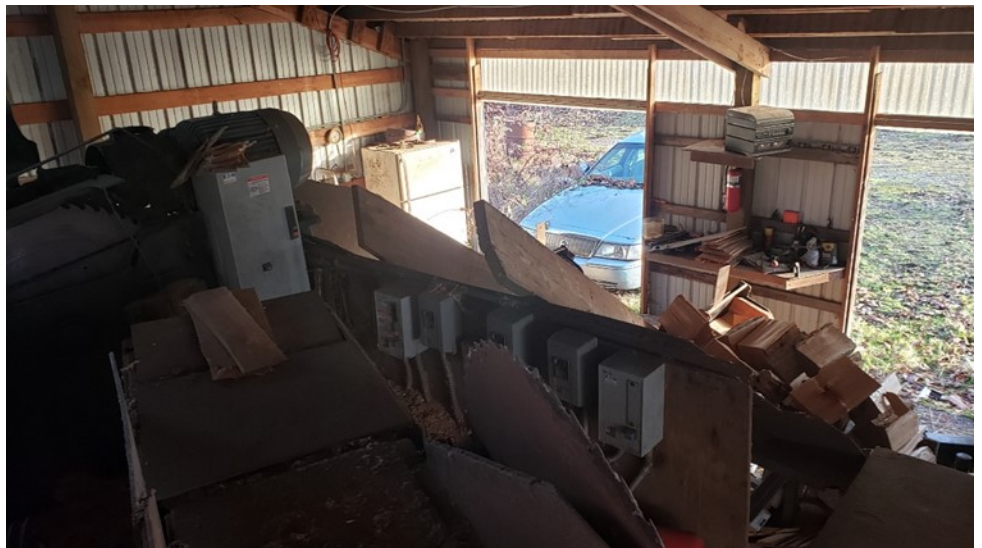
Photo 20: Next to the saw, shingle boards were categorized and sent down the ramps to be carried over to the next processing building.

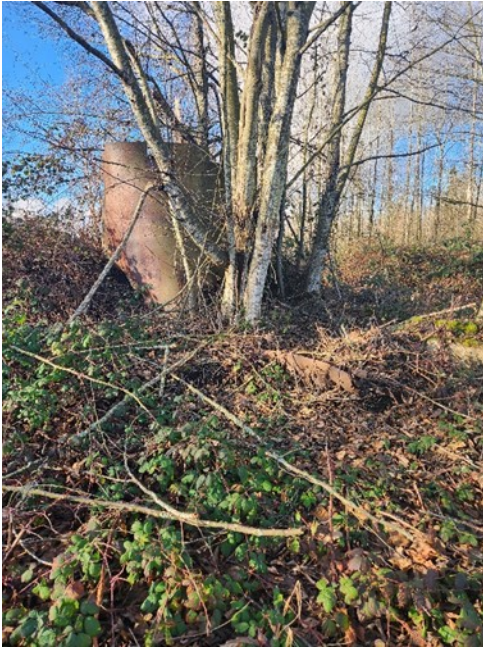
Photo 21: Incinerator used to burn sawdust and scrap. The owner claims this incinerator was EPA compliant. Located just to the north of the mill. Photo taken looking north.

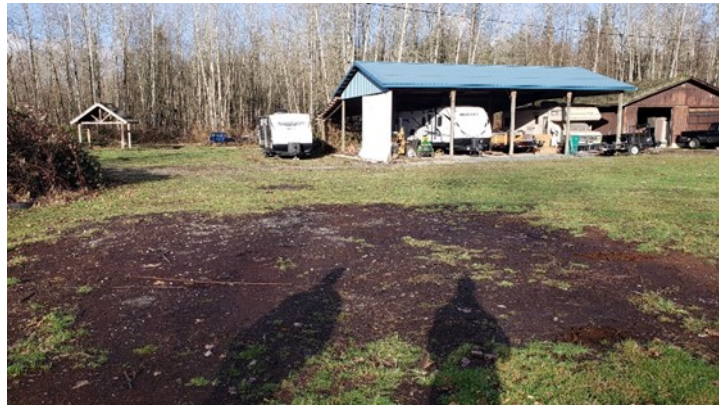
Photo 22: A view of the pole barn and garage near the central portion of the deforested area of the property. Photo taken looking north.

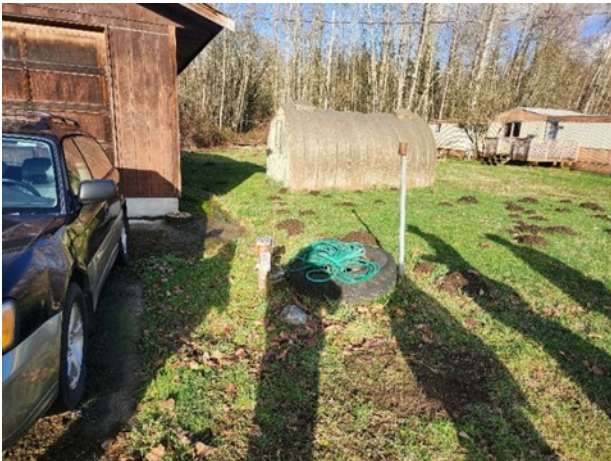
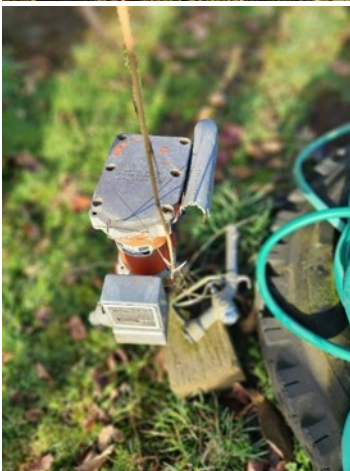
Photos 23 & 24: Next to the garage, there is an Underground Storage Tank containing gasoline. Owner claims the tank was likely pumped out by his father following the closure of the mill. However, the vent pipe smelled like product was still present. The tank is presumed to be 4-5' long and 3' wide.

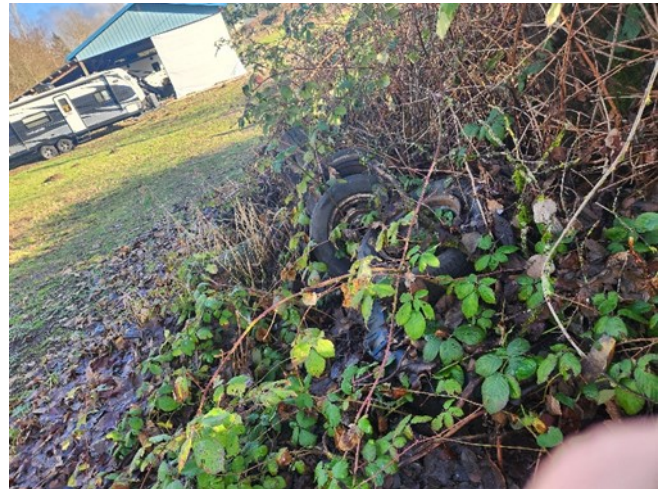
Photo 25: According to the owner, this is the approximate location of the water well and former pump house. Over time, the wellhead has been overtaken by blackberries. Staff were unable to definitively identify the wellhead due to the overgrowth. Staff also identified a pile of tires. Photo taken looking east.

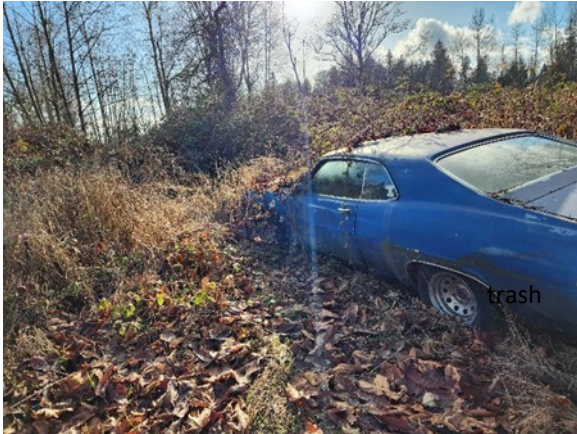
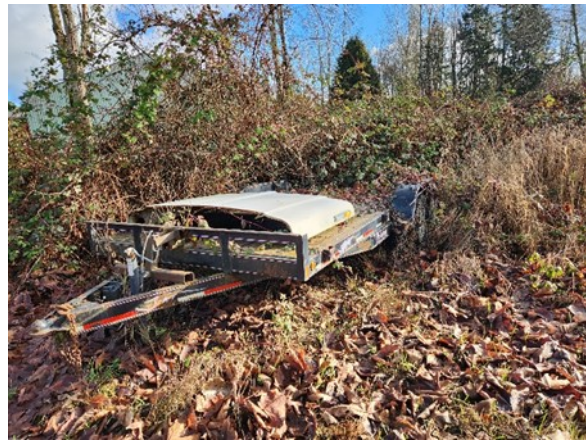
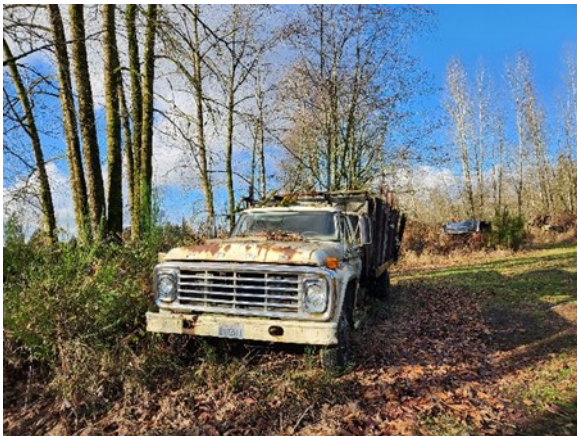
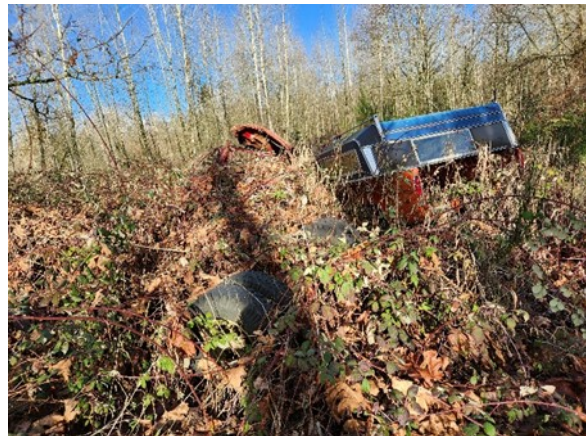
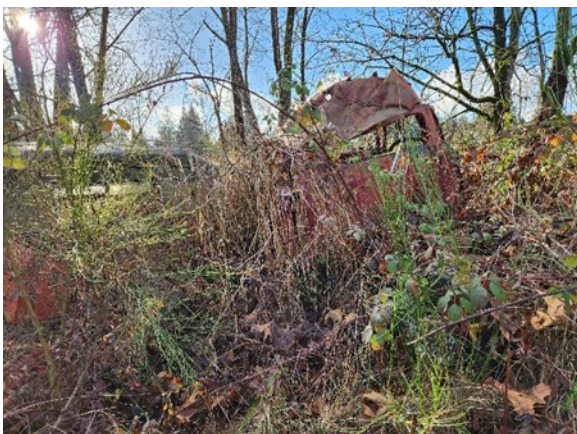
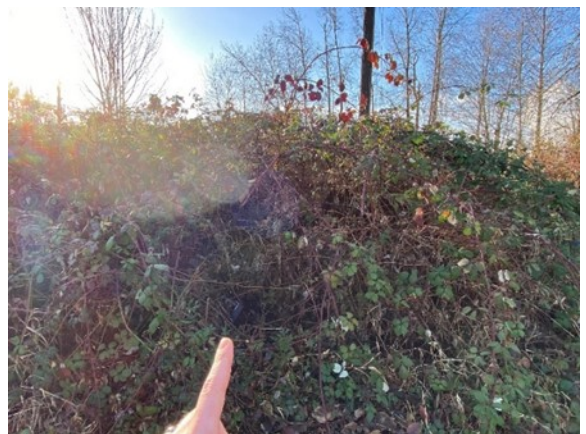
Photos 26-32: Surrounding the mill, countless broken down and abandoned vehicles, a log loader, and equipment were found, along with trash, scrap metal, tires, etc. Many have been reclaimed by the land (e.g. blackberries); some so overgrown it is hard to discern the vehicle and/or garbage. The condition of soils underneath these vehicles and trash is unknown, due to physical limitations of investigation. It is safe to assume all blackberry bushes in this section of the Lind property have trash, vehicles, and other material that should be removed from the property prior to closing.

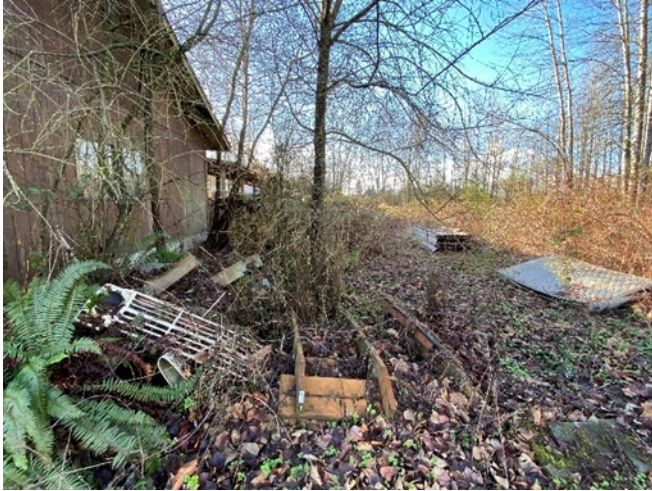
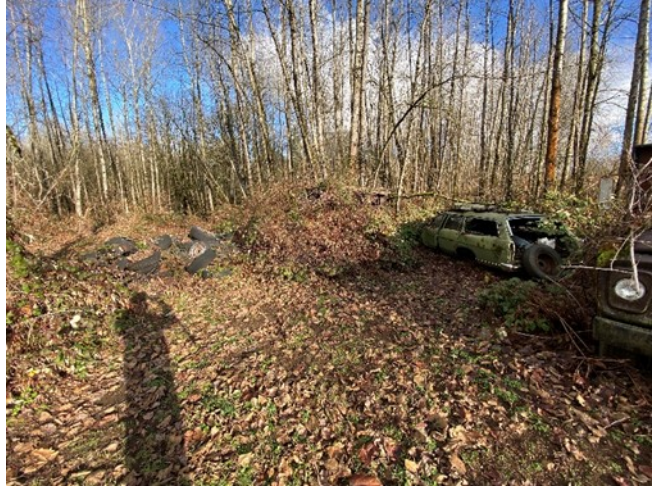
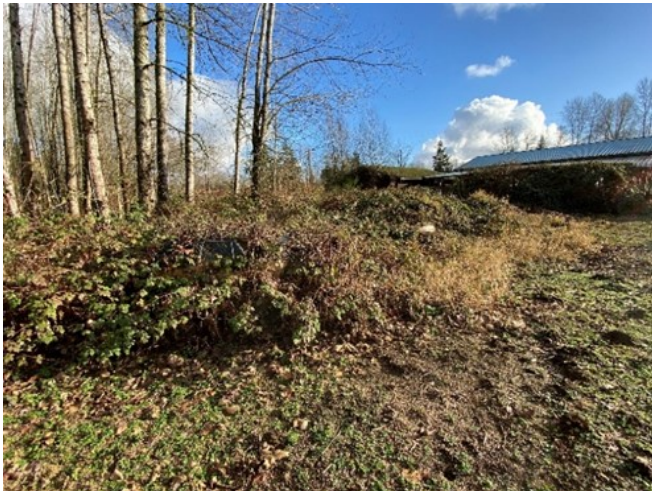
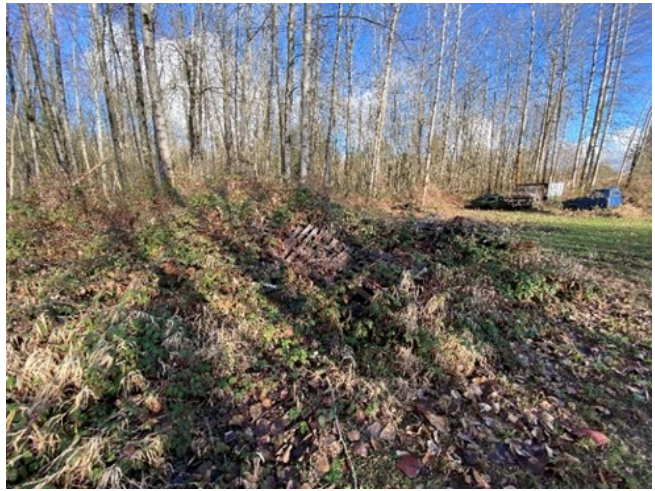
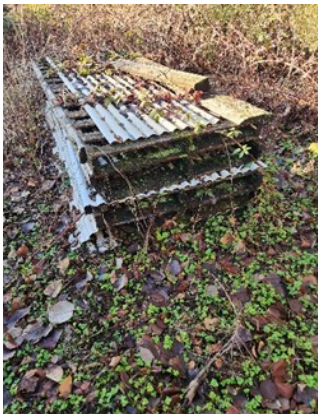
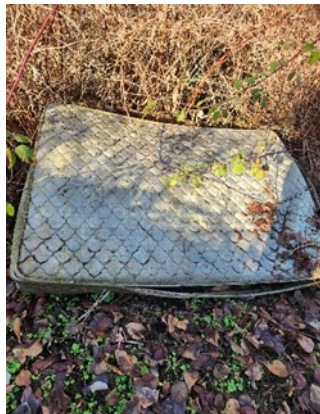
Photos 32-38: Behind the garage and pole barns, many more cars, trash, and tires were found, including corrugated metal and an old mattress. Photos looking generally north and east.

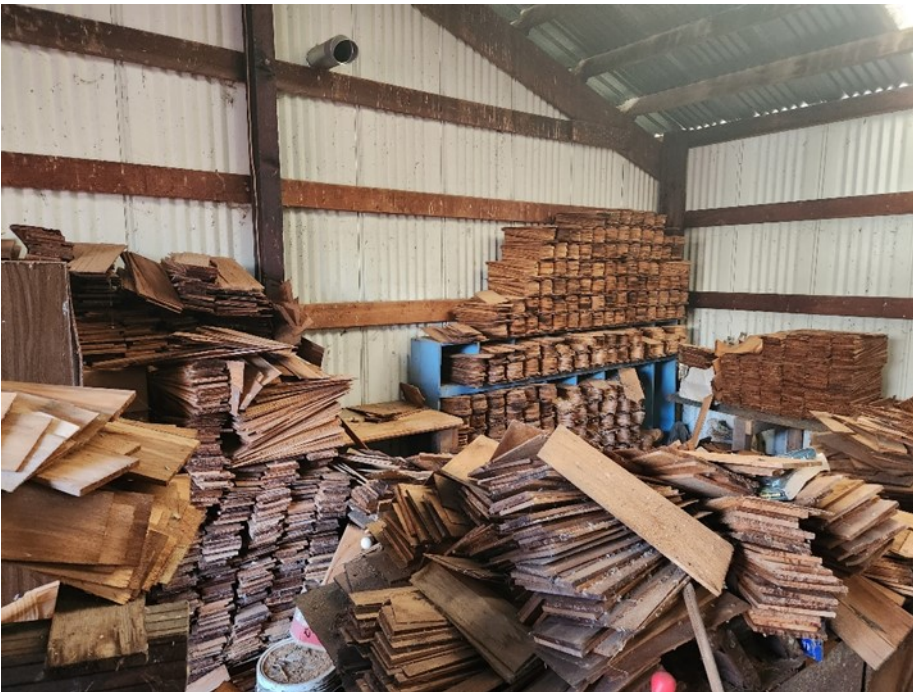
Photo 40: Inside the finishing building, piles of finished product can be seen. The pipe in the photo connects to the next room, used to transport vacuumed sawdust.

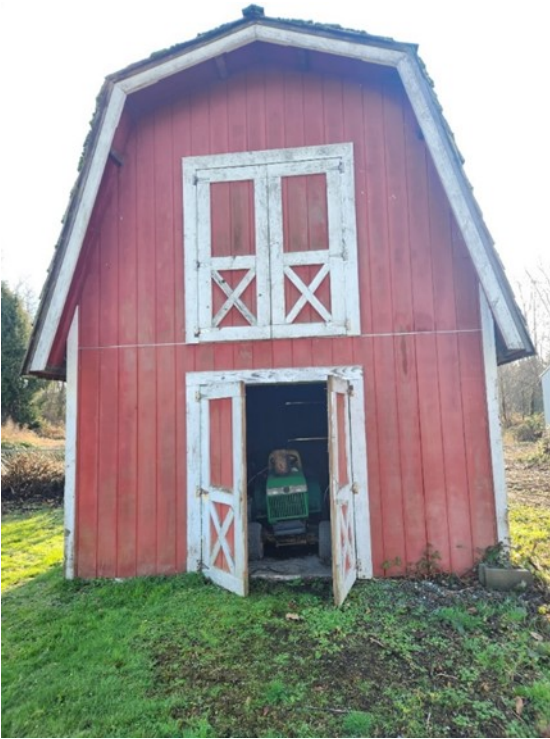
Photo 41: A dilapidated barn near the central portion of deforested section of the property. Used primarily for storage of lawn tools and equipment.

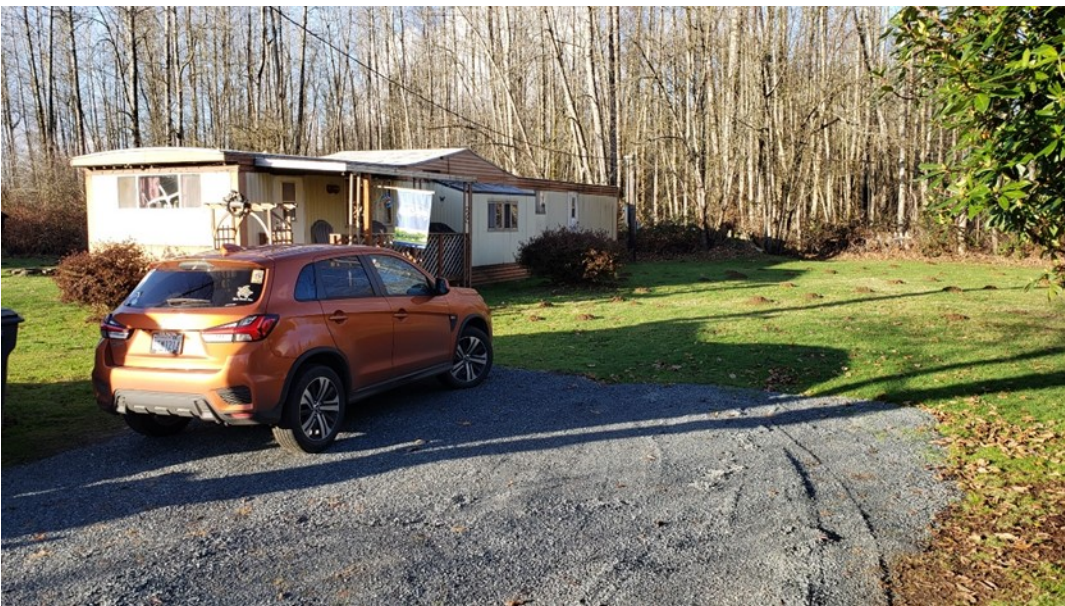
Photo 42: The second residence on the property, referenced in this documents as the 'mobile'. Photo taken in the second driveway to 15th Ave, looking north into the forested portion of the property.

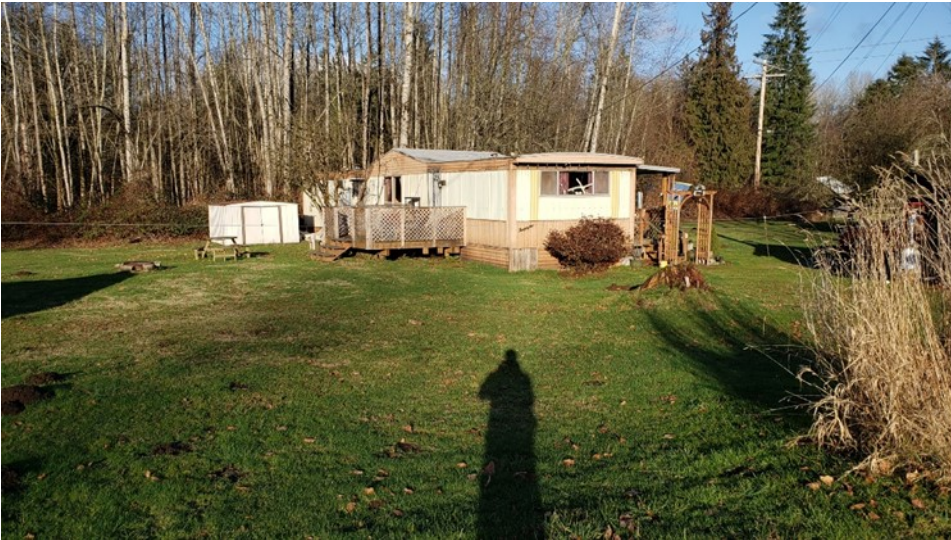
Photo 43: The backside of the mobile, looking north.

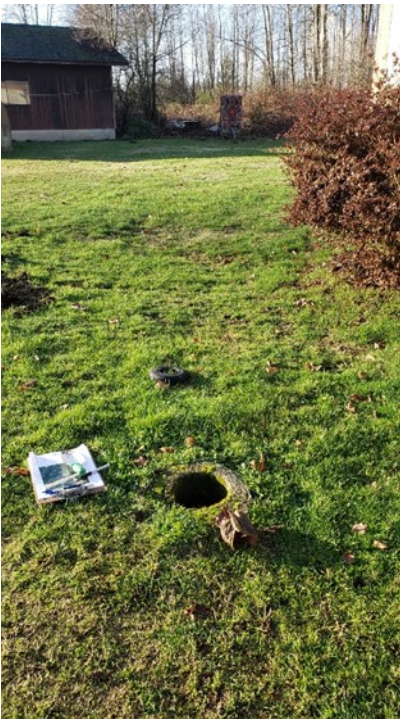
Photo 44: On the south side of the mobile, a concrete hole/pipe was located. Likely irrigation infrastructure, but nothing was found on the inside.

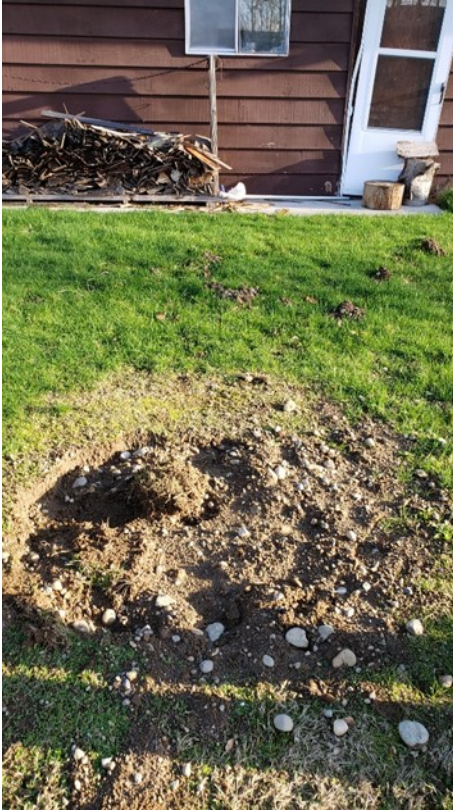
Photo 46: Approximate location of the septic tank for the main residence, located on the western side of the building.

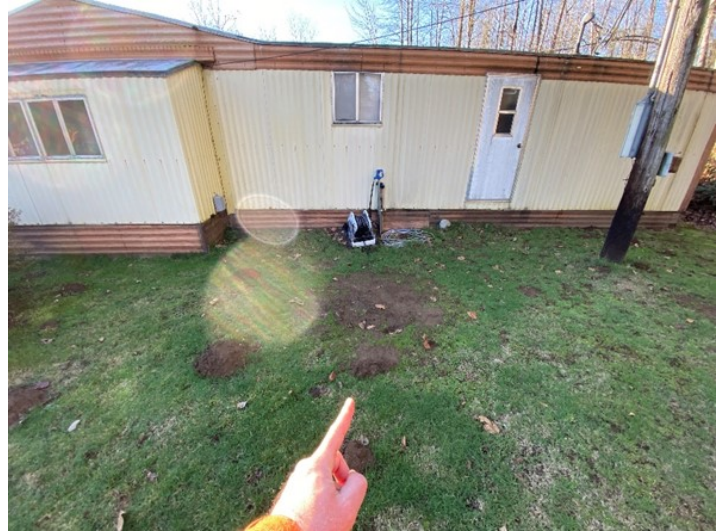
Photo 47: Approximate location of the septic tank for the mobile, located on the eastern side of the building.

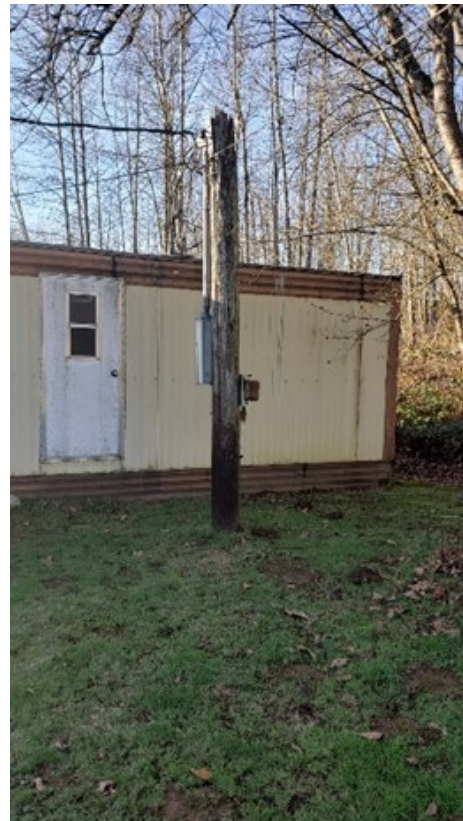
Photo 49: Rotting power pole, next to the mobile on the eastern side of the building.

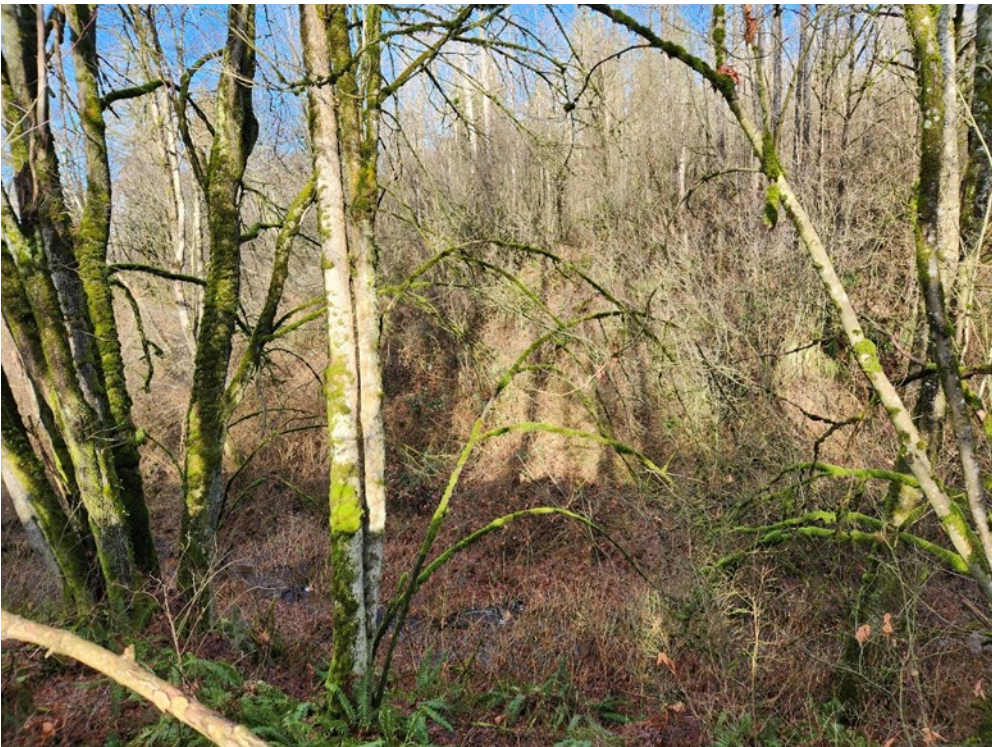
Photo 51: Looking north across the gully, into the densely vegetated northern section of the property. Staff walked through this area and found nothing of concern.

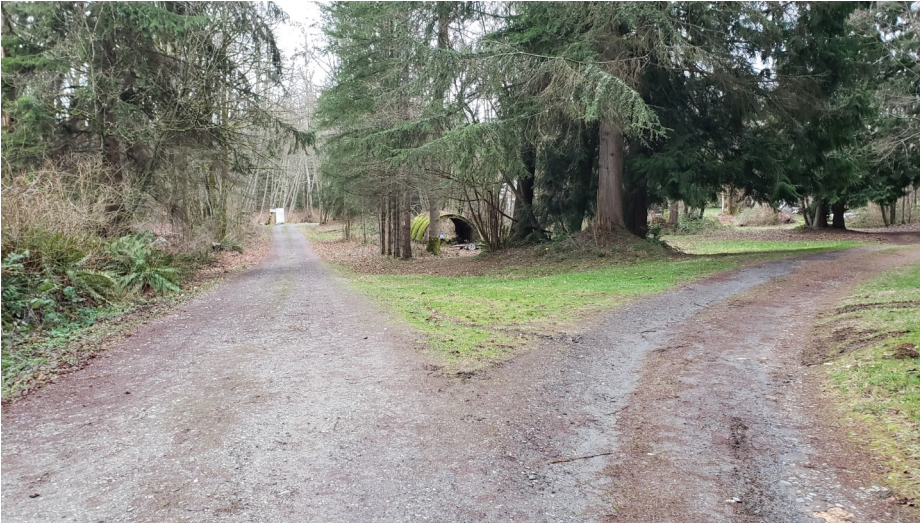
Photo 5: Moving west down the sloped driveway, the road forks. This driveway eventually reconnects with itself in the lower, western portion of the property.

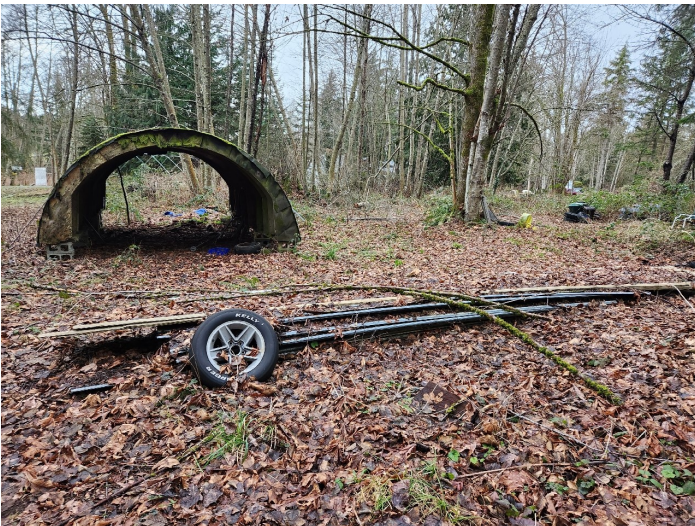
Photo 6 (Map Number 3): An arched, semi-permanent hoop shed and assorted pipes and tires. Photo taken looking west, near the southwest corner of the property.

We recommend that all garbage, refuse, rubbish, vehicles and other items be properly removed and disposed. The black drainage pipe, next to the RV parking, should be further investigated to ensure it wasn't being used to transport black waste. The oil spots around the shop's parking area are unlikely to harbor deep contamination, but should be cleaned up and checked. Soils underneath the various derelict vehicles should be investigated for surface level oil contamination. Otherwise, staff were not aware of any significant threat of oil or HAZMAT contamination. **Low Level of Risk that can be Mitigated.**

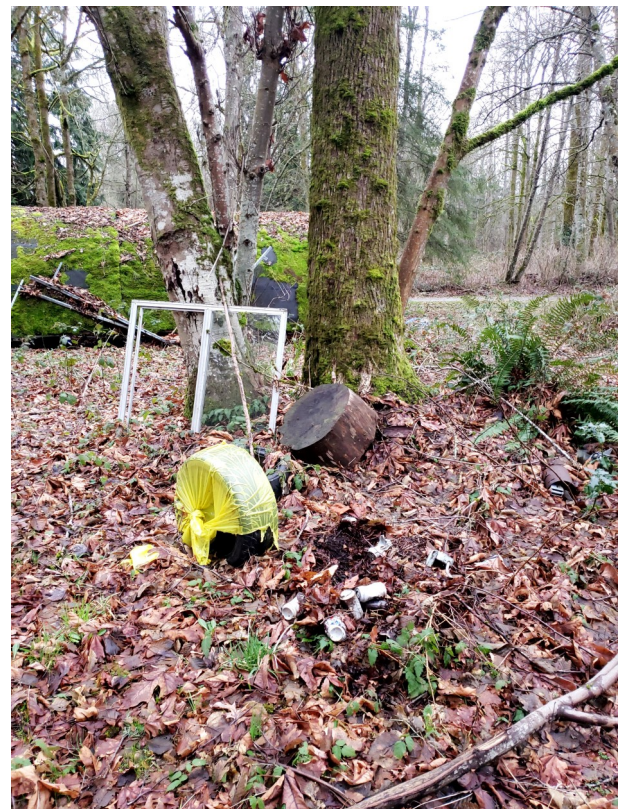
Photo 7: Just north of the hoop shed, window frames, and a trash pit (mostly beer cans) were located. Photo taken looking south.

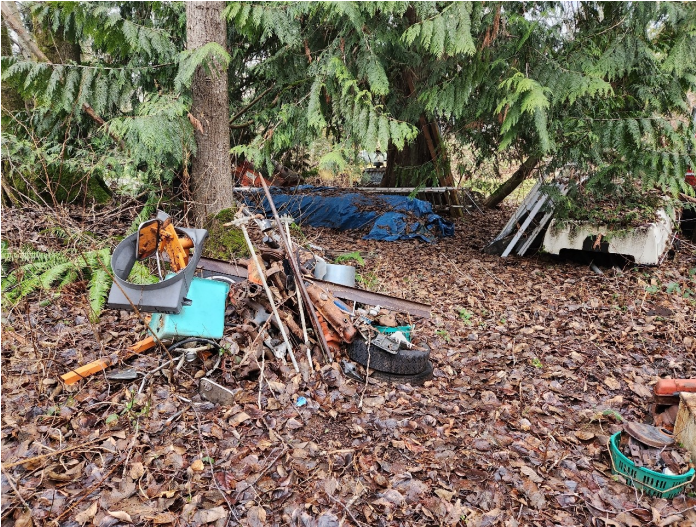
Photo 8 (Map Number 5): Old car parts, a boat, and other rubbish. Found near the western property border.

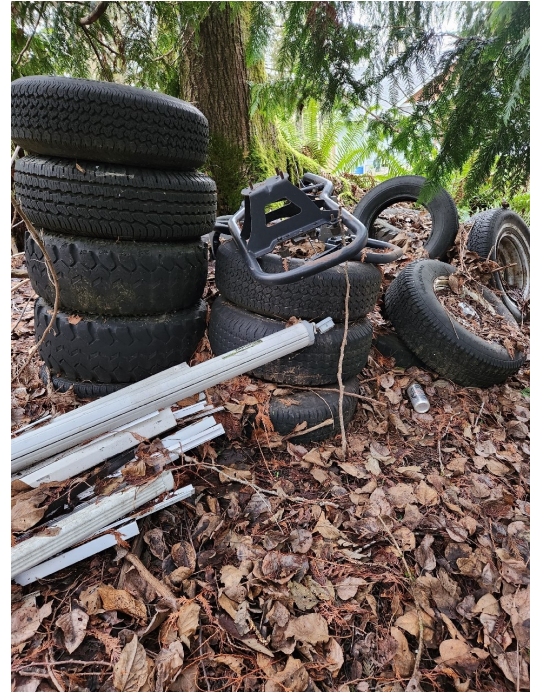
Photo 9 (Map Number 6): A pile of tires and other metals. Found just north of Photo (8).

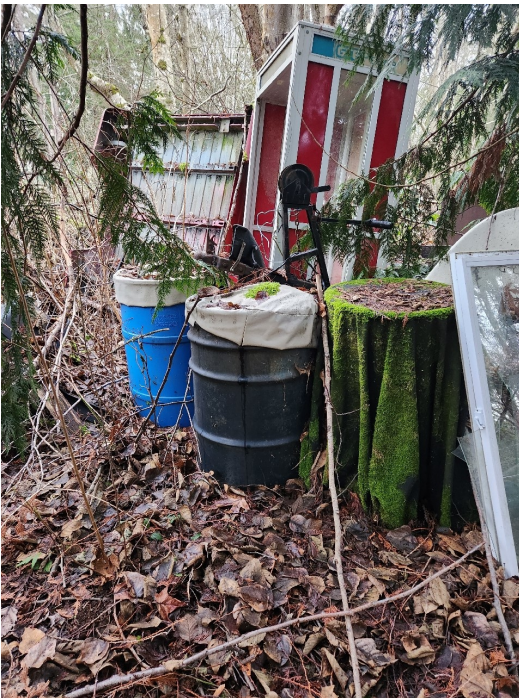
Photo 10 (Map Number 7): Empty 55-gallon drums, an old telephone box, lights, window frames, and other rubbish. Found just north of Photo (9).

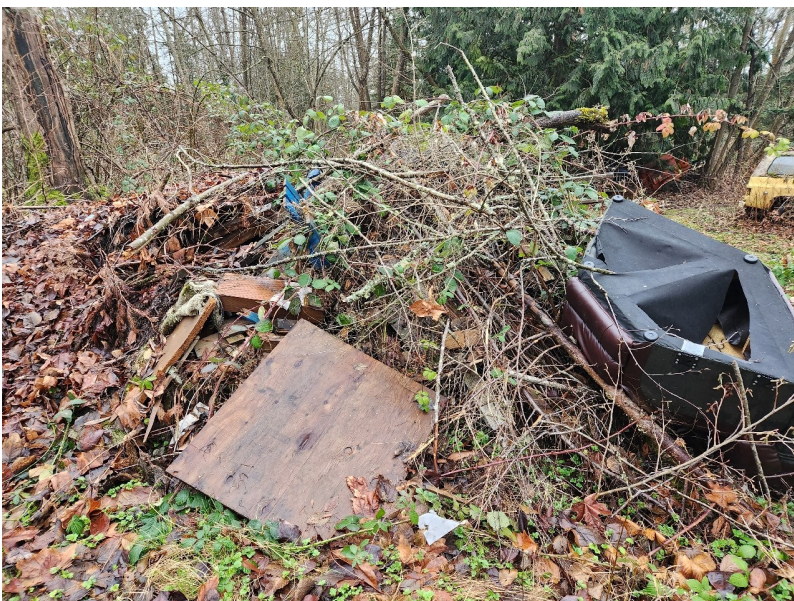
Photo 14 (Map Number 10): Another pile of rubbish, just north of the yellow derelict vehicle. Photo taken looking west near the western property boundary.

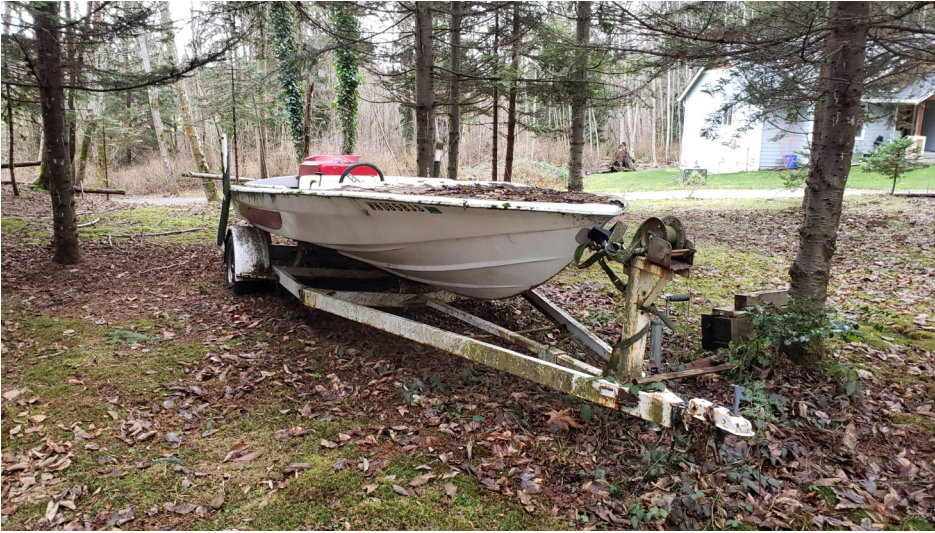
Photo 15: A derelict boat near the southwestern corner of the property. Photo taken looking southwest. The home seen in the background is the neighboring property main residence.

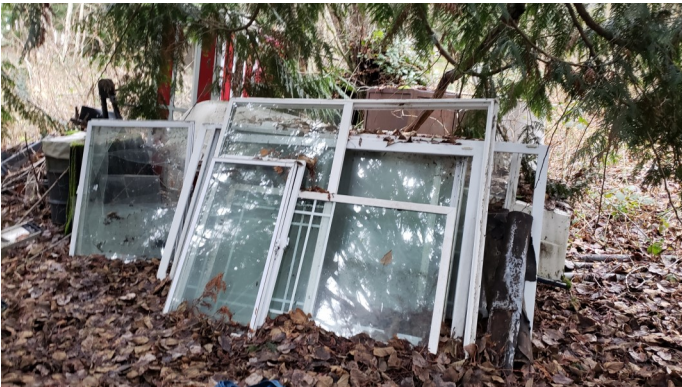
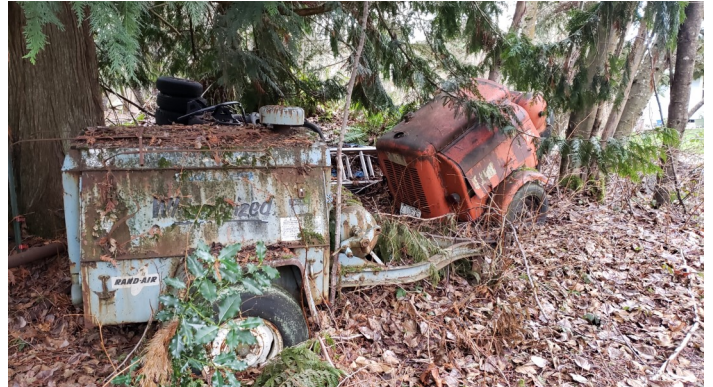
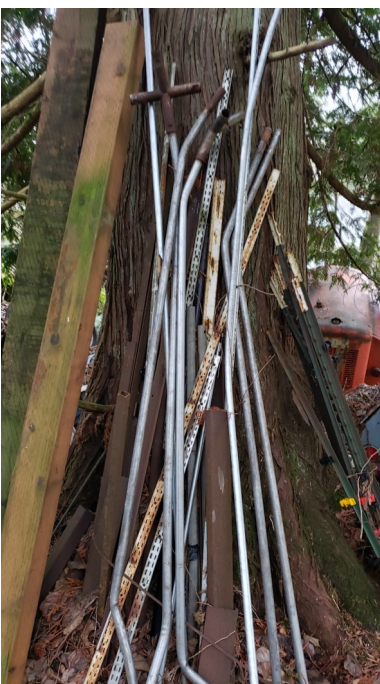
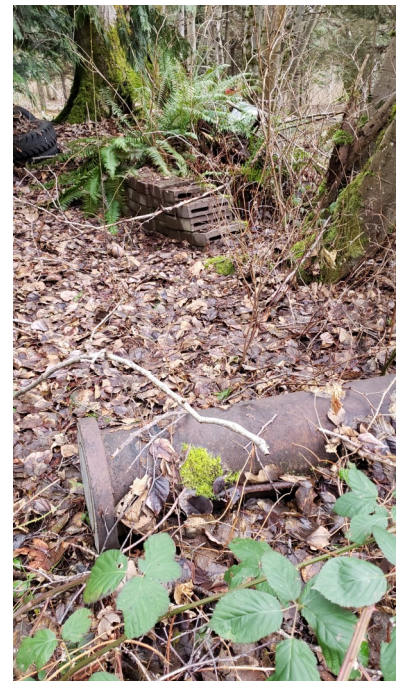
Photo 16-19: Near the midpoint along the western property boundary, windows, mobile generators, and various pipes were found. The generators did not appear to have contaminated the soil.
