Stillaguamish Tribal Response Program

Public Record Packet Summary

Lind Property Site Assessment

Assessment date: January 19, 2023

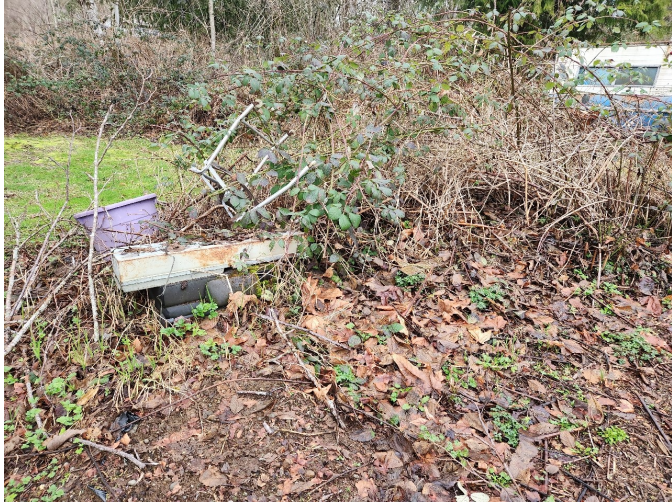
Photo 20 (Map Number 9): Another pile of rubbish, near the northwestern corner of the property. Photo taken looking north.

We recommend that all garbage, refuse, rubbish, vehicles and other items be properly removed and disposed. The black drainage pipe, next to the RV parking, should be further investigated to ensure it wasn't being used to transport black waste. The oil spots around the shop's parking area are unlikely to harbor deep contamination, but should be cleaned up and checked. Soils underneath the various derelict vehicles should be investigated for surface level oil contamination. Otherwise, staff were not aware of any significant threat of oil or HAZMAT contamination. **Low Level of Risk that can be Mitigated.**

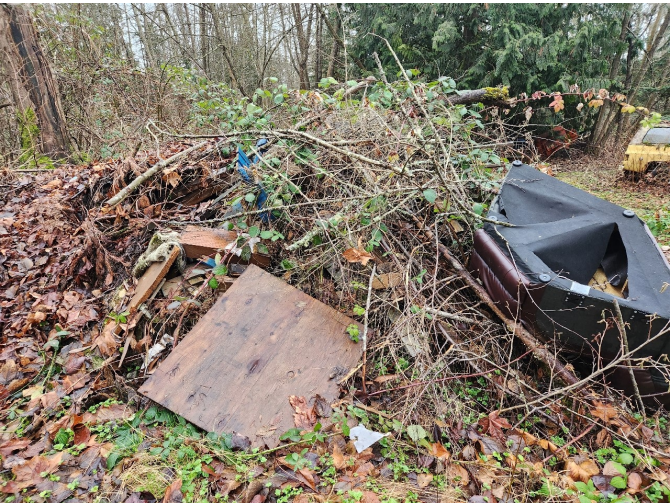
Photo 21 (Map Number 10): Another pile of rubbish, including dimension lumber, near the northwestern corner of the property. Photo taken looking southwest.

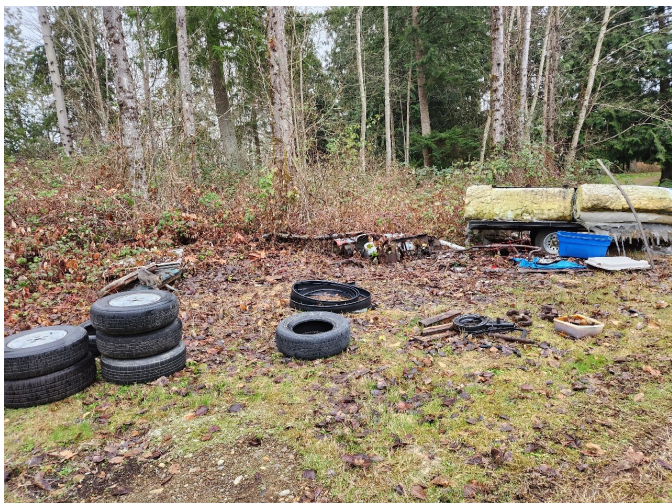
Photo 22 (Map Number 11): Tires and various car parts, as well as a trailer loaded with housing insulation. Photo taken looking north.

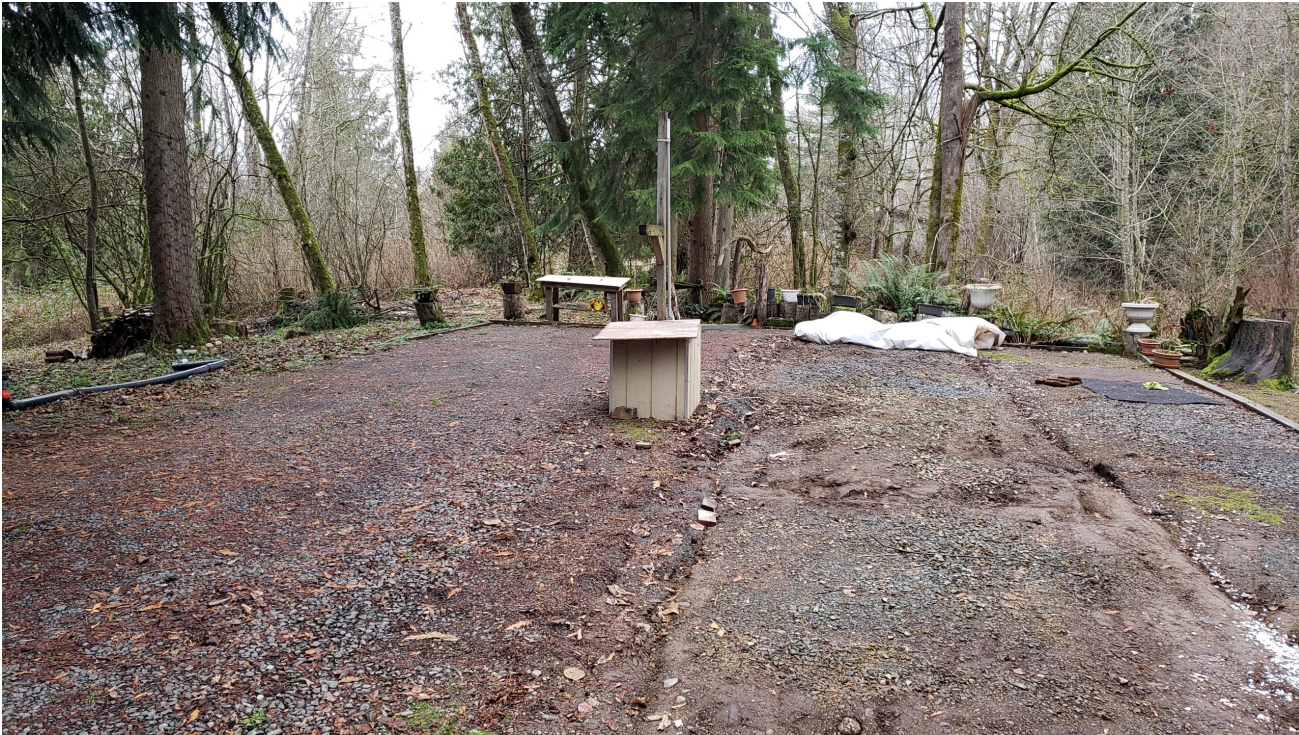
Photo 24: A wider view of the RV/fifth wheel parking area, water/electricity hookups are located in the box. To the right of this photo (north) the property slopes down into an intermittent stream.

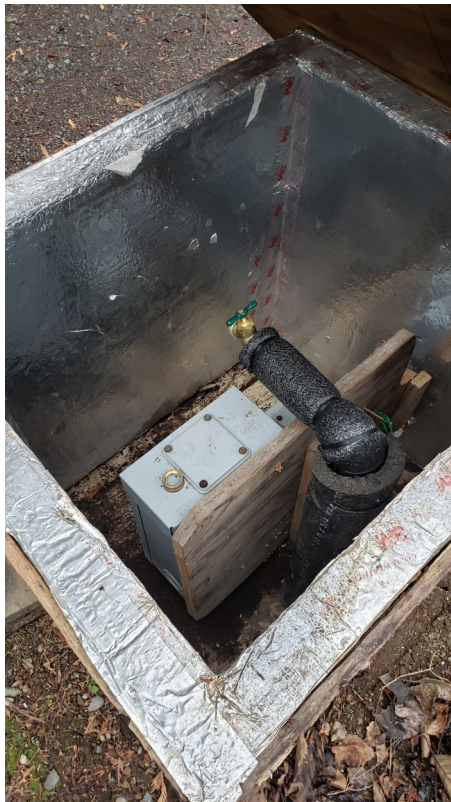
Photo 25: A closer look inside the RV hookups box.

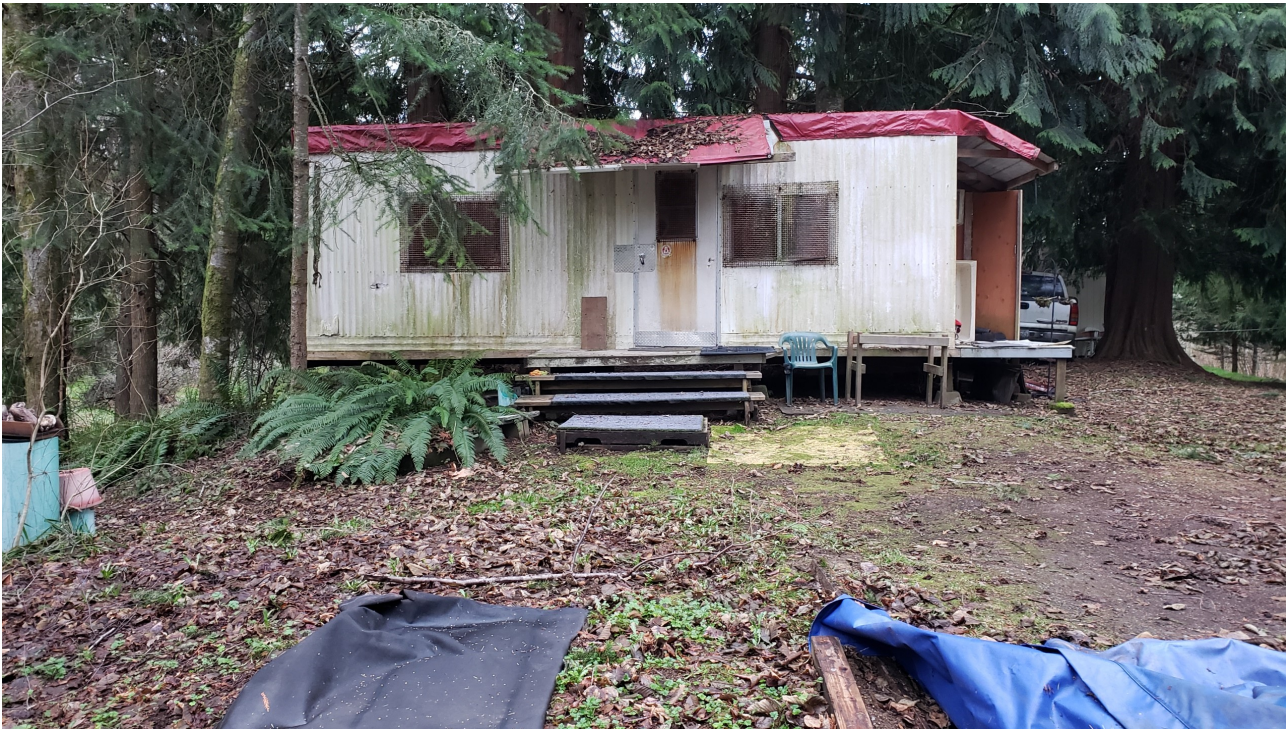
Photo 27: A mobile home found near the RV parking area (to the southeast). Staff searched for water/electric hookups but did not find any. Photo taken looking southeast.

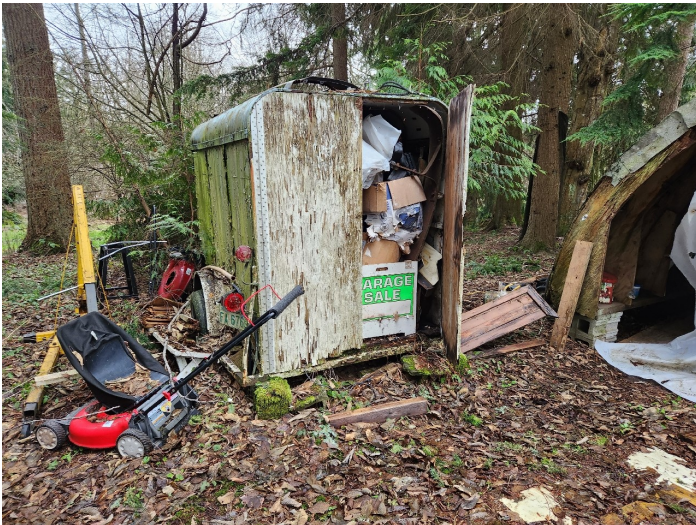
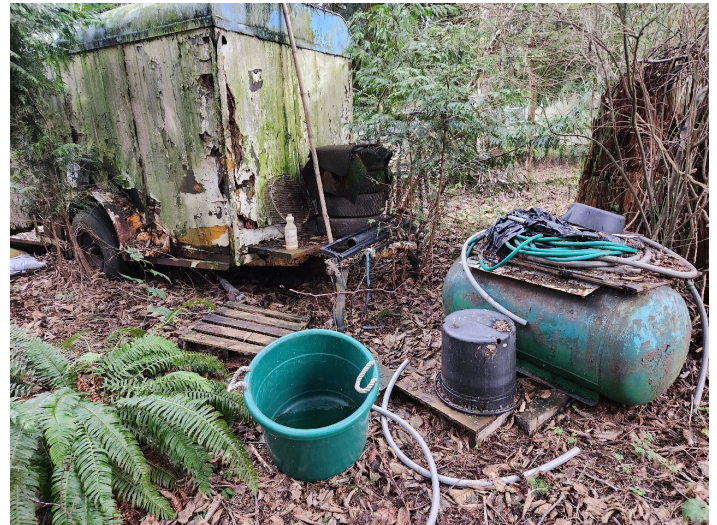
Photos 30 & 31 (Map Number 14): A dilapidated trailer filled with garbage and surrounded by various household machinery and items, including a lawnmower and old propane tank.

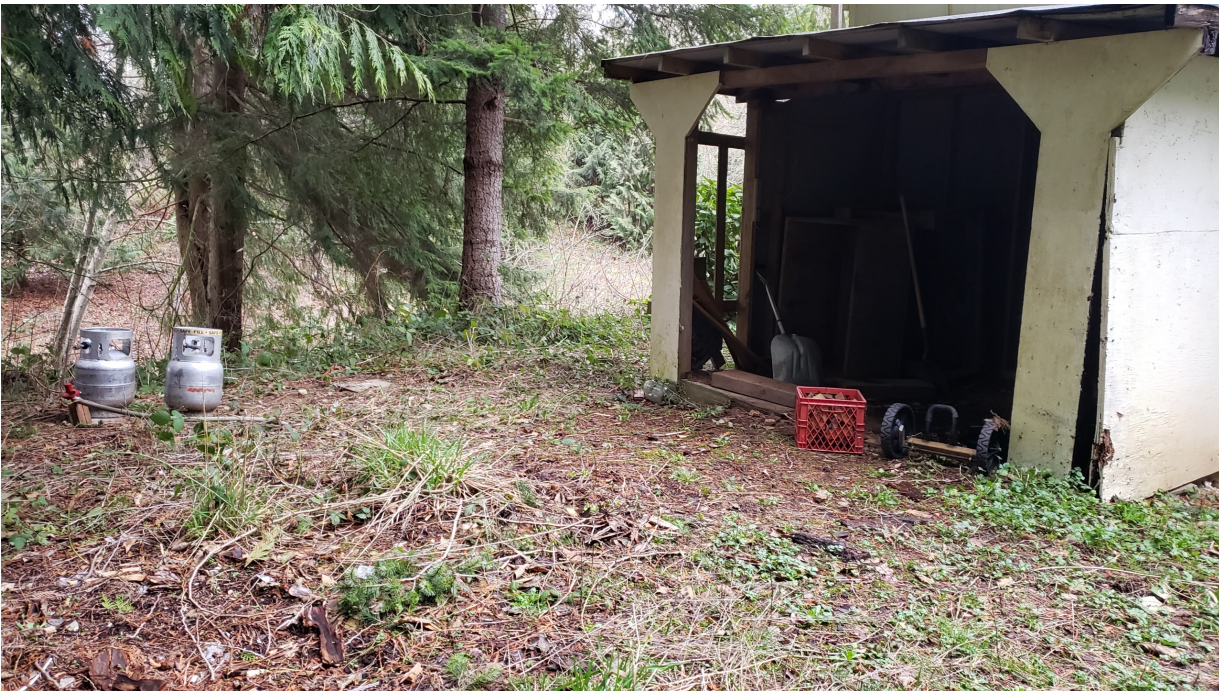
Photos 33: A shed attached to the western side of the main residence. Additionally, two propane tanks can be seen. The owner installed pipe to provide propane into the main residence.

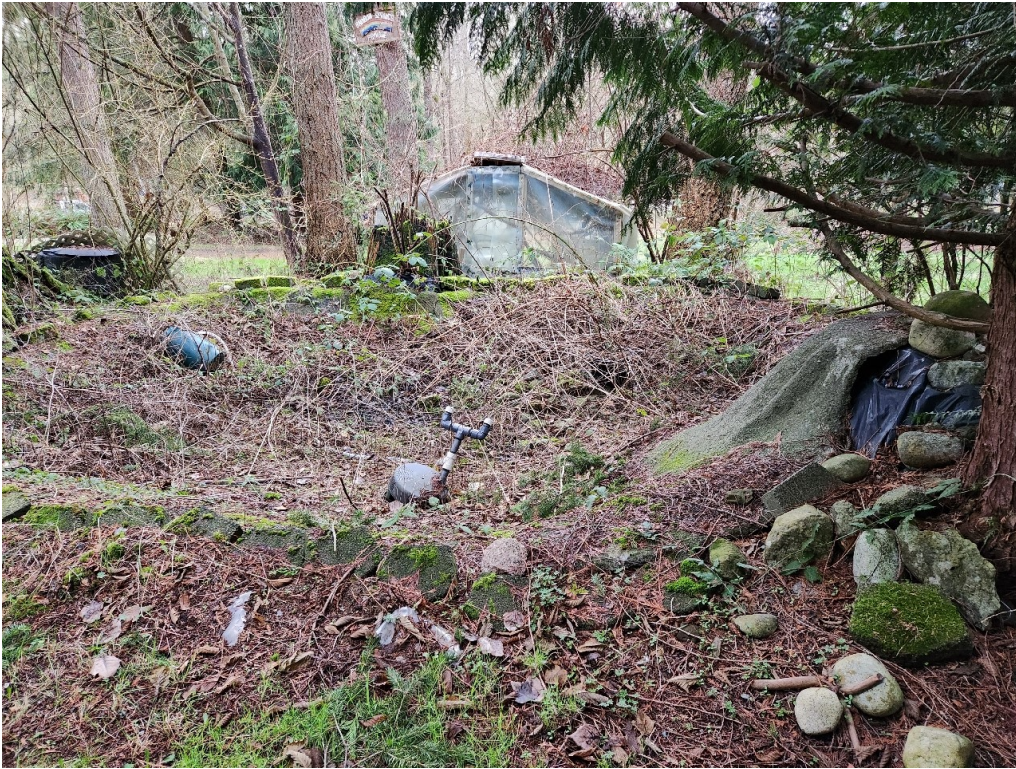
Photo 34 (Map Number 15): A man made pond that appears to have been out of use for many years; behind a greenhouse full of gardening supplies. This is located just west of the main residence. Photo taken looking generally south.

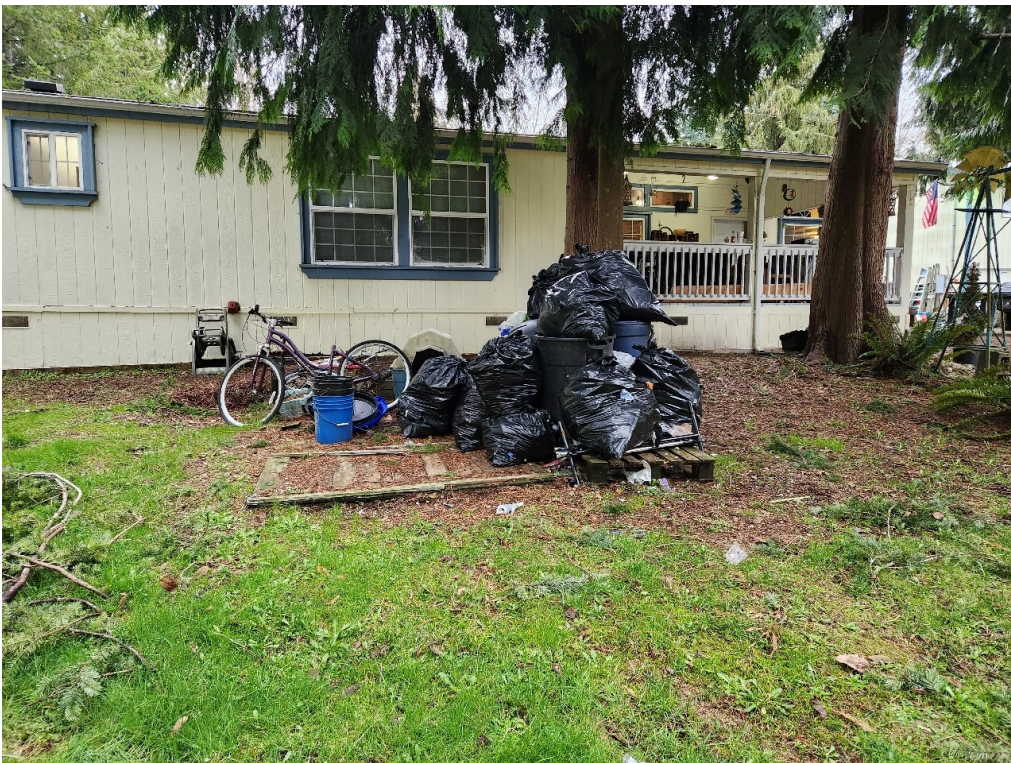
Photo 35 (Map Number 16): A pile of garbage on the western side of the main residence.

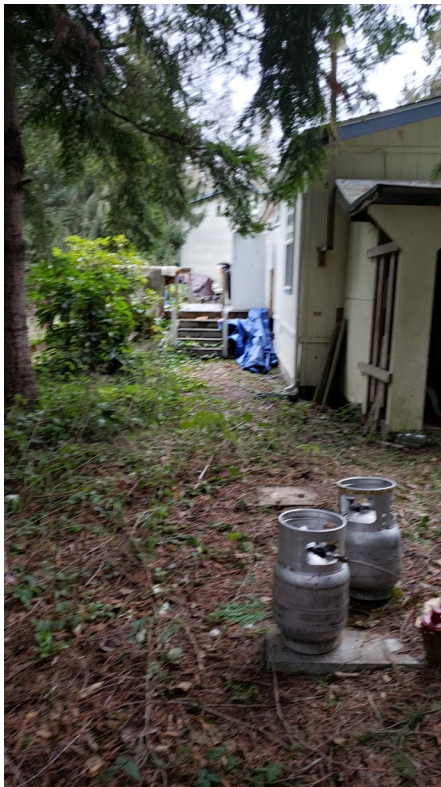
Photo 37: The northern side of the house. Photo taken looking east.

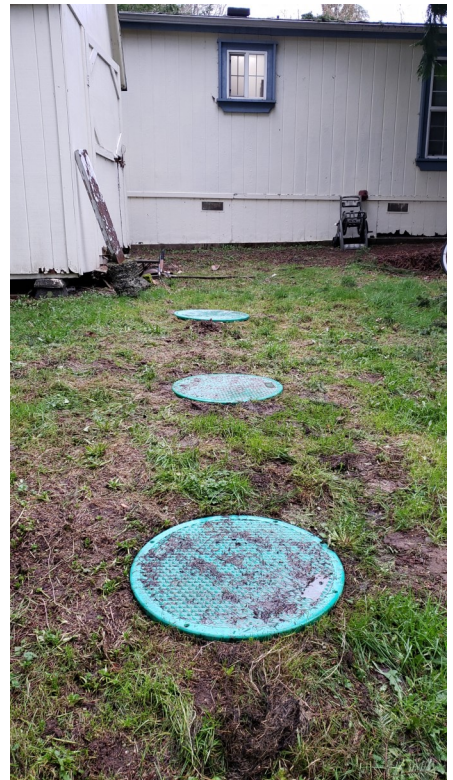
Photo 38: Septic field on the south-western side of the main residence. A storage shed can also be seen (on the left side of the picture).

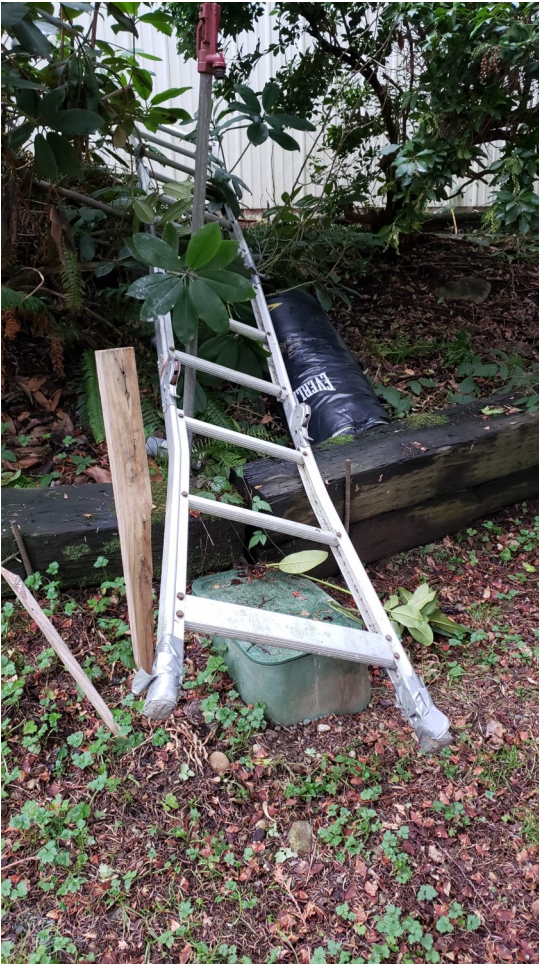
Photo 43: Valve box for the property. According to the owner, water is piped in from the neighboring Gibbons property. The owner states the water is of high quality and volume. The water pipe runs from the eastern part of the Gibbons property runs across a small wetland, across the stream on the Ketchum property, and terminating on the eastern side of the shop.

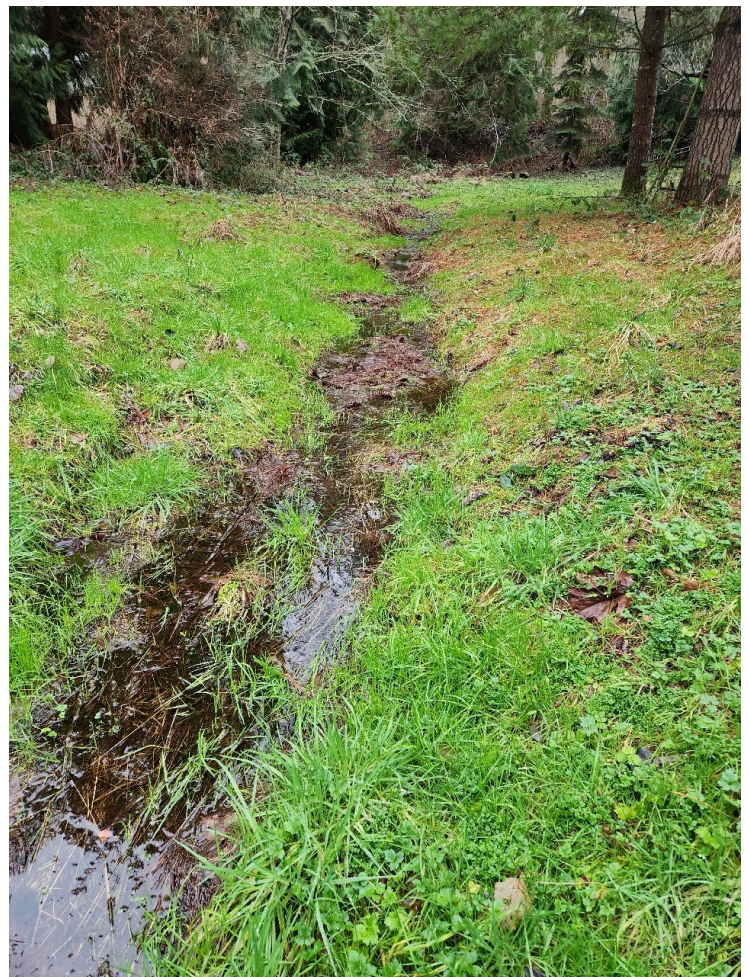
Photo 44 (Map Number 18): The intermittent stream that flows generally east-west on the property.

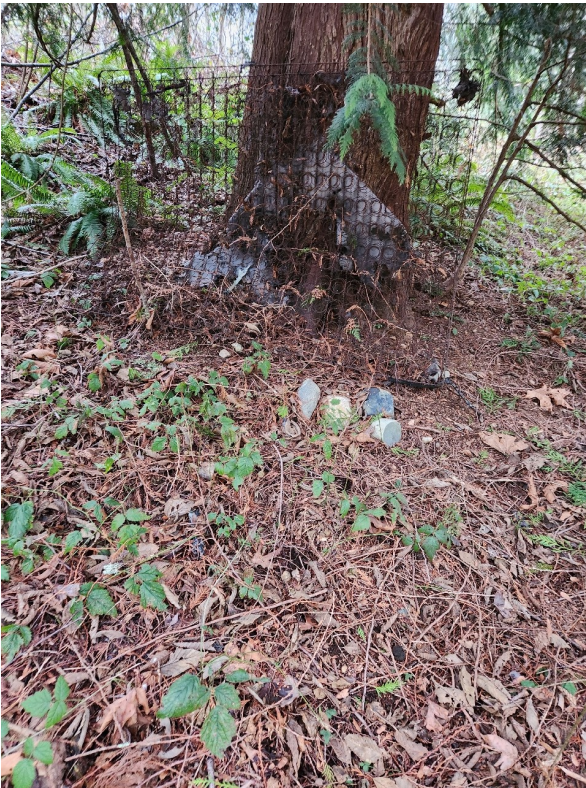
Photo 45 (Map Number 19): A small pile of garbage near the northeastern corner of the property. This area of the property slopes up to the northeast.

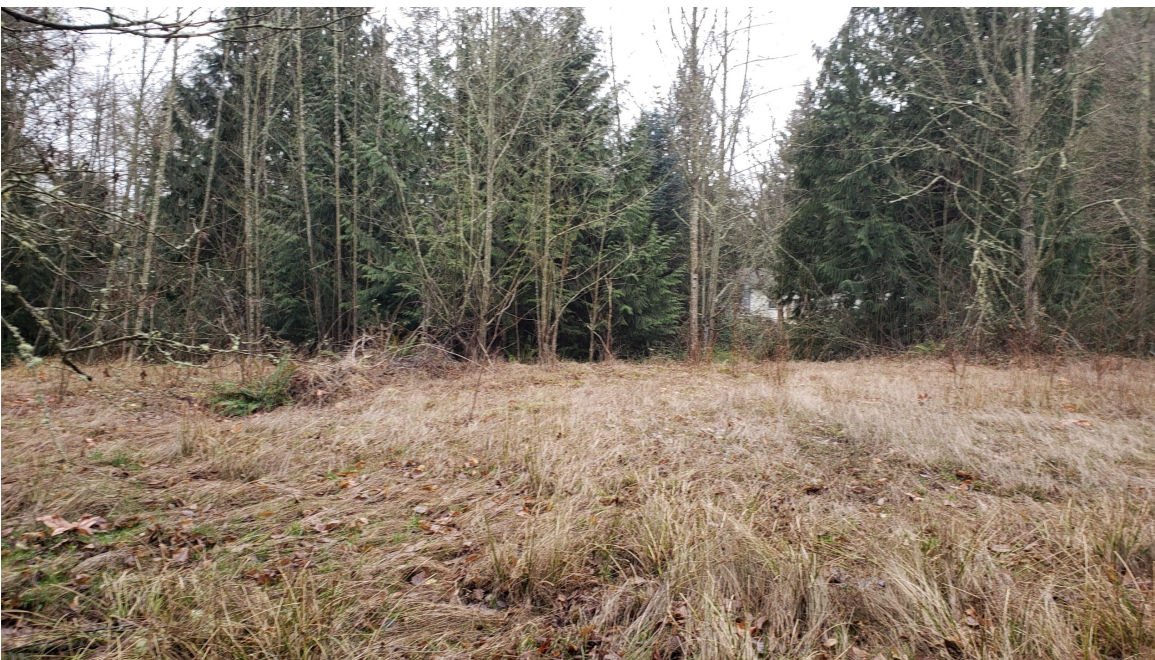
Photo 46: Just up the hill from Photo (45), a cleared area on top of the hill. The main residence can just be seen through the timber. Photo taken looking southwest.

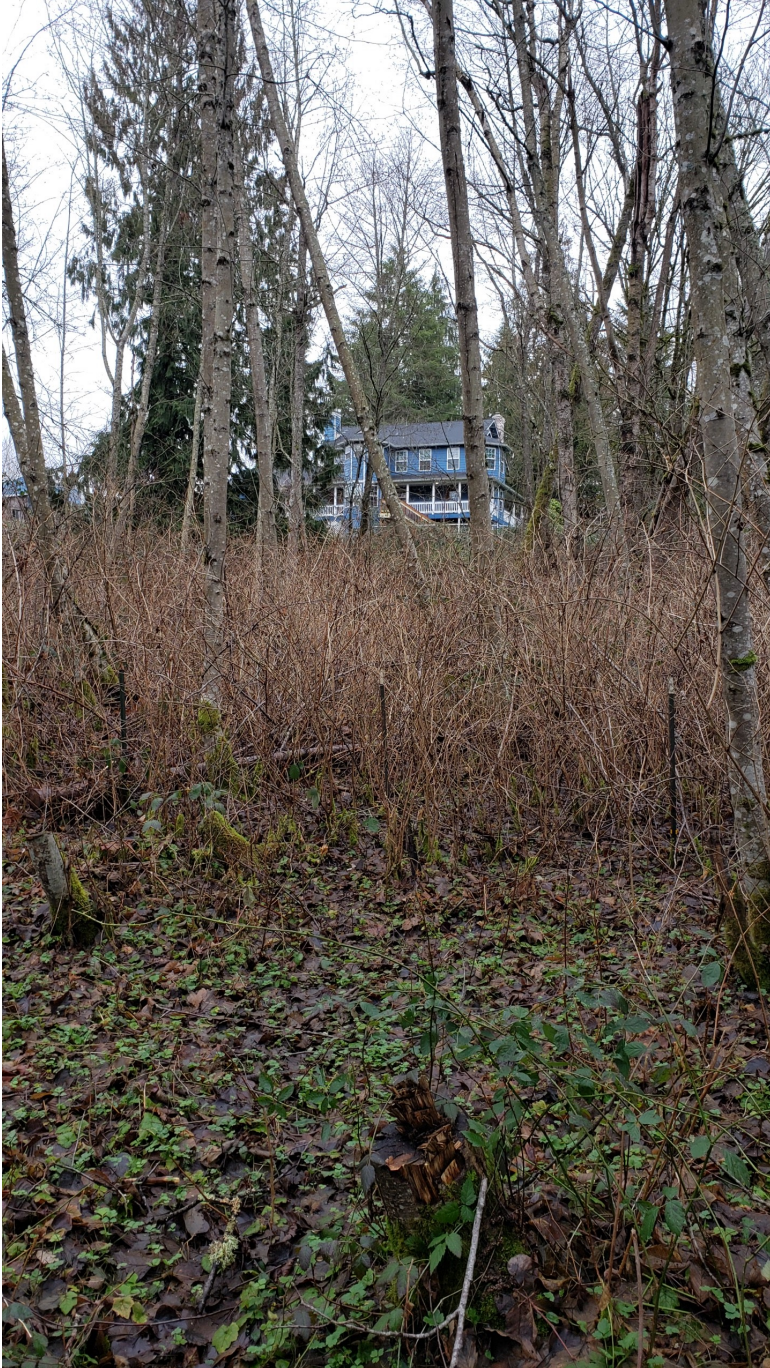
Photo 47: The wetland separating the Ketchum and Gibbons property (the eastern property line).

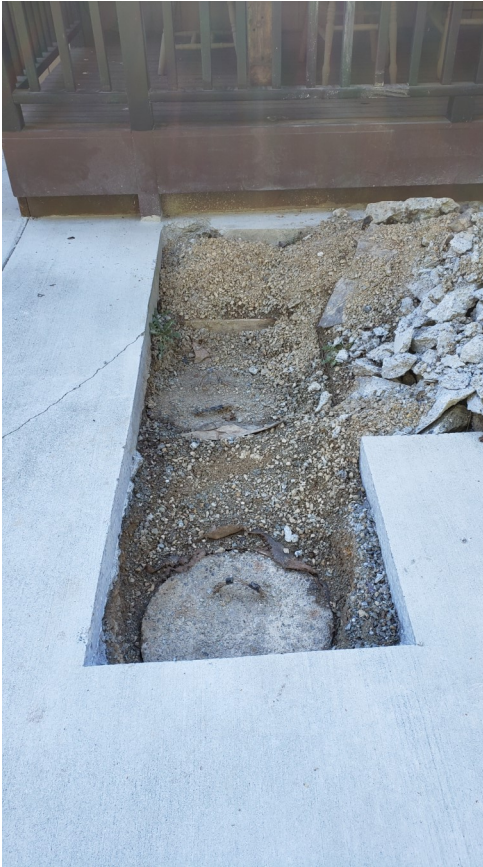
Photo 10: Septic tank access points, just off the deck of the main residence. The contractor which laid the concrete accidentally covered this access points.

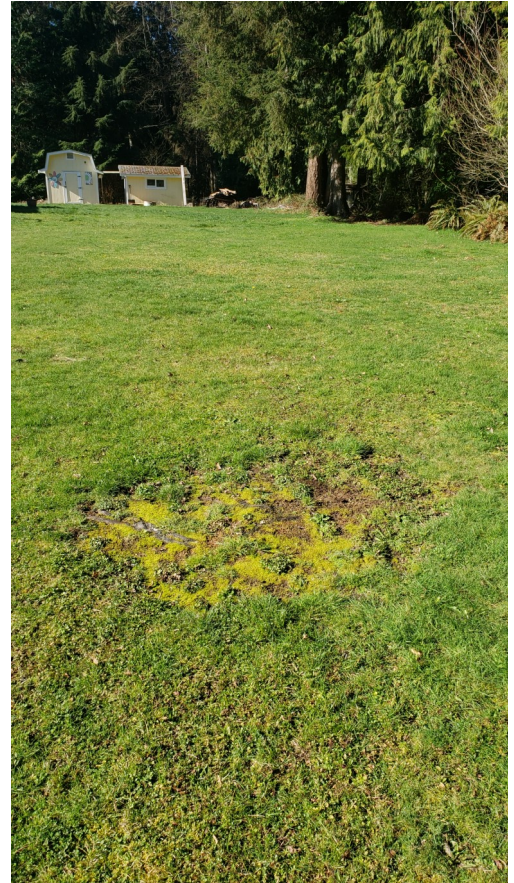
Photo 11: A circle of disturbed grass in the backyard. Top soil was analyzed and did not appear to be anything of concern. Likely a previous location for a portable, plastic pool.

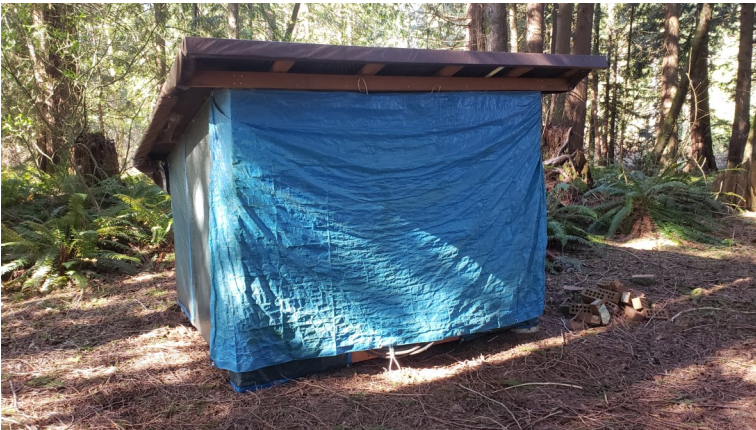
Photo 17: A tarped shed filled with hoses and metal fencing. This items should be removed by the seller before closing. The owner states he's getting a large dumpster to remove refuse and old equipment from the property. Photo taken looking west.

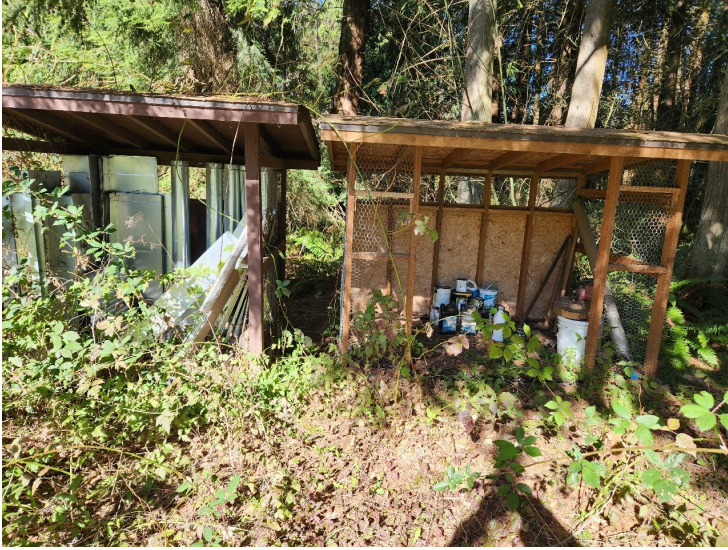
Photo 19 (Map Number 23): Two open-air storage sheds. The one on the left has metal pieces and other miscellaneous items. The shed on the right houses old paint and radiator fluid. These items should be removed from the property before closing. Photo taken looking south.

This property was in great condition and doesn't appear to show any significant environmental risks. However, there are some areas that should be given attention and removed, including: the small oil spots in the gravel driveway, the used oil, paint, and radiator fluids, and the various small piles of wood/equipment. If these items are properly disposed of this property shows **No Apparent Risk**.

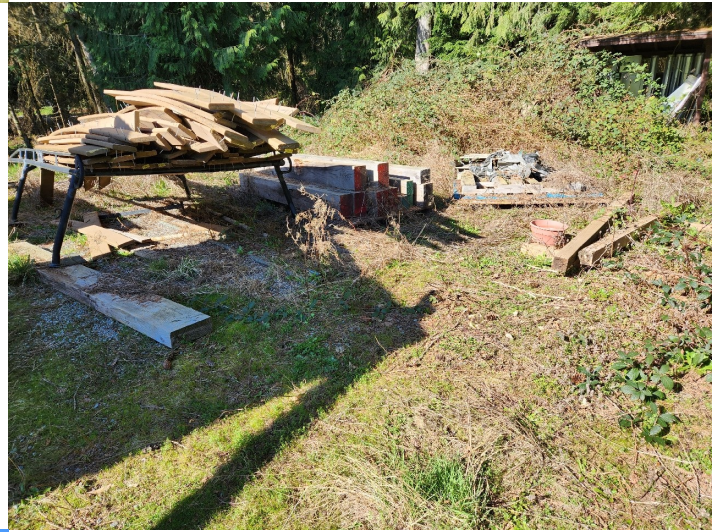
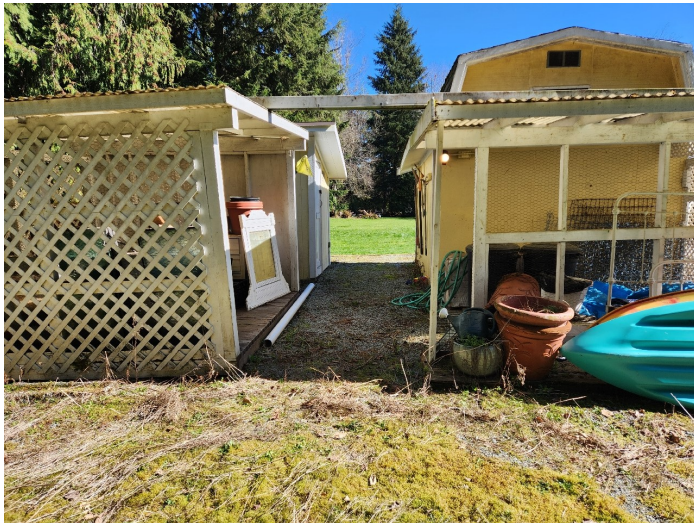
Photo 21 (Map Number 25): Two sheds with various refuse and used oil. These items should be properly disposed of before closings. Photo taken looking east.

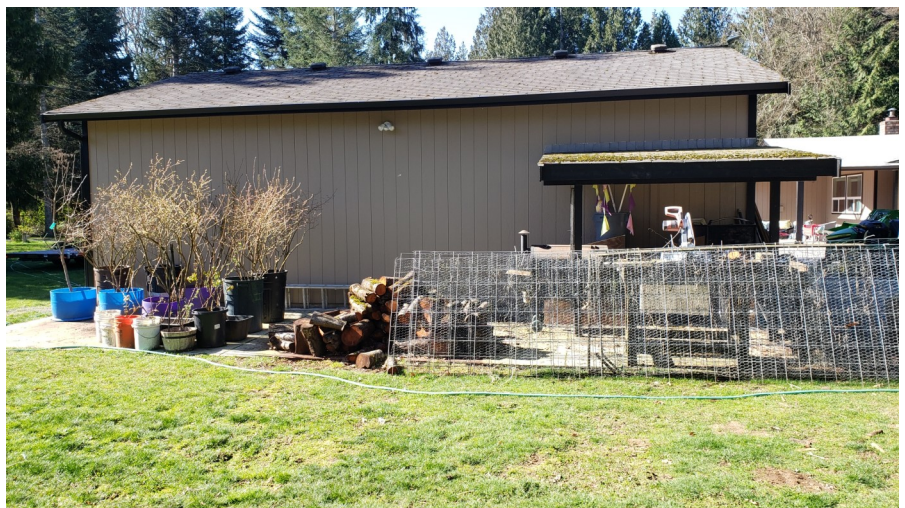
Photo 24: The southeast side of the garage. Potted plants, landscaping and outdoor materials were found. Soil around the garage appeared to be free of oil and HAZMAT contamination. Photo taken looking southwest.

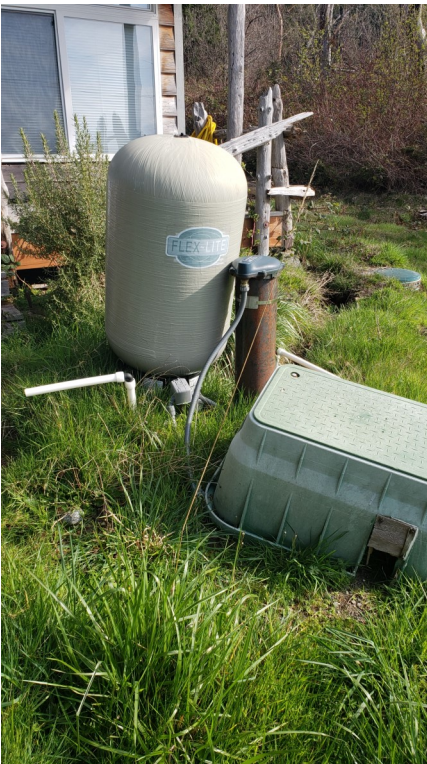
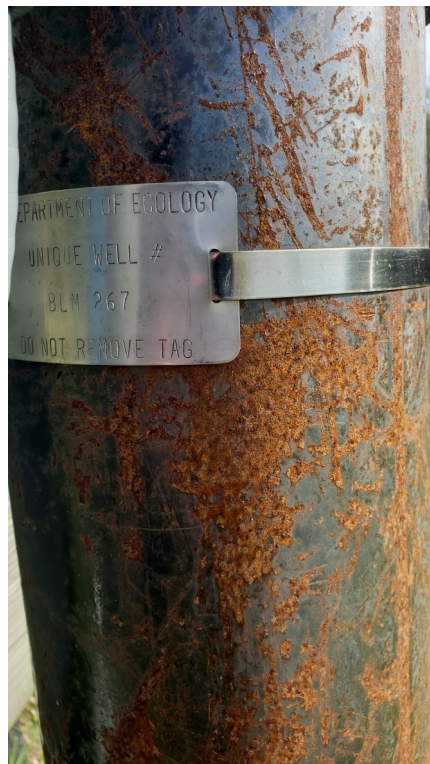
Photos 2 & 3: The drilled well and pressure tank for the property. This infrastructure is located just to the south of the residence on the property. The well infrastructure appears to be functional, despite the shoddy appearance.

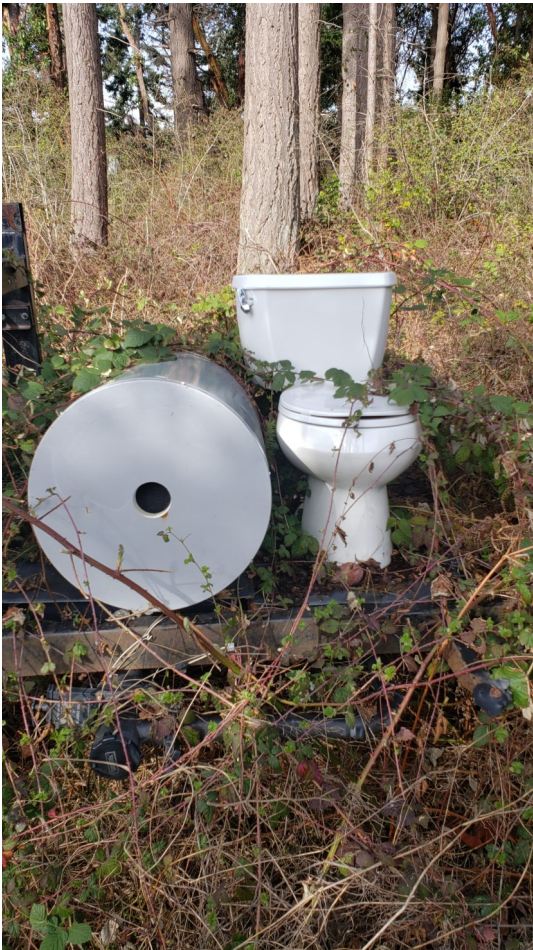
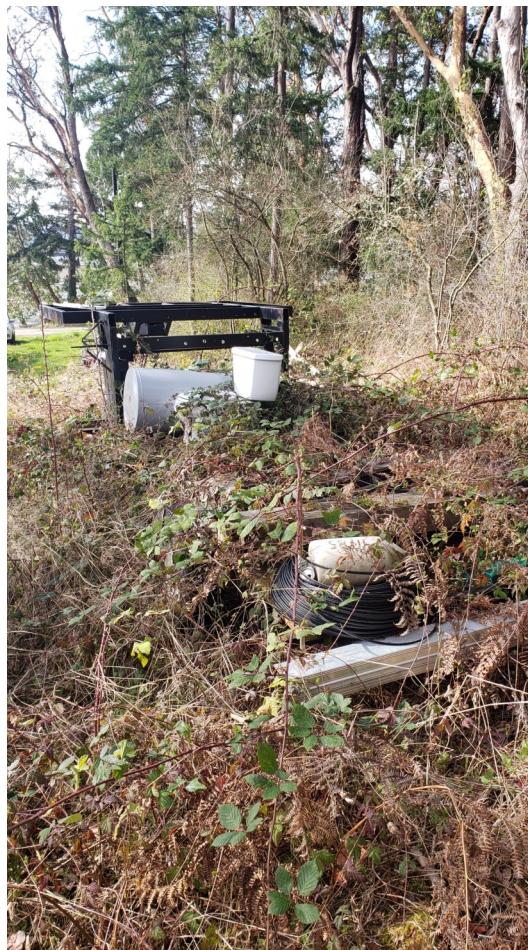
Photo 10: The large gooseneck flatbed trailer on the property, found along the western property line, near the central portion of the property, behind (north) the residence. A tank, toilet, electrical wire and wood was found on the trailer. All of these items, including the trailer, should be removed and properly disposed of prior to closing.

Photos 11 & 12: A closer look of the contents on the trailer.

This property was in decent condition and doesn't appear to show any significant environmental risks. However, there are some areas that should be given attention and removed, including: the piles of lumber, corrugated metals, trailer and trailer items, paint cans, and other household/outdoor material and equipment strewn throughout the property. If the above items can be disposed of, this property shows **No Apparent Risk**.

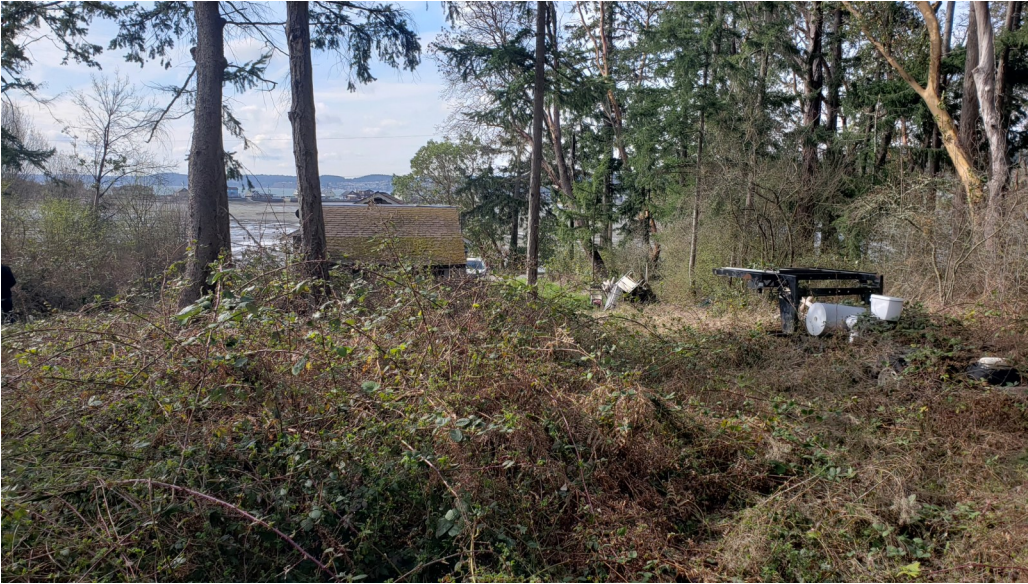
Photo 16: An additional overview of the property, taken near the center point of the property. Photo taken looking south.

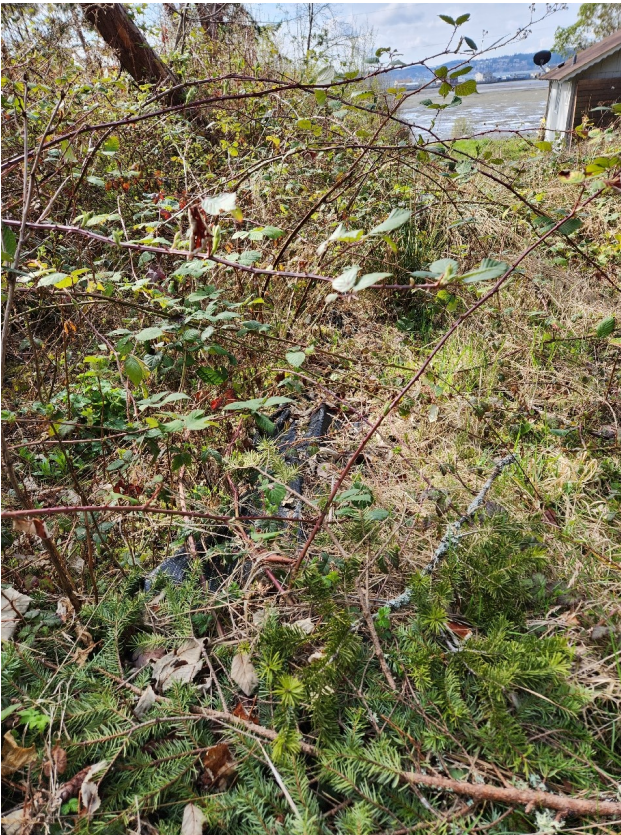
Photo 17: Looking down the eastern property line, silt fabric can be seen through the vegetation. This area could drain water during rainy months. Photo taken looking south.

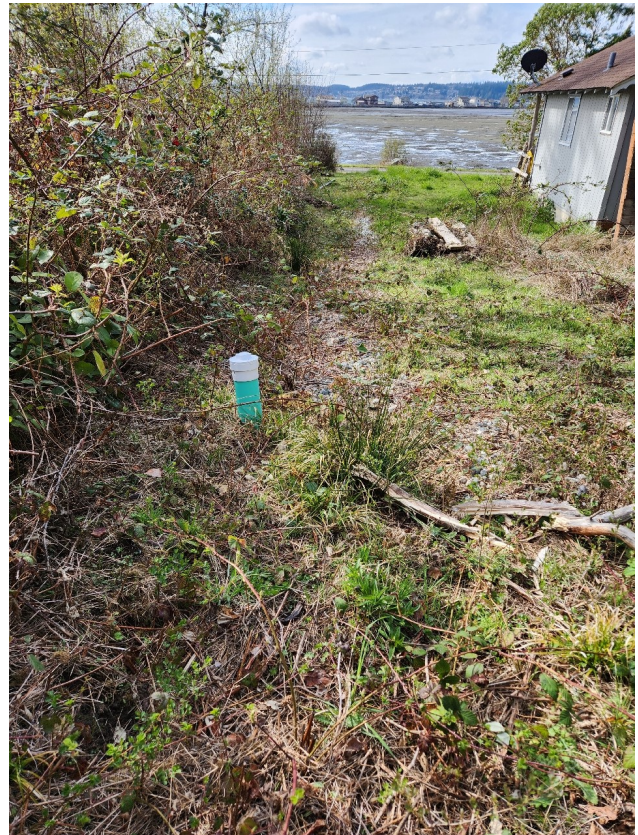
Photo 18: Looking down the eastern property line, a pipe presumably involved in the septic system was located. Additionally, river rock has been used as fill for a trench that was dug leading away from this pipe. Photo taken looking south.

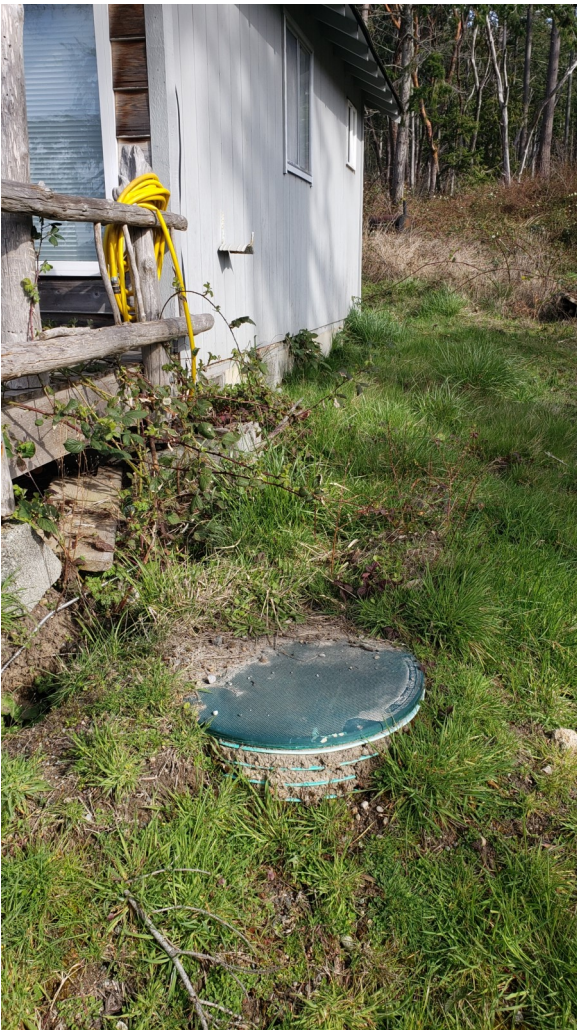
Photo 20: The septic tank on the property, just to the east of the residence. Photo taken looking north.

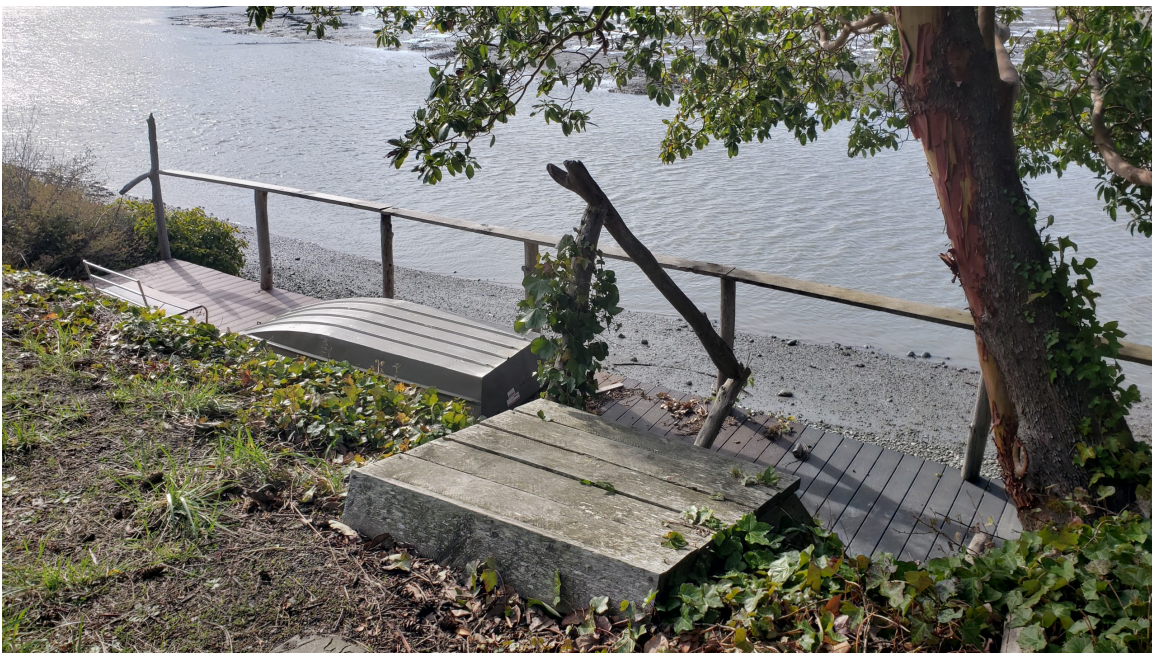
Photo 22: The steps and deck which give access to Triangle Cove, just across S Barnum Road from the residence. Photo taken looking south.

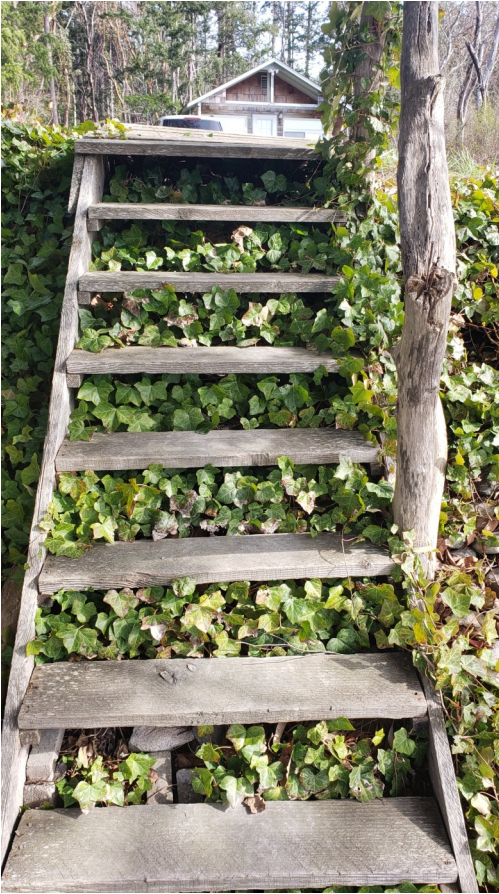
Photo 23: The steps leading down from S Barnum Road—the Vo Residence can be seen in the background. These steps are in disrepair and very rickety and appear to be located on the Vo parcel. Photo taken looking north.

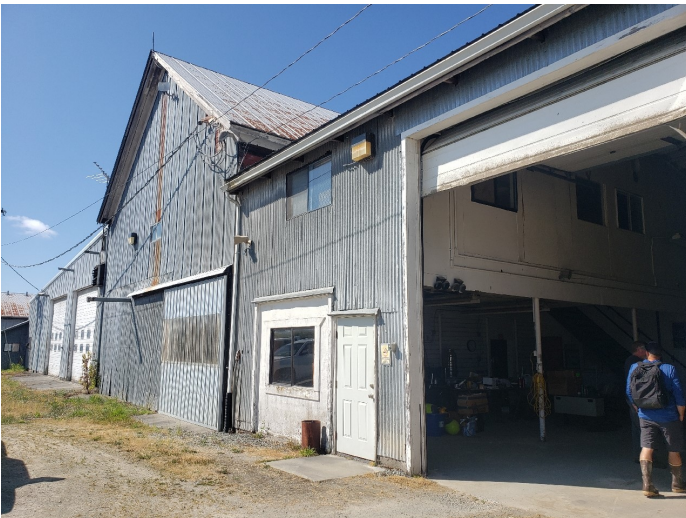
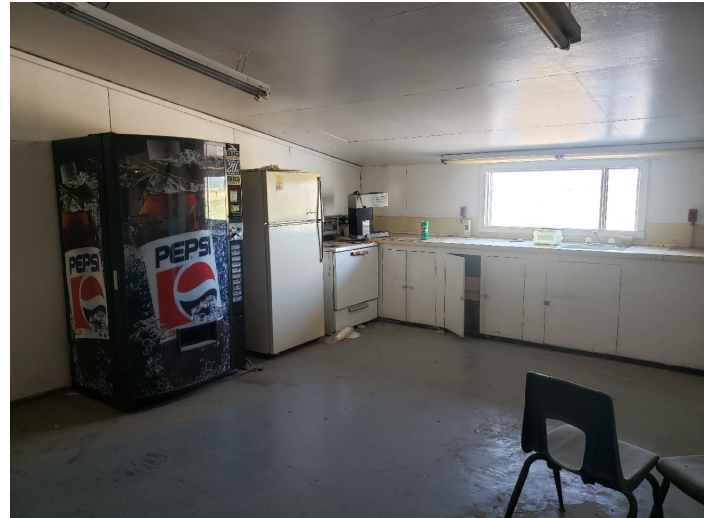
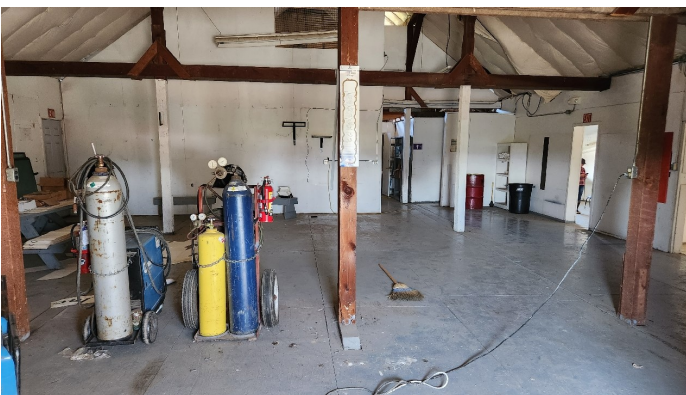
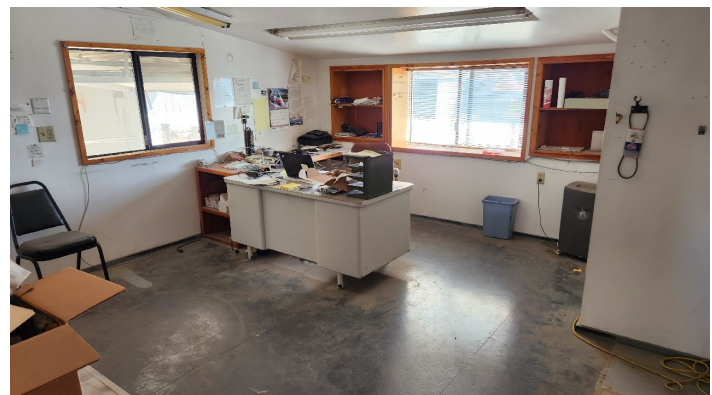
Photos 1-4: The main (north) shop on the property which supported farming operations. Inside there were office spaces, meeting areas, workshops, automotive/equipment repair bays, filling stations, among others. Photo (1) was taken looking southwest at the main entrance into the shop. Photos 2-4 depict some of the rooms/areas found within the main shop. Map Photo IDs from top left photo to bottom right: 41, 42, 43, 44.

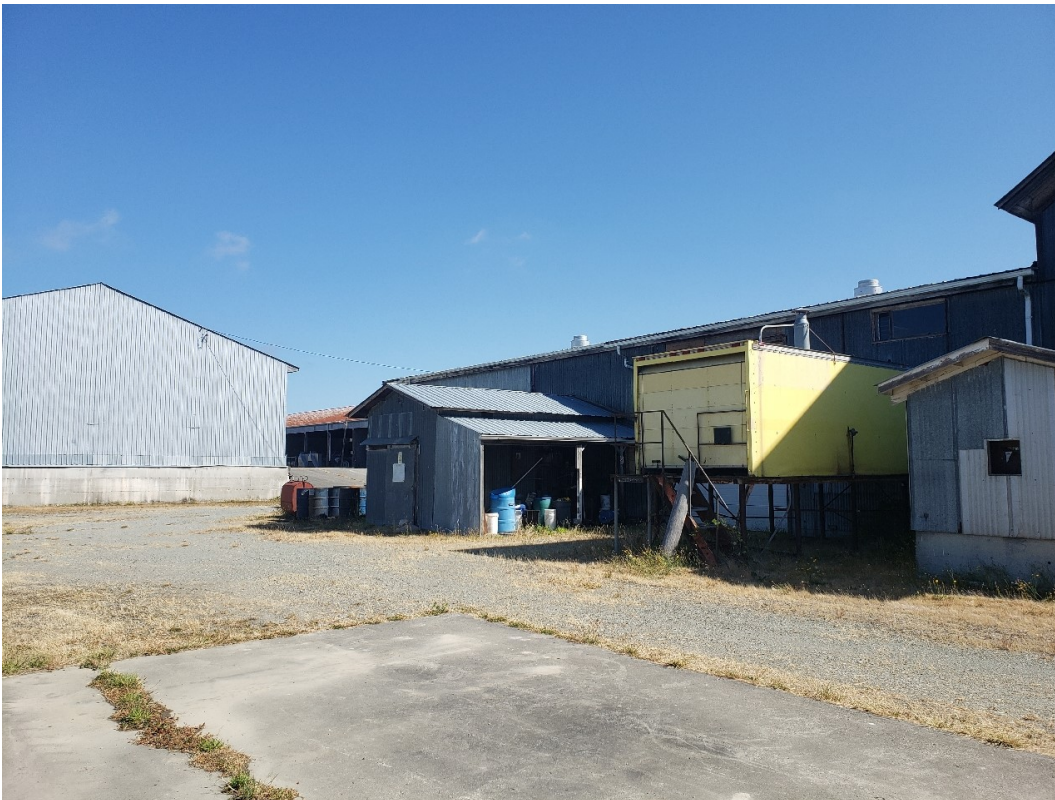
Photo 6: The western side of the north shop. The door to enter the motor oil storage room seen in Photo (5) can be seen to the right of the 55-gallon drums. This photo depicts a storage area of used 55-gallon drums, an oil filter recycler (open-air shed on the left), a semi-permanent building which houses a large air compressor (yellow structure), and another fueling station (shed on the right). Map Photo ID: 56.
