Stillaguamish Tribal Response Program

Public Record Packet Summary

Lind Property Site Assessment

Assessment date: January 19, 2023

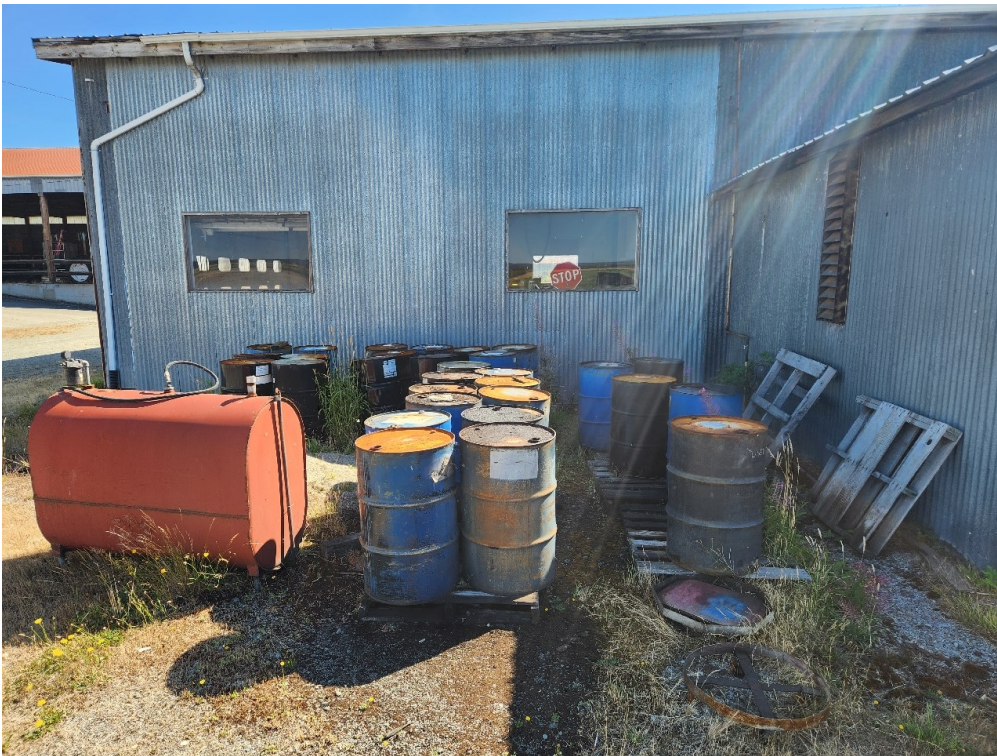
Photo 7: Approximately 26, 55-gallon drums which were previously filled with various oils and hydraulic fluids. At the time of survey, all 55-gallon drums were empty. Another larger fuel tank was also present, but appeared empty as well. Photo was taken looking east, just to the north of the motor oil storage room inside the main shop. Map Photo ID: 47.

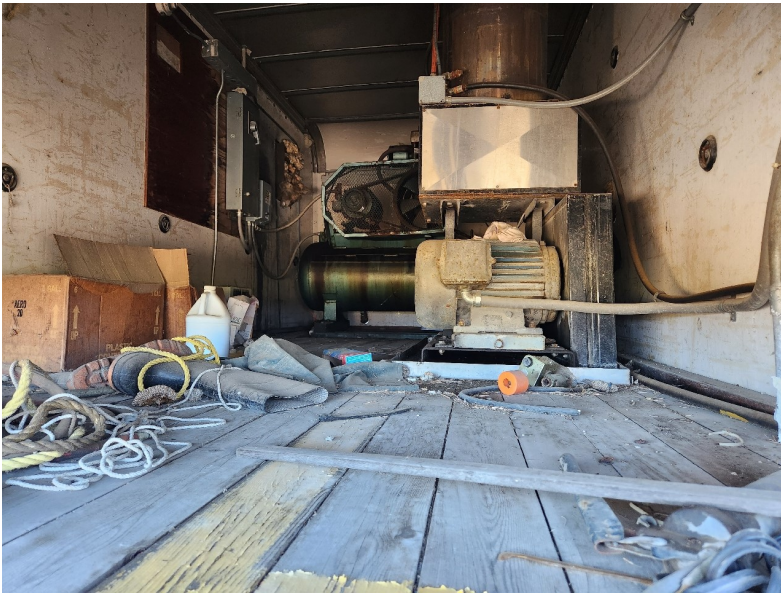
Photo 10: Inside the yellow, semi-permanent structure featured in Photo (6). This structure houses an air compressor that feeds airlines throughout the main shop and secondary shop on the property. Map Photo ID: 55.1

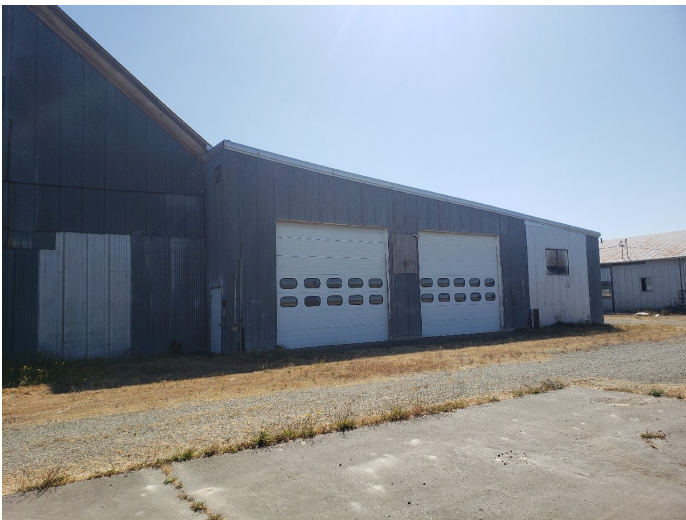
Photo 12. The western side of the automotive/equipment repair section of the main shop. Photo taken looking east. Map Photo ID: 52.

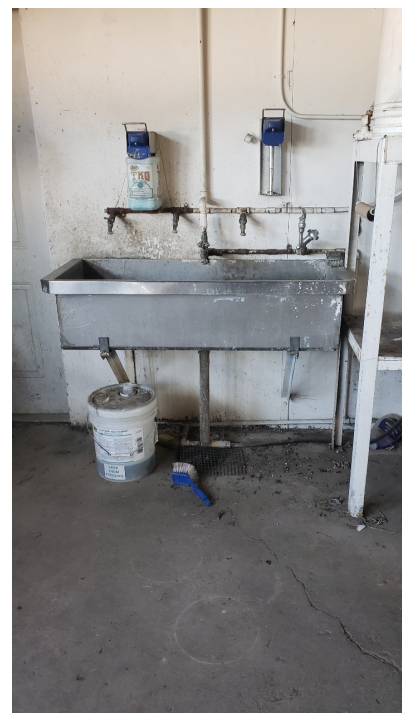
Photo 13. An industrial sink located inside the main shop. Staff were unsure where this sink drained and what is was used for. Map Photo ID: 67

There are areas of surficial hydrocarbon contamination on the property (e.g. oil stains), limited to areas where equipment was housed, maintained, and fueled. There are also several areas where oil storage existed and refueling occurred—soil subsurface should be analyzed in these locations to ensure contamination is not present. The drainage systems from both sinks and storm drain should be investigated further, both in terms of what was put down the drains and where they drain to.

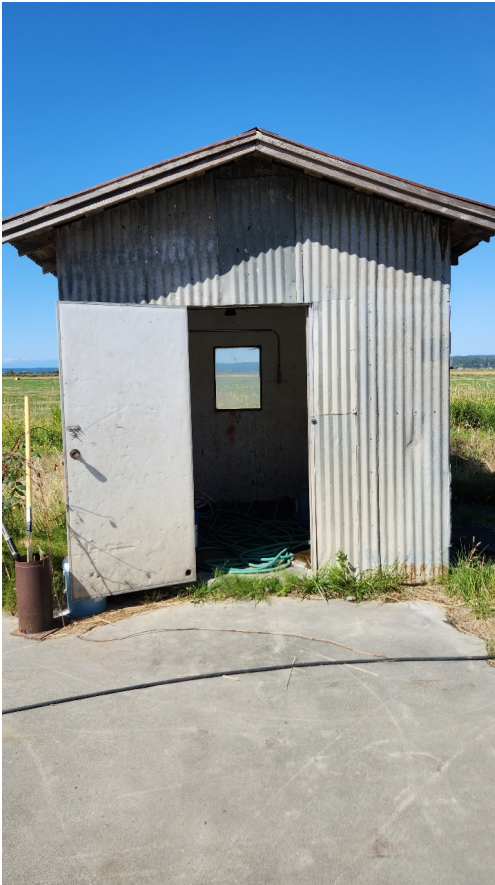
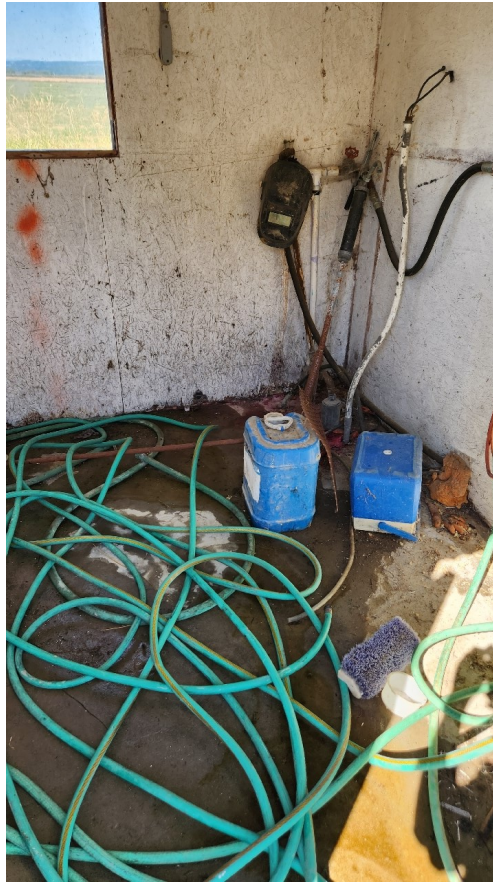
Map Photo IDs: 53.1 and 53.2

Photos 14 and 15: An outbuilding that was used for an unknown purpose. Currently, it stores a welding mask, grease gun, hose, and some containers.

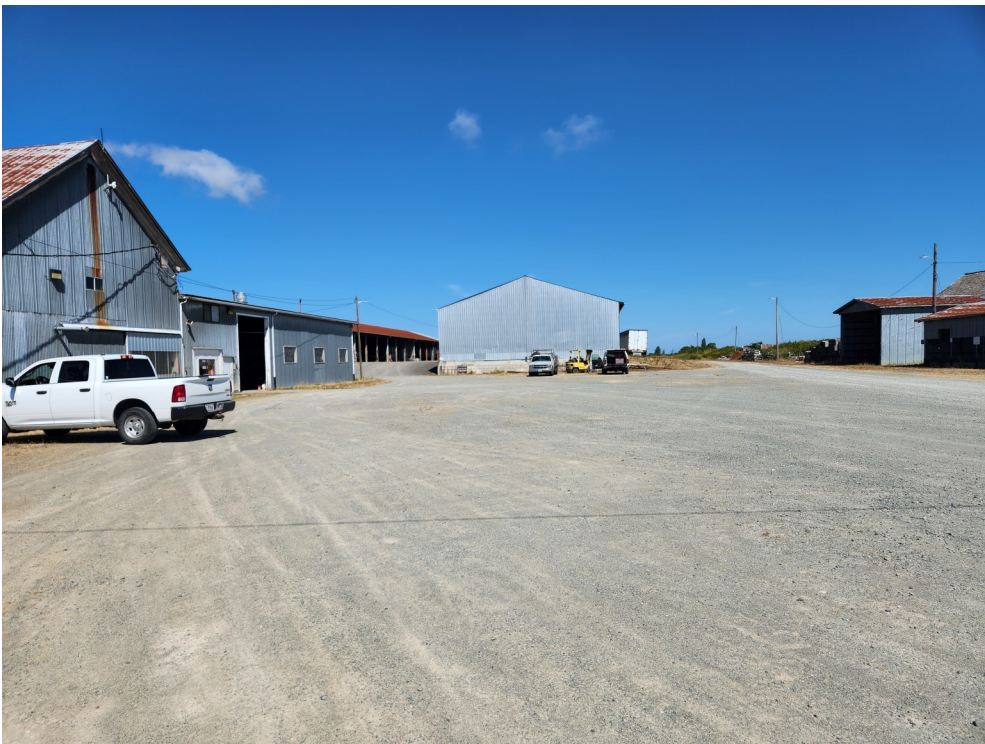
Photo 16: The main parking area for the developed portion of the property. The main shop is to the left, pole barns in the center, and historic shop/barn to the right. Map Photo ID: N/A

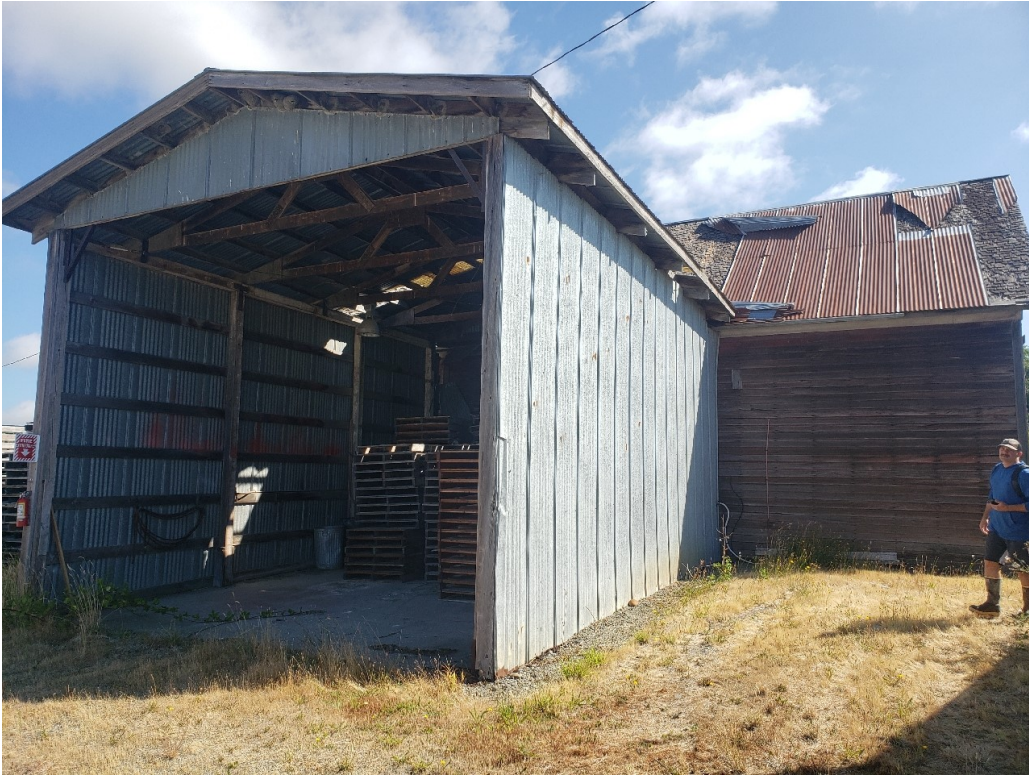
Photo 17: The historic barn on the property, just east of the main shop. A covered area has been added, currently storing pallets. Map Photo ID: 34

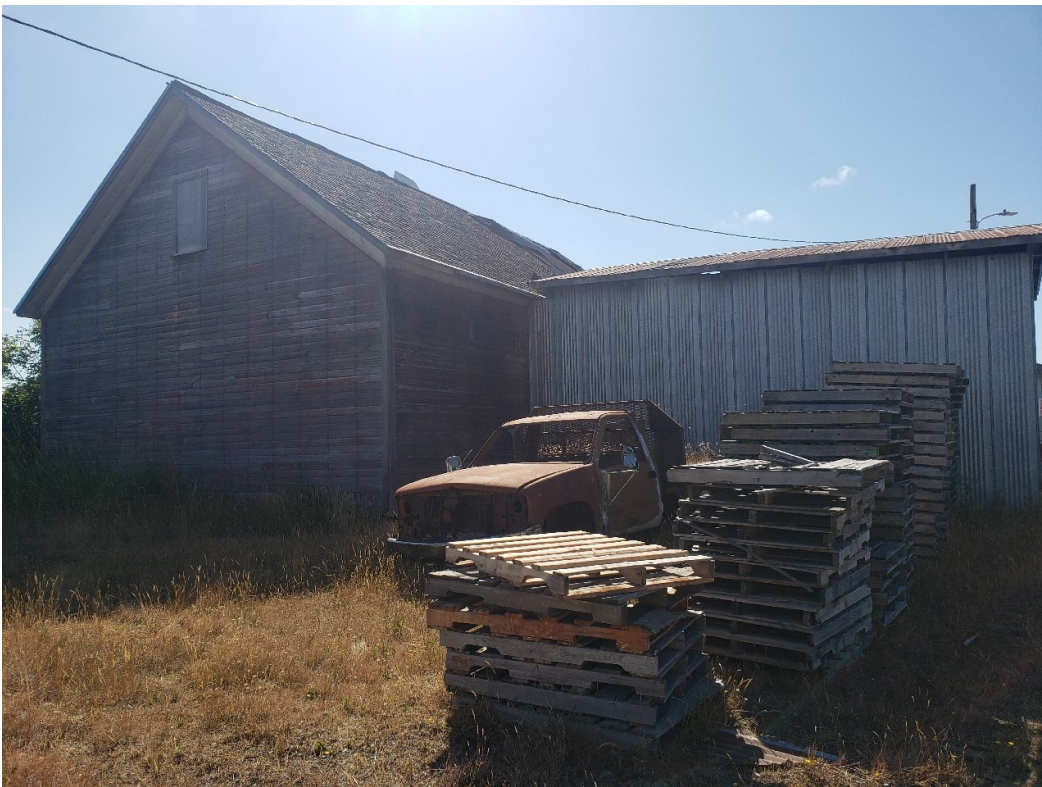
Photo 20: The east side of the historic barn. Staff located more pallets and a rusted-out work truck—no HAZMAT were located. Photo taken looking west. Map Photo ID: 37

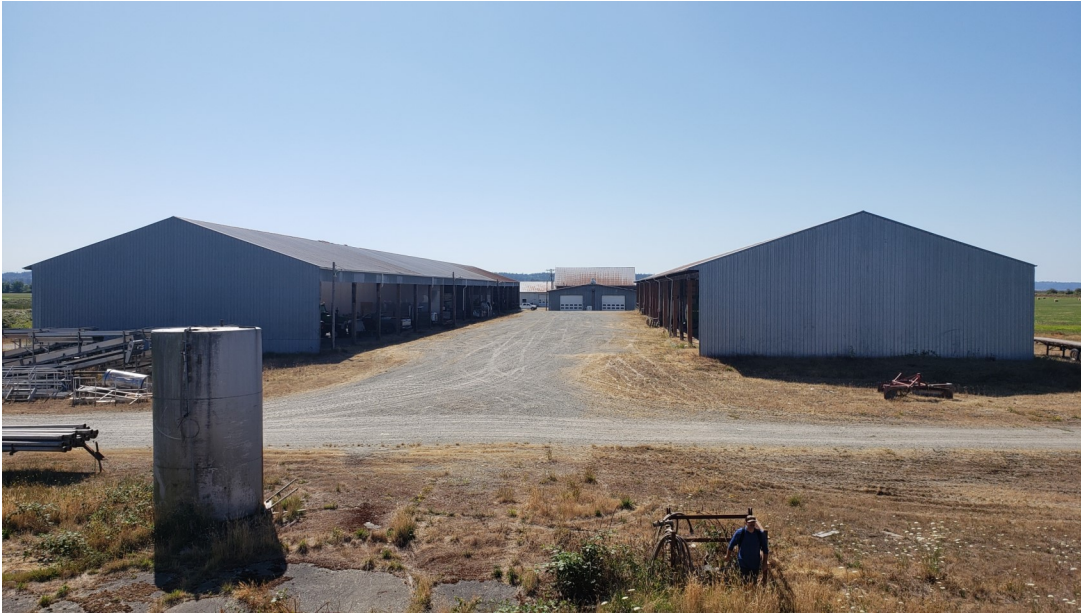
Photo 21: The two large pole barns just north of the main shop (pictured in the center of the photo). This section of the property has been built up and is the highest point on the property, besides the hill on which the photo was taken. These barns were used for the storage of large farming and processing equipment for TCF operations. Photo taken looking south. Map Photo ID: N/A.

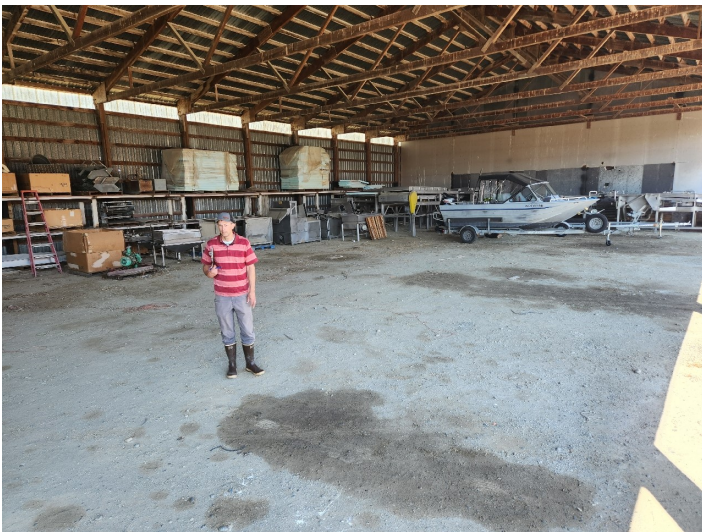
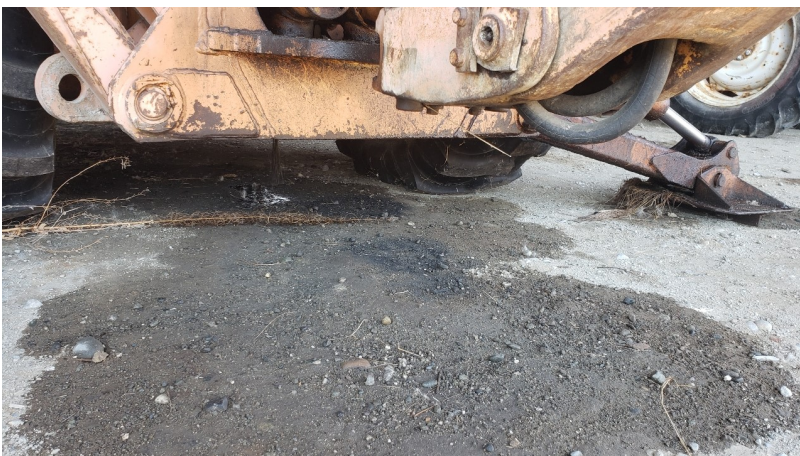
Photos 22-24: The gravel floor inside the pole barns had patches contaminated with oil and hydraulic fluids. These oiled/stained gravels were likely surficial, however standing pools were seen (like Photo (23) on the left). Map Photo IDs: 73, 75, and 76.

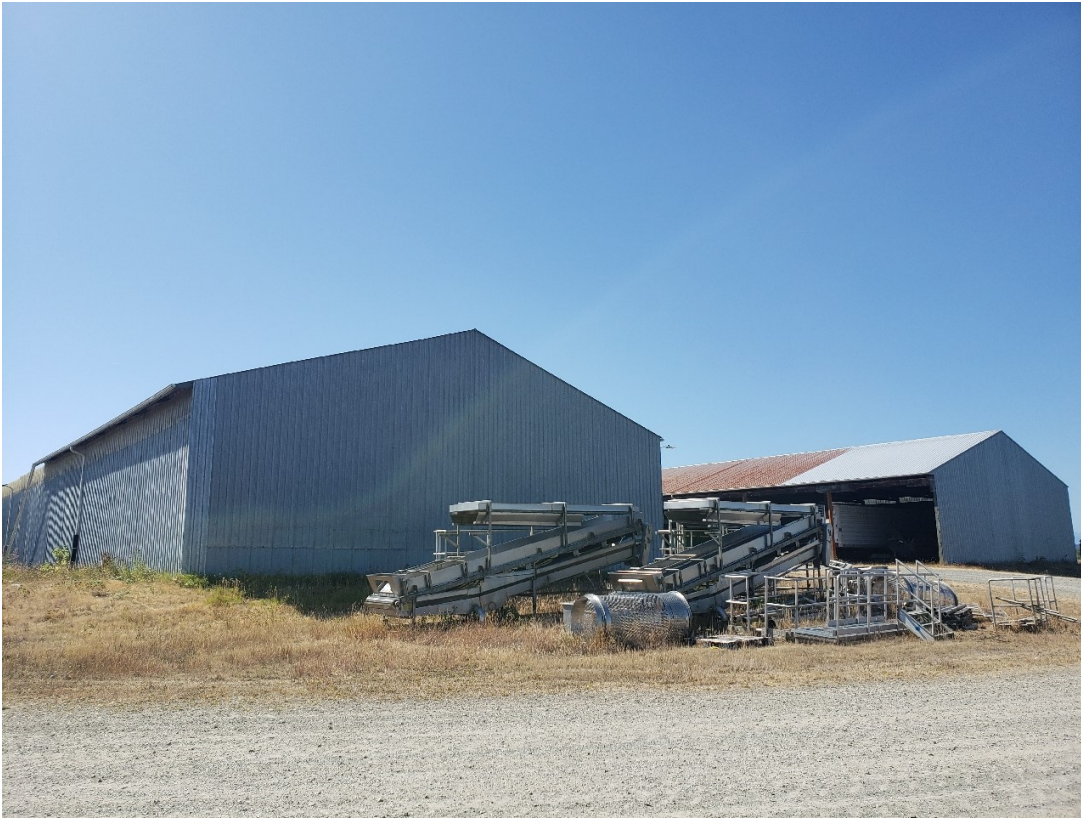
Photo 29: The north side of the two pole barns. TCF was using this location to store surplus equipment, no HAZMAT was located in this area. Photo taken looking south. Map Photo ID: 84.1

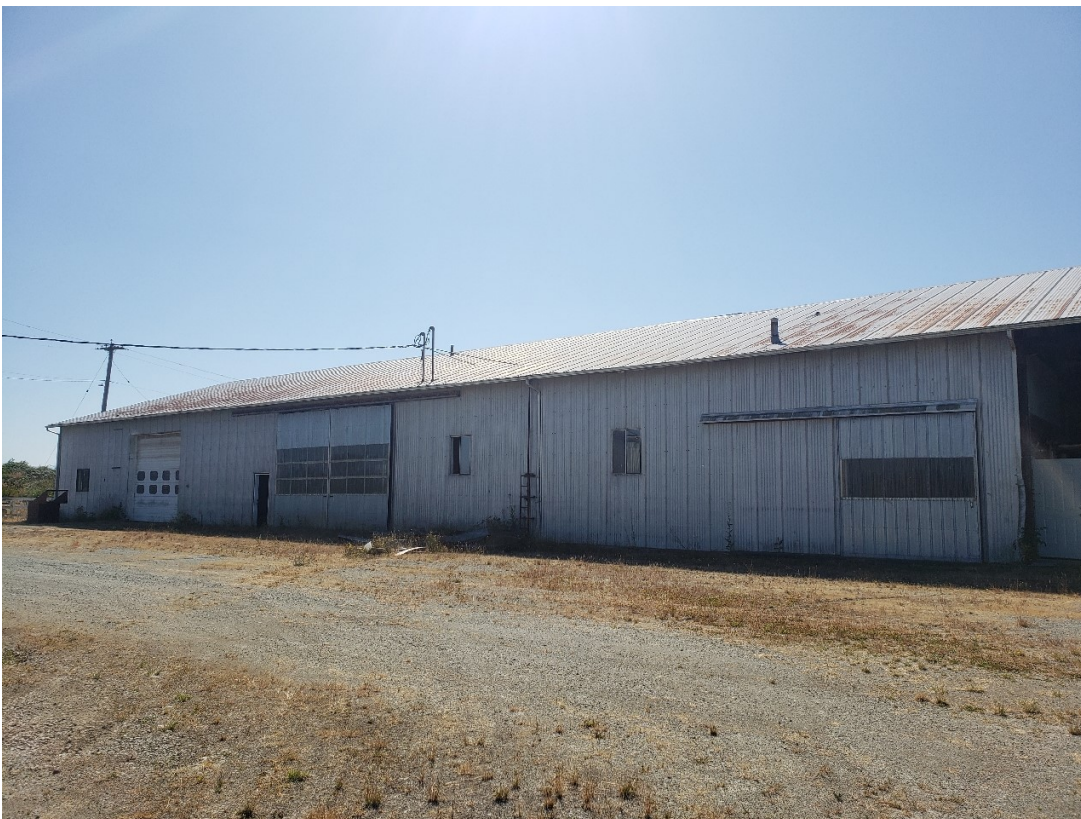
Photo 30: The second shop on the property, just to the south of the main shop. This shop contained similar contents including: farm maintenance equipment, oils, aerosols, among other household items. Oil stains were present at various locations in the building. Photo taken looking south. Map Photo ID: 61.

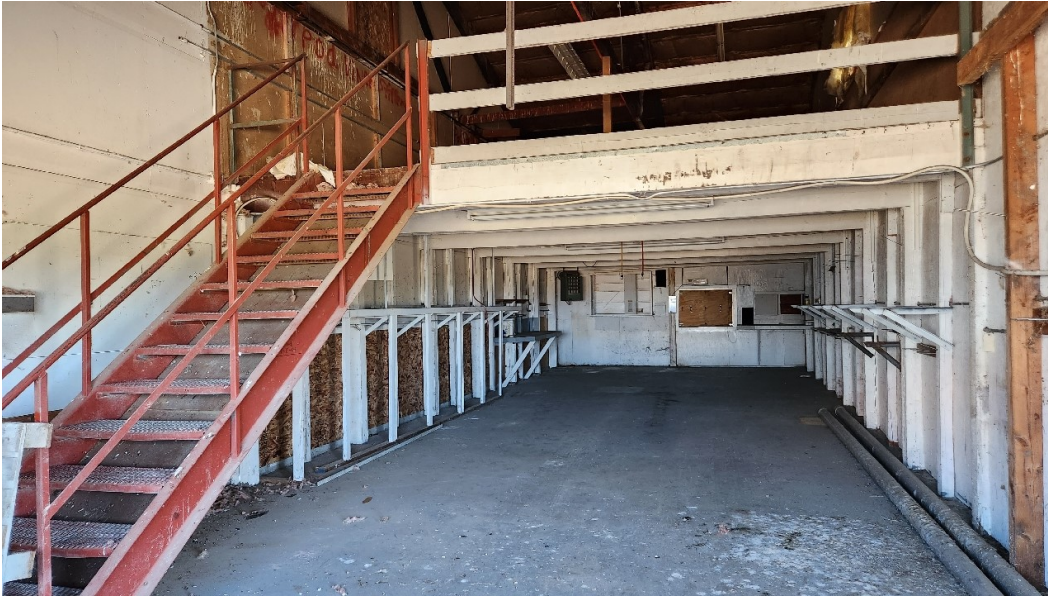
Photo 31: Inside the second shop, a staircase leads to an upstairs storage area. Picture taken in the western half of the second shop. Map Photo ID: 68.1

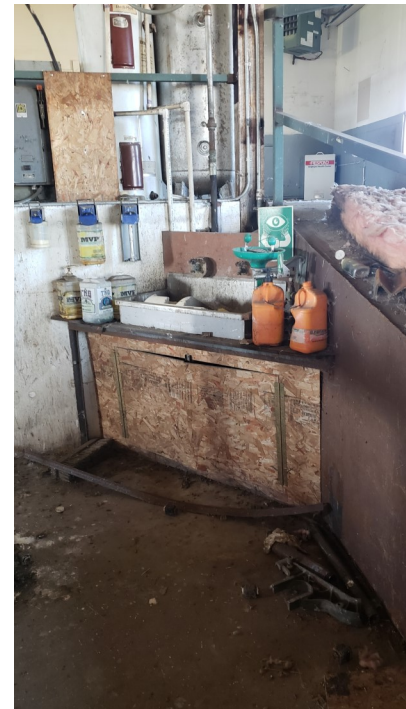
Photos 32-34: The eastern portion of the second shop. This area of the shop had loose and falling insulation, extensive bird and rodent feces, and oil stains on the concrete floor. It hadn't been used in years. Various large equipment, cabinetry, chemicals, were located, along with a second industrial sink (draining location unknown). Map Photo IDs: 68.2, 68.3, and N/A (sink).

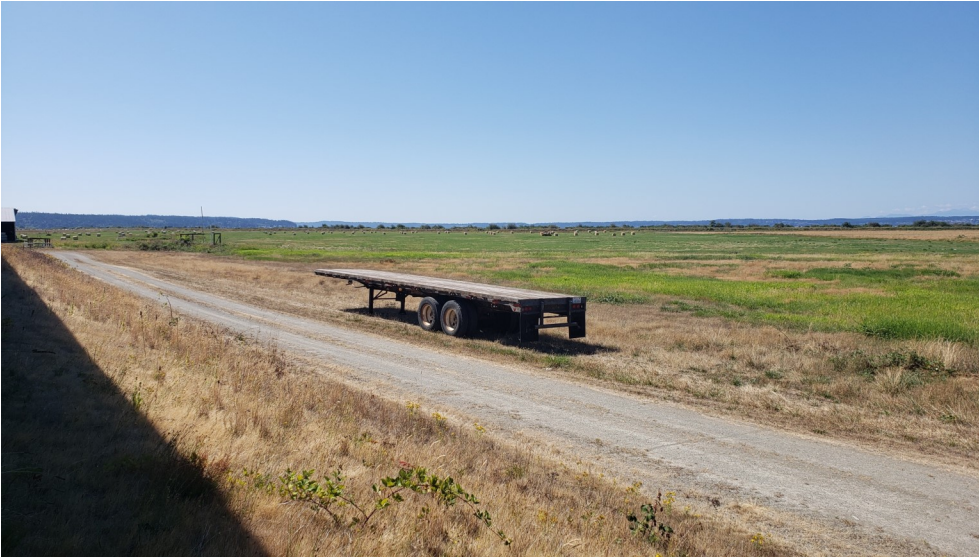
Photo 37: The farm road that wraps around the pole barns, giving access to the northern farmed sections of the property. Photo taken looking southwest. Map Photo ID: N/A

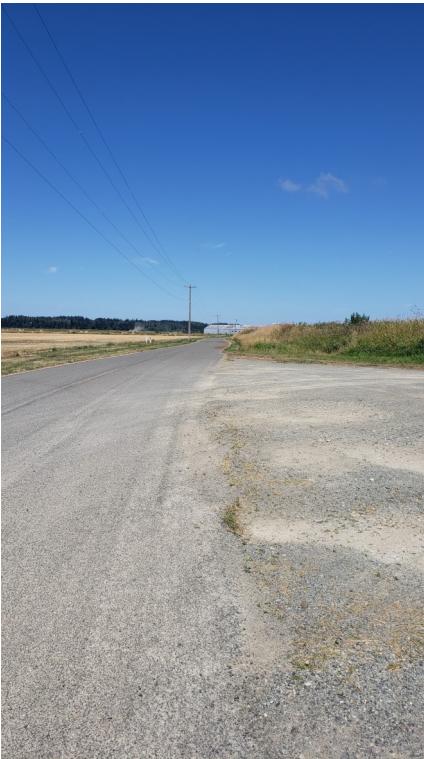
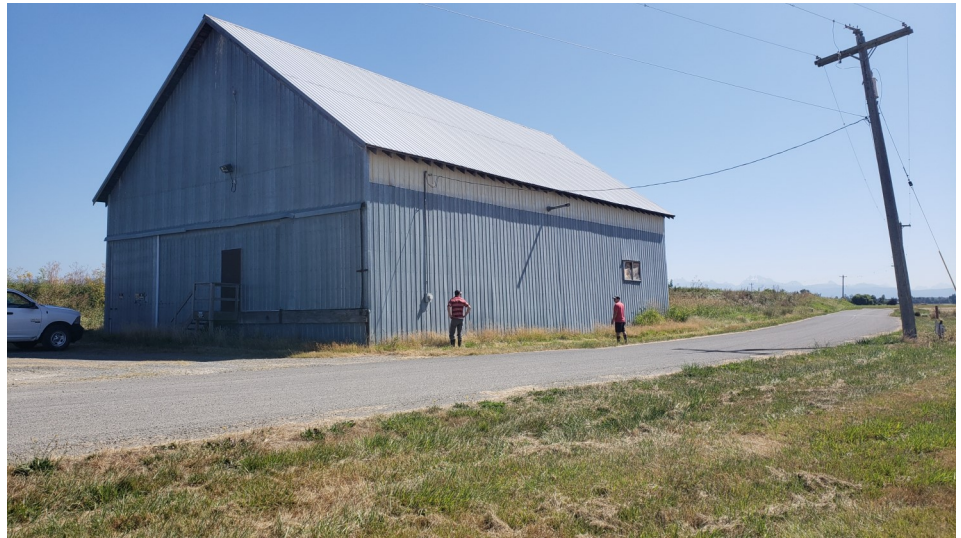
Photos 38 and 39: (Left) Thomle Road looking north towards the second shop on the property. (Right) A barn used to store unknown equipment off Thomle Road, 1400' south of the main shop. Staff were unable to look inside do to security restrictions (e.g. the one door had been secured with 50+ screws to prevent break-ins).

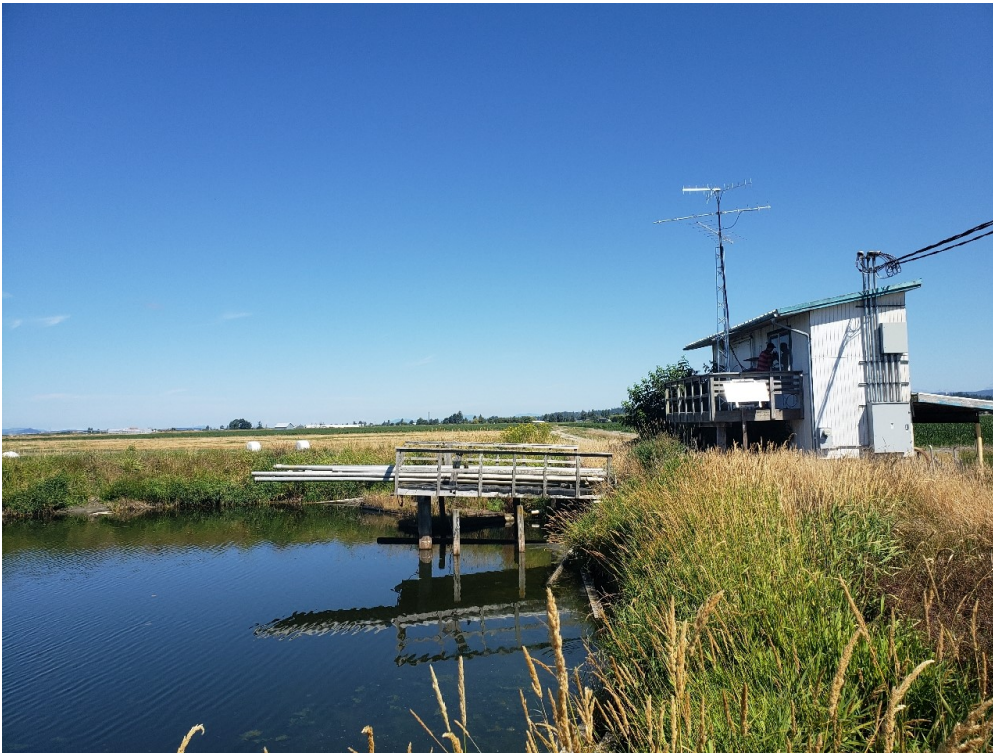
Photo 40: The pump house located at the southern and oldest irrigation pond. Vegetable processing water from TCF would be pumped into these ponds, then pumped out to fertilize/irrigate the fields. This is also the location of a Stillaguamish Tribe MOTUS tower. These ponds were built on the lowest elevation portion of the property (historic tidal wetland channel). The large barn off Thomle Road pictured in Photo (39) can be seen in the distance. The pump house is approximately 1 mile from the main, developed portion of the property. Photo taken looking north. Map Photo ID: 95.1

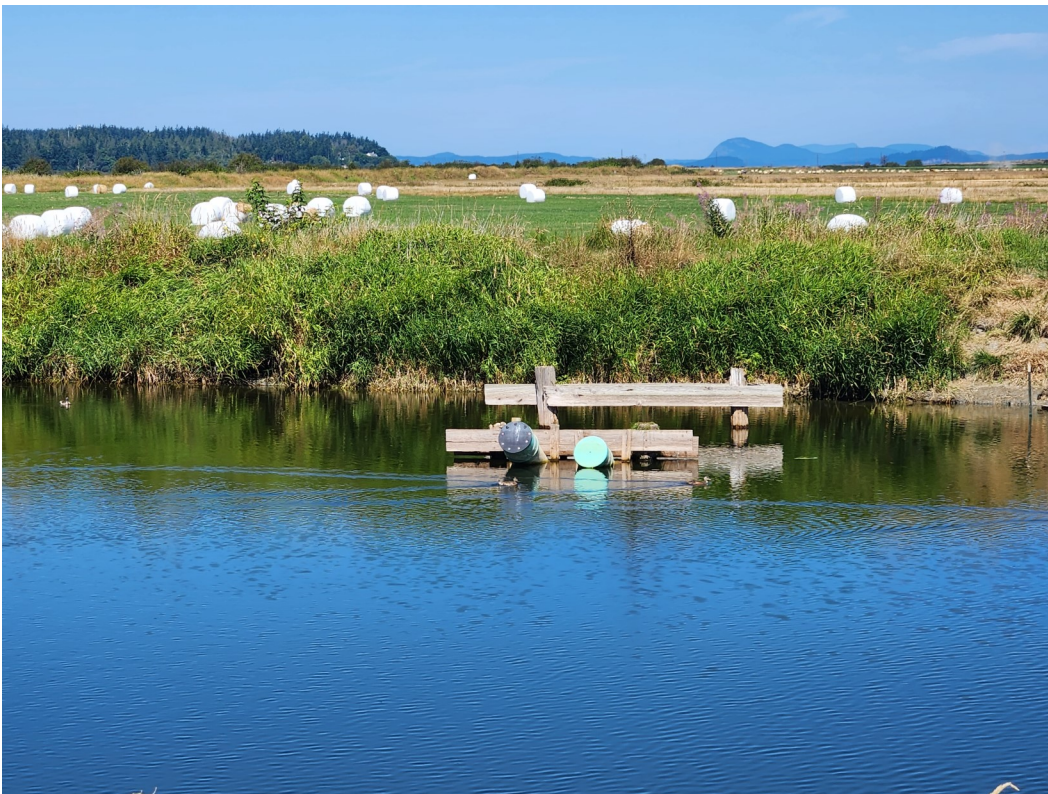
Photo 41: Two of four vegetable processing water outlet pipes from the main TCF facility. These pipes are just west of the pump house (right). Photo was taken looking north across the northern, farmed portion of the property. Map Photo ID: N/A

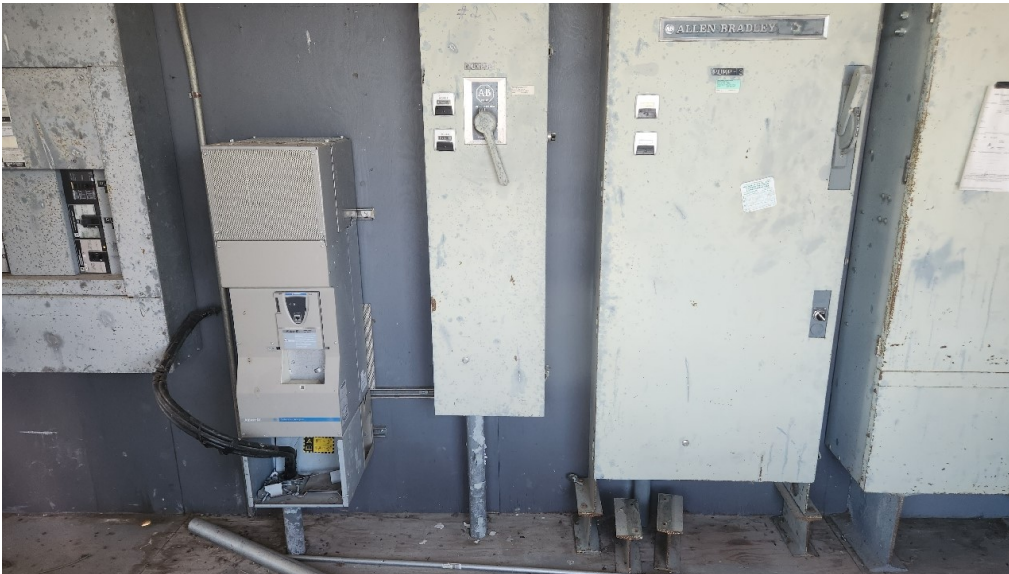
Photo 42: Electrical equipment inside the pump house featured in Photo (40). Map Photo ID: 99.1

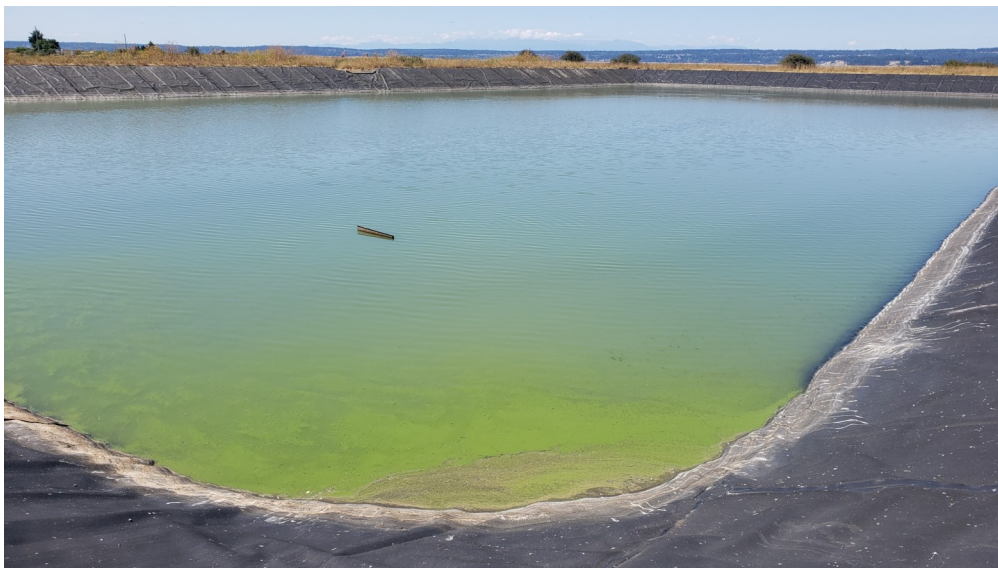
Photo 43: The second, newer and lined irrigation pond, just south of the other pond. This pond is approximately 100 yards long. Steve Karcher believes an underground pipe can fill this pond from the other, likely passively as both ponds are near the same elevation. Staff were unable to verify the presence of an underground pipe. Photo was taken looking south. Map Photo ID: N/A

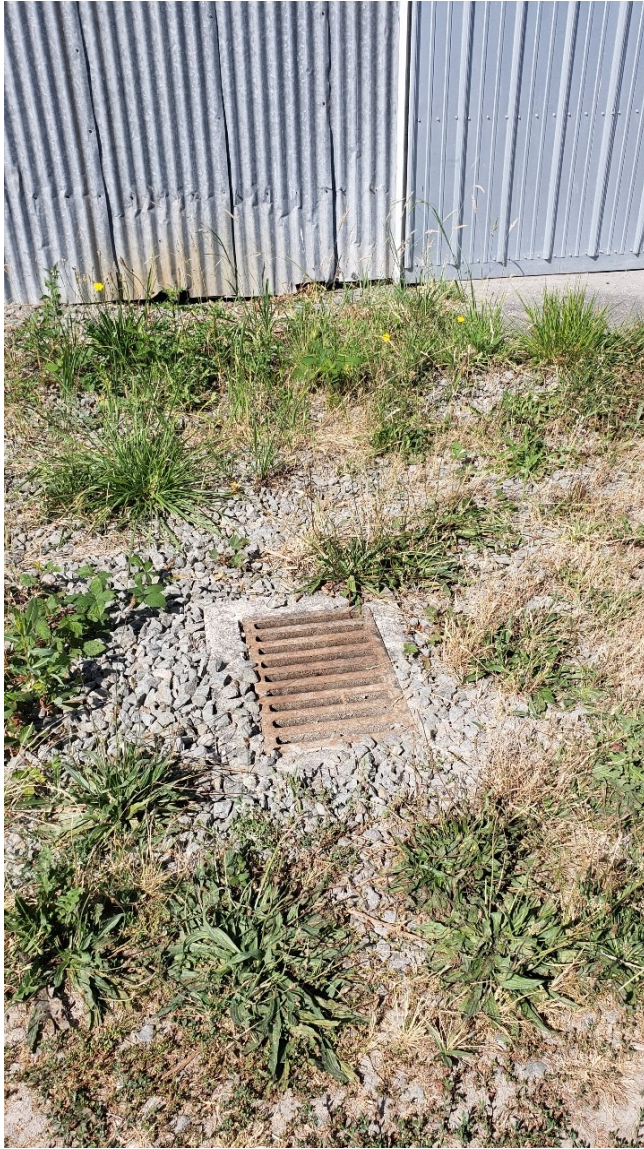
Photo 44: A drain outside the north shop (in the parking area). Staff were unsure if this discharged into a French Drain system, an Underground Storage Tank, or piped to another location.

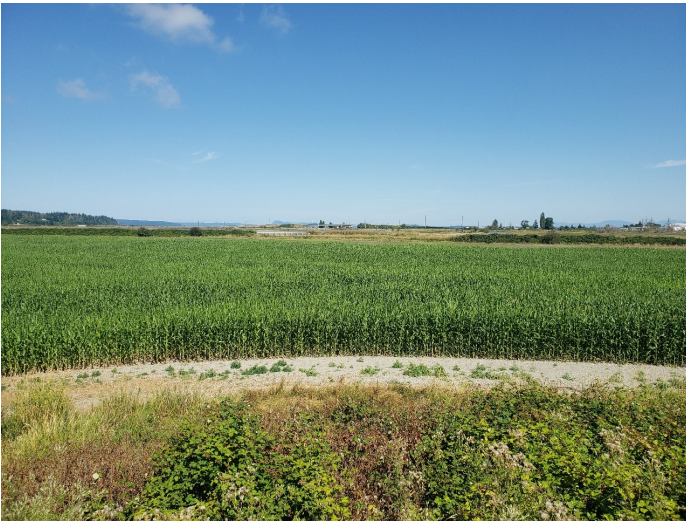
Photo 45: The northern end of the property which borders the southern end of zis a ba I. Map Photo ID: 80

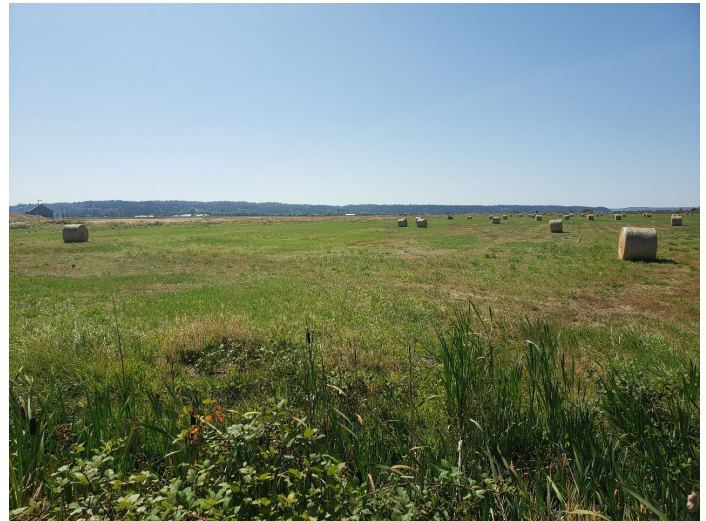
Photo 46: Looking over the southern portion of the property. This farmed area covers the majority of the property. The Thomle Road barn can be seen to the left. Map Photo ID: 69

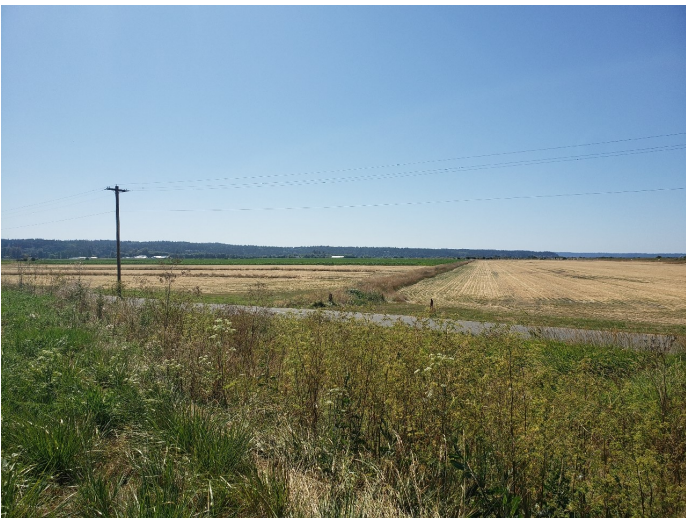
Photo 47: Another view of the southern portion of the property, taken from the Thomle Road barn looking southwest. Map Photo ID: 92.3

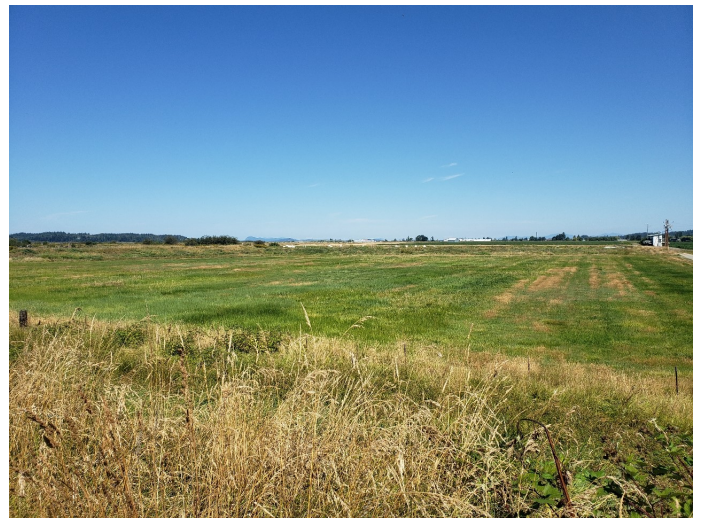
Photo 48: Looking north across the property from the northern waste water pond. Map Photo ID: 98.1
