## Stillaguamish Tribal Response Program

### 2024 Public Record Packet Summary

# Local Brownfields Public Record Report

**Kunkel Property Site Assessment**

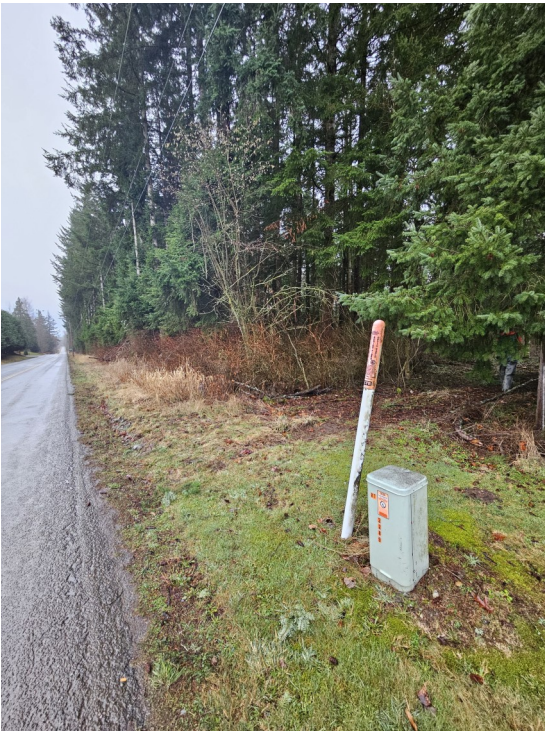
Photo 1: The eastern property line which parallels 4th Ave. NW. Photo taken from the northeastern corner of the property looking south.

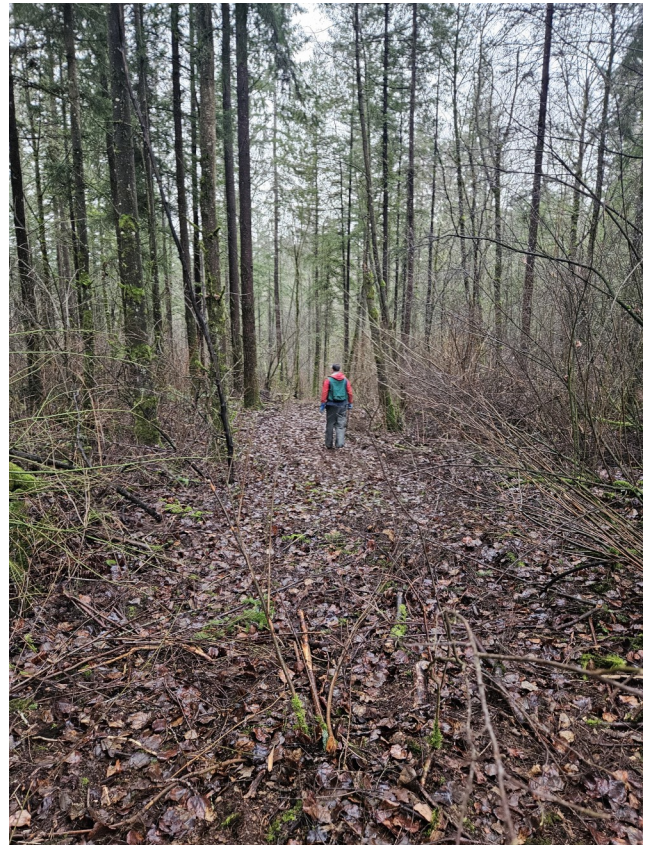
Photo 2: Looking southwest into the central portion of the property, along a newly constructed trail. This trail slopes down from the northeastern corner of the property seen in Photo (1). This trail was likely constructed by developers who were interested in development opportunities.

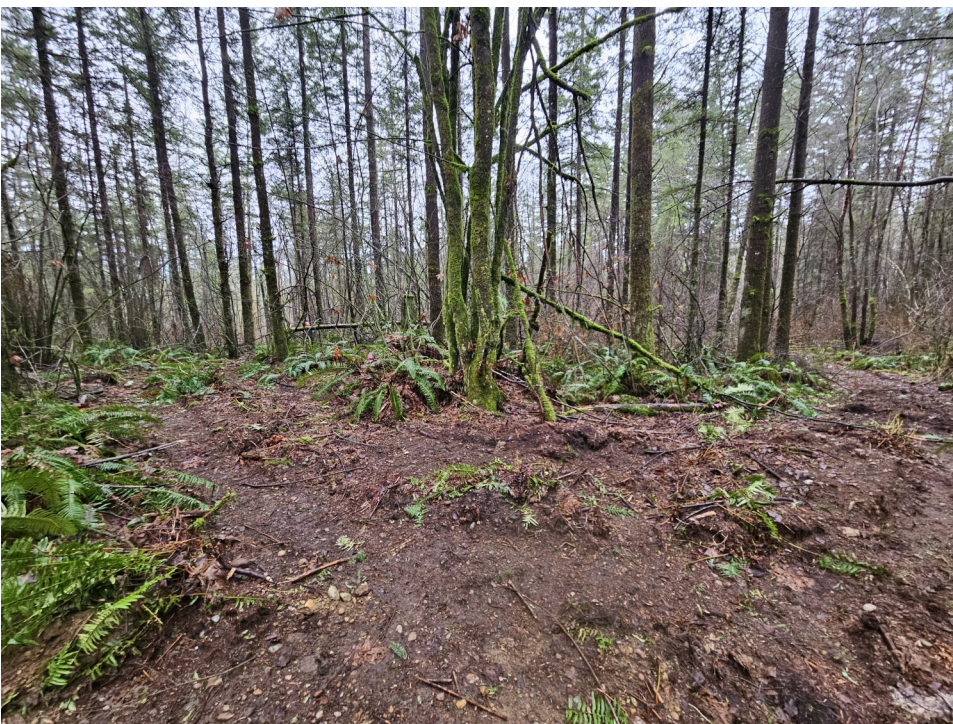
Photo 4: Trail junction just north of the property center point. Left fork leads towards the southeast property corner, the right fork lead towards to the northwest property corner. Photo taken looking southwest and downhill.

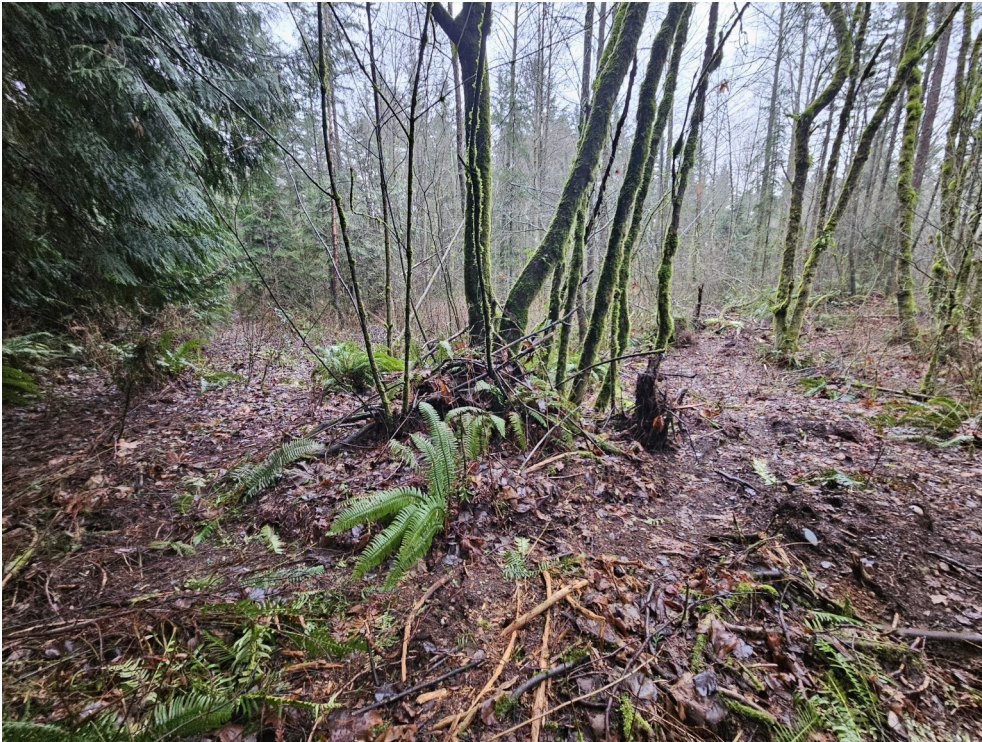
Photo 5: Looking south across the property from the northern property line. Generally, this property is third generation timber.

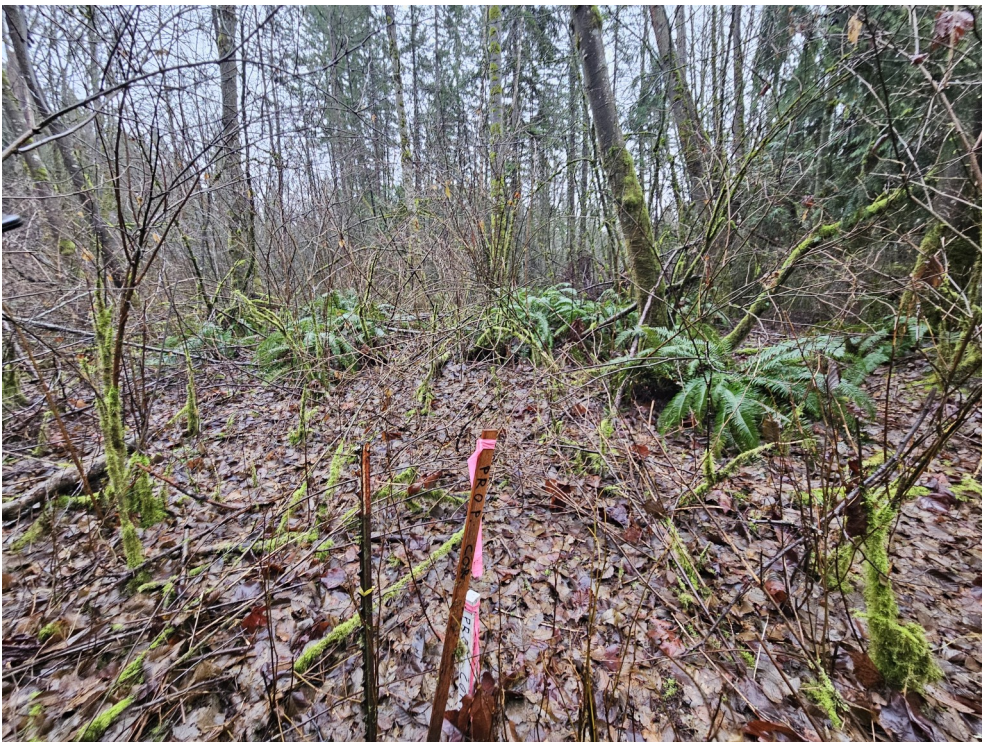
Photo 6: The northwestern property corner, looking southeast. This area is gently sloped towards the central portion of the property and has areas of standing water/wetlands with evidence of seasonal creeks that likely drain into Sunday Creek.

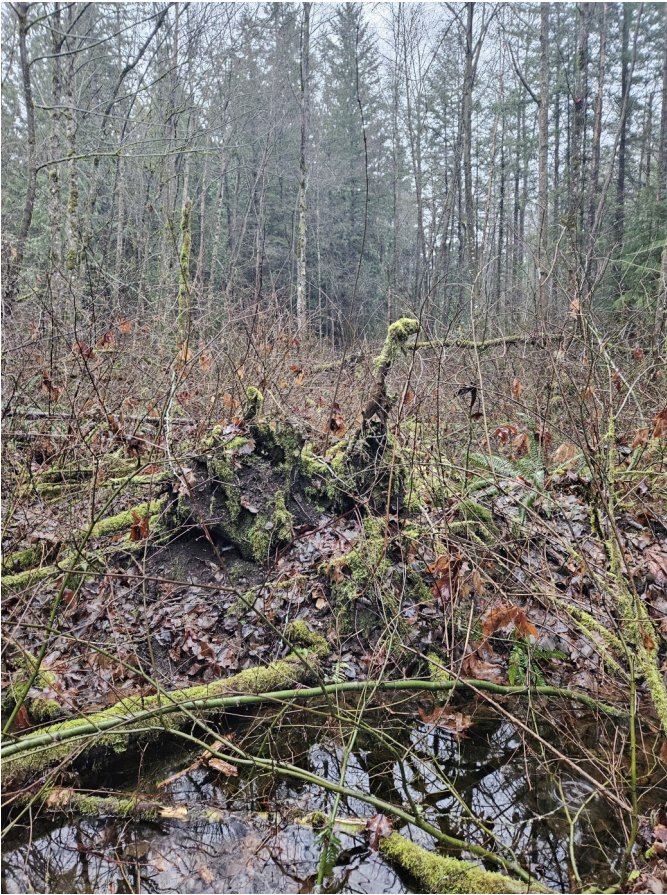
Photo 7: Looking upslope to the northern property line seen in Photo (5). This area had pockets of standing water and wetlands, and evidence of seasonal creeks.

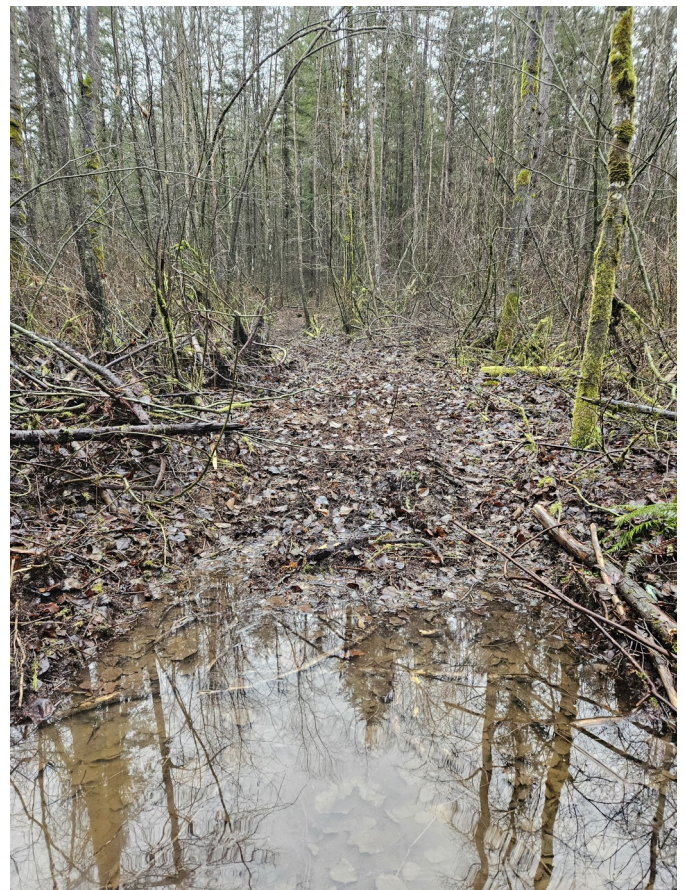
Photo 10: Another watered section of the south spur of the trail, just south of percolation test pit from Photo (9). Photo taken looking southeast.

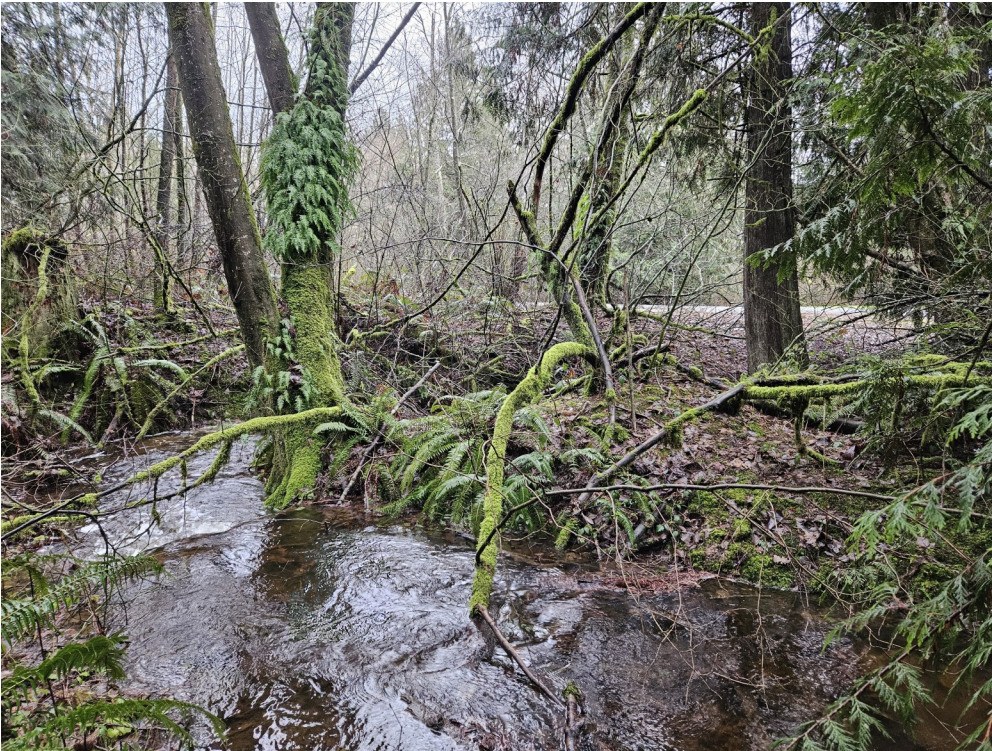
Photo 11: Sunday Creek flowing across the southern property line that runs parallel with 244 St. NW. Sunday Creek enters the property at the center point of the western property line. From here, Sunday Creek runs generally southeast.

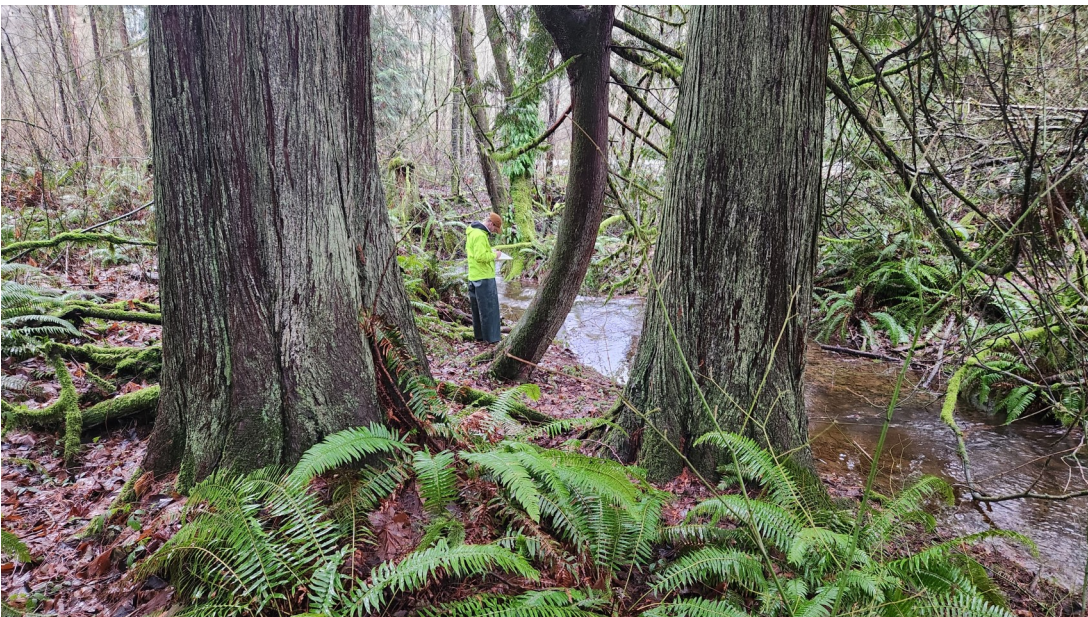
Photo 12: The midpoint of Sunday Creek on the property. Many cedar trees inhabit this zone of the property.

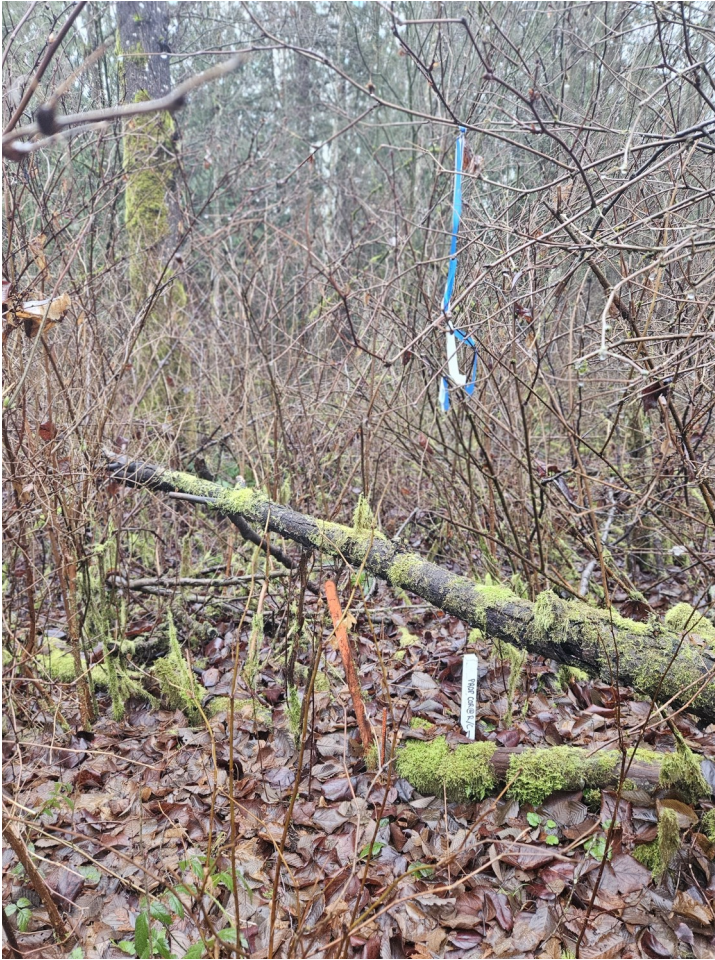
Photo 13: The western property line, looking east. Sunday Creek is just beyond this photo.

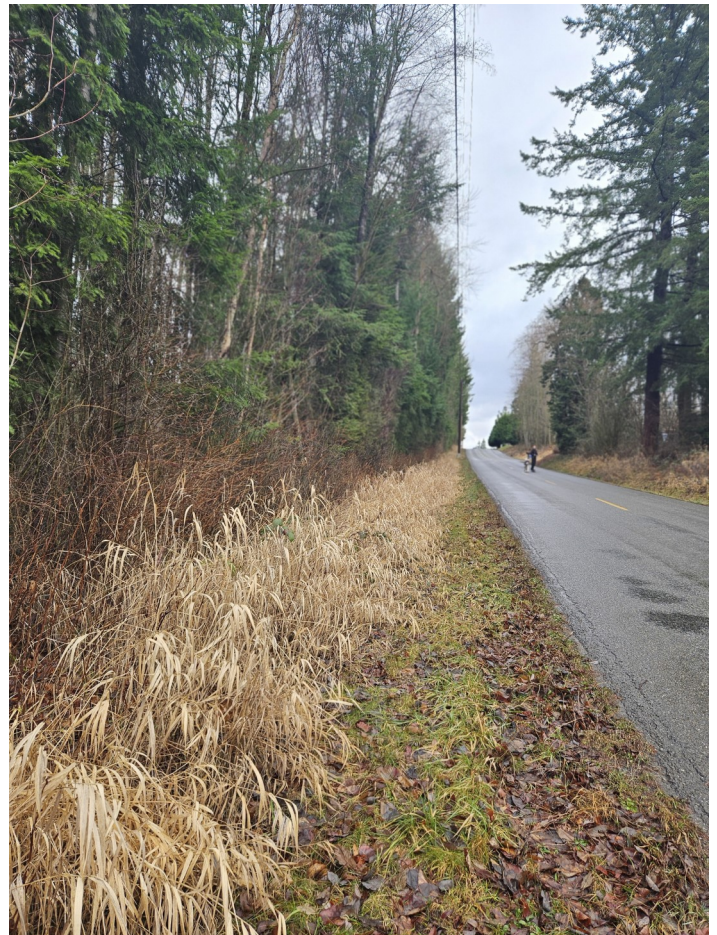
Photo 14: The southeastern property corner, looking north along 4th Ave. NW. The tree composition (alder, cottonwood) in this area indicates the soil is saturated. As you travel north, firs become more numerous, suggesting better draining soils.

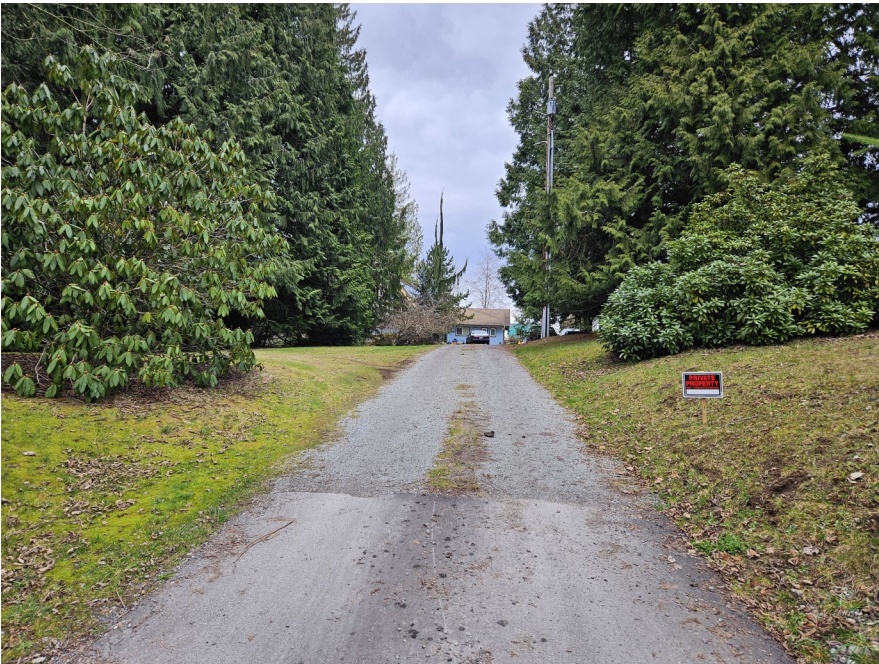
Photo 1: Driveway off 236th St. NE onto the Bergstrom property. The Stillaguamish Tribe owns the surrounding properties (Roller and McMac).

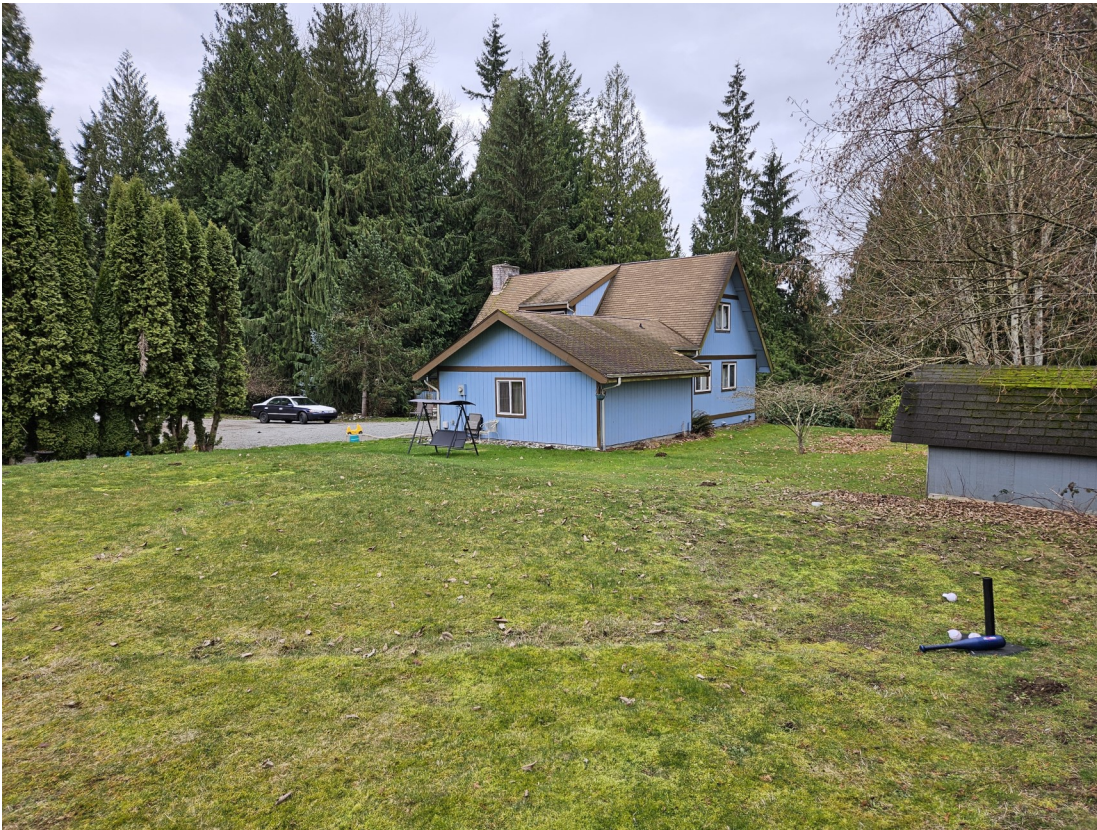
Photo 13: The backyard of the property with the main residence in the background. Photo taken from the northeast corner of the property.

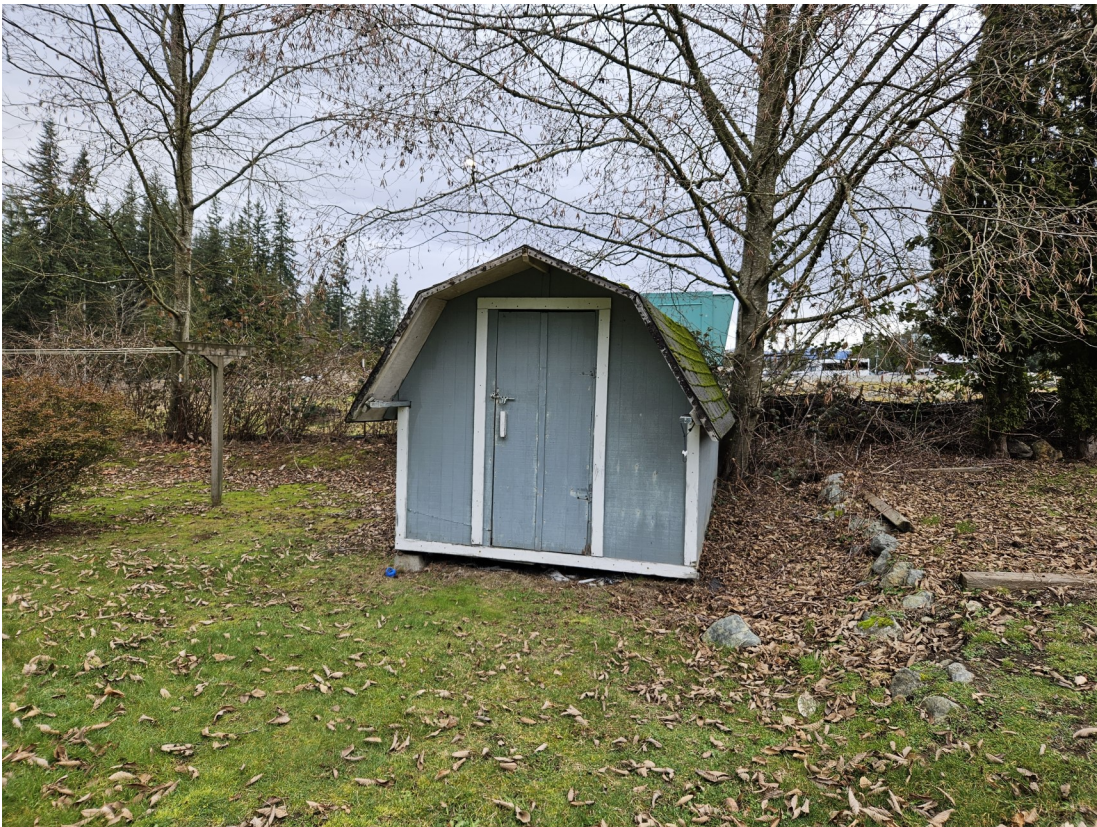
Photo 14: A small shed along the northern property line, seen in Photo (11).

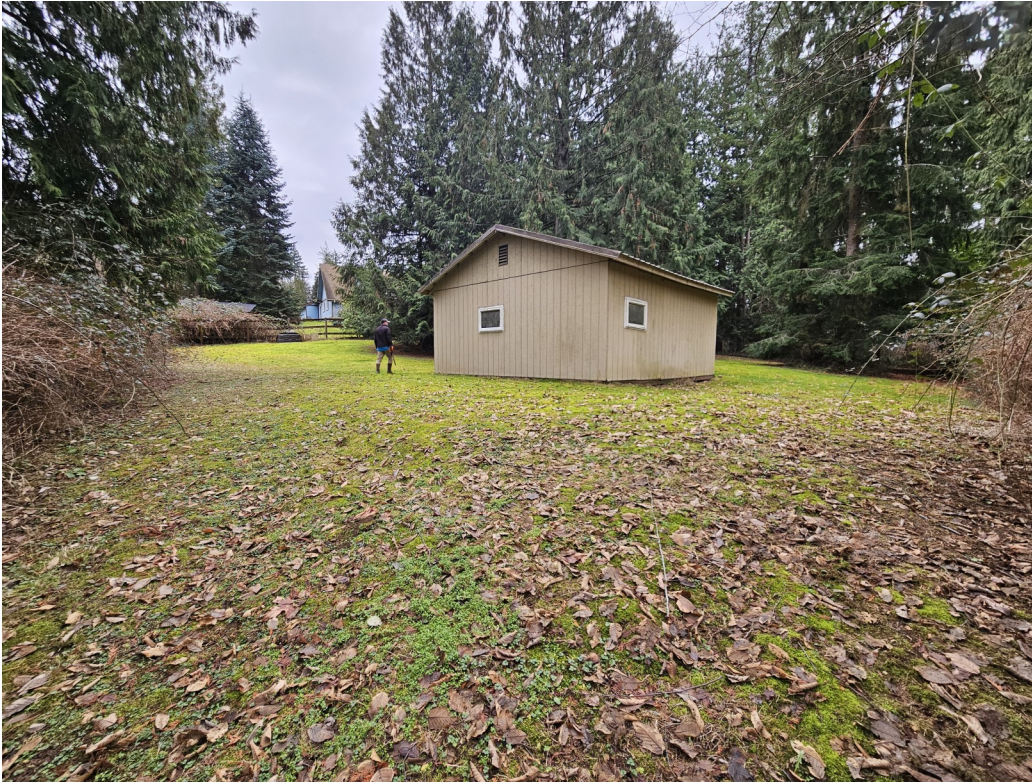
Photo 18: A view of the property from the northwest corner. The gardening shed from Photo (17) can be seen.

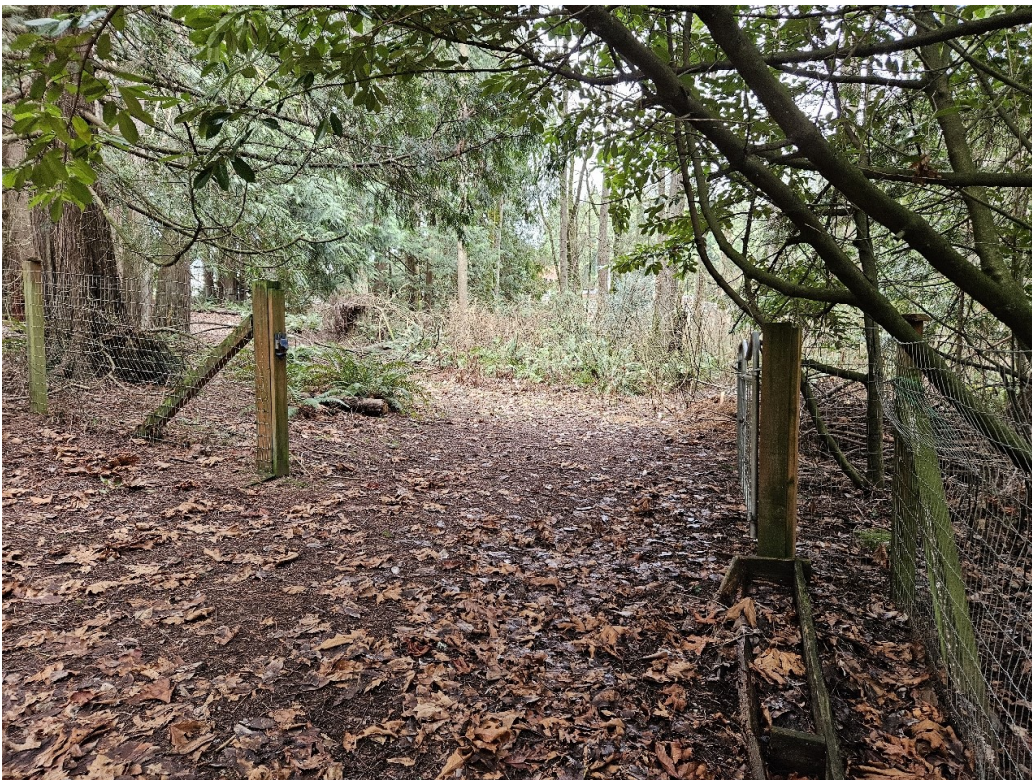
Photo 19 (Map point 108): A fence and gate near the western property line. This gate has a access road running through it which connects with the main driveway. The fence runs generally west-east and sections off the forested portion of the property. Photo taken looking south.

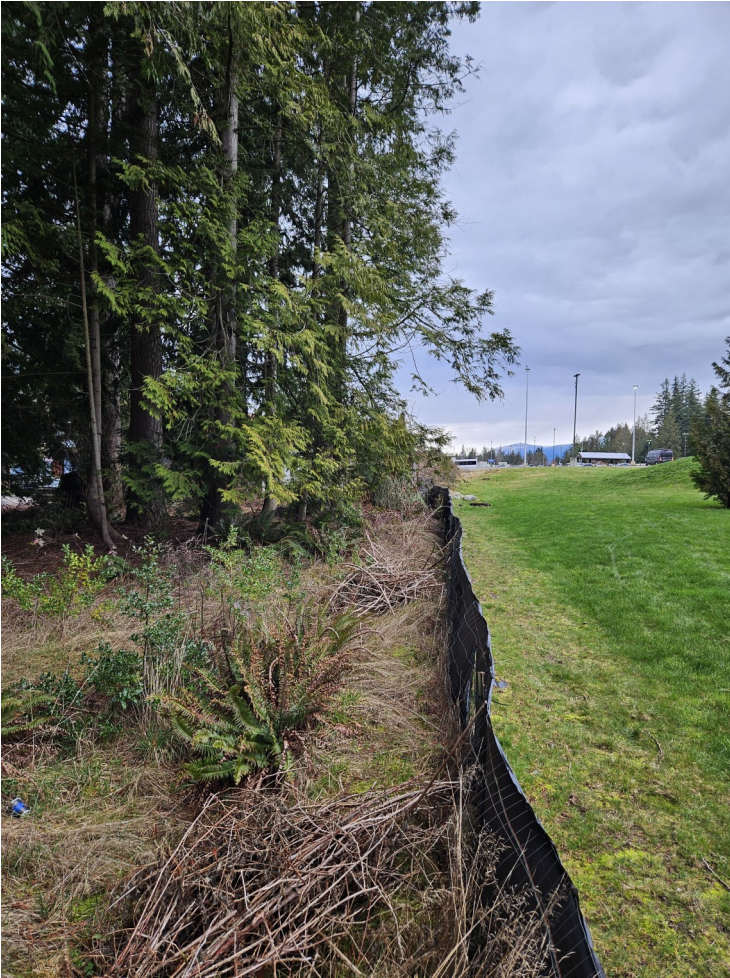
Photo 22: The eastern property line looking north towards Angel of the Wind Casino.

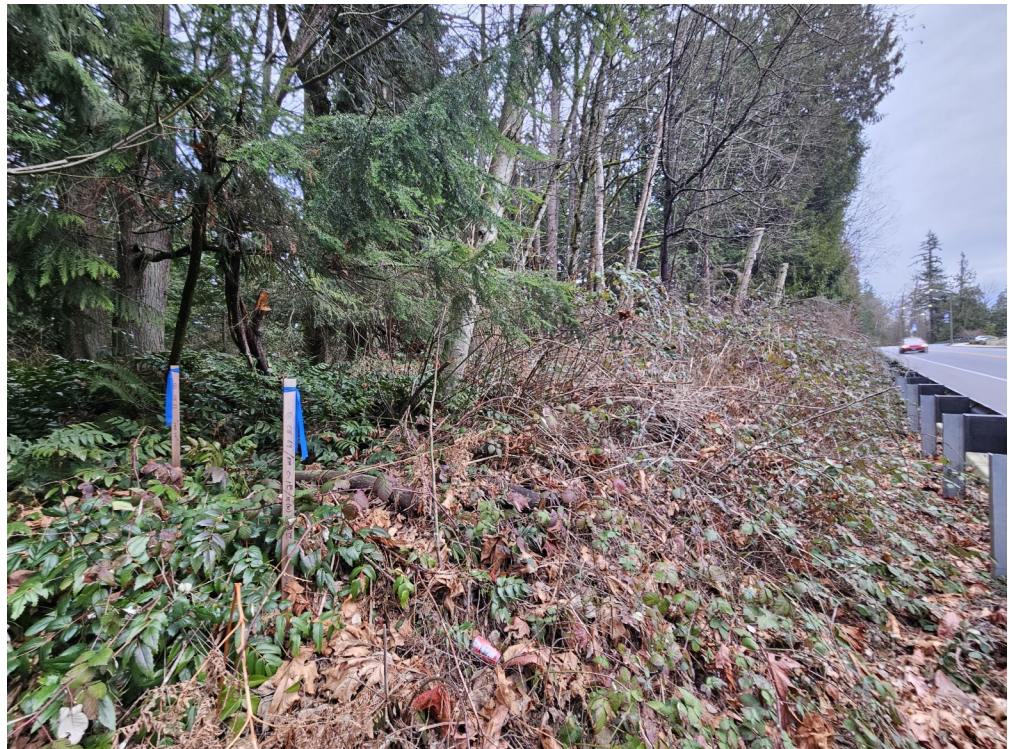
Photo 23: The southern property line along 236th St NE, looking east.

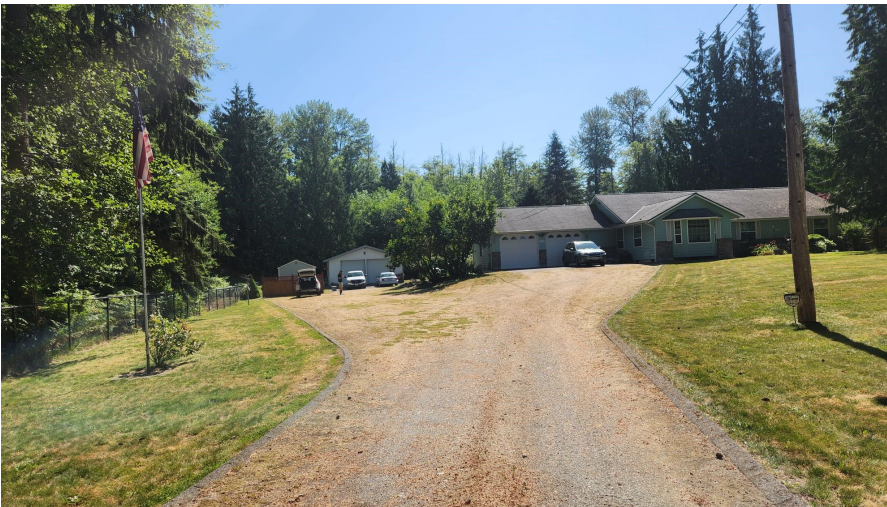
Photo 1: Driveway off 35th Ave NE onto the Eaton property. The Stillaguamish Tribe owns the neighboring property to the north, Zerby

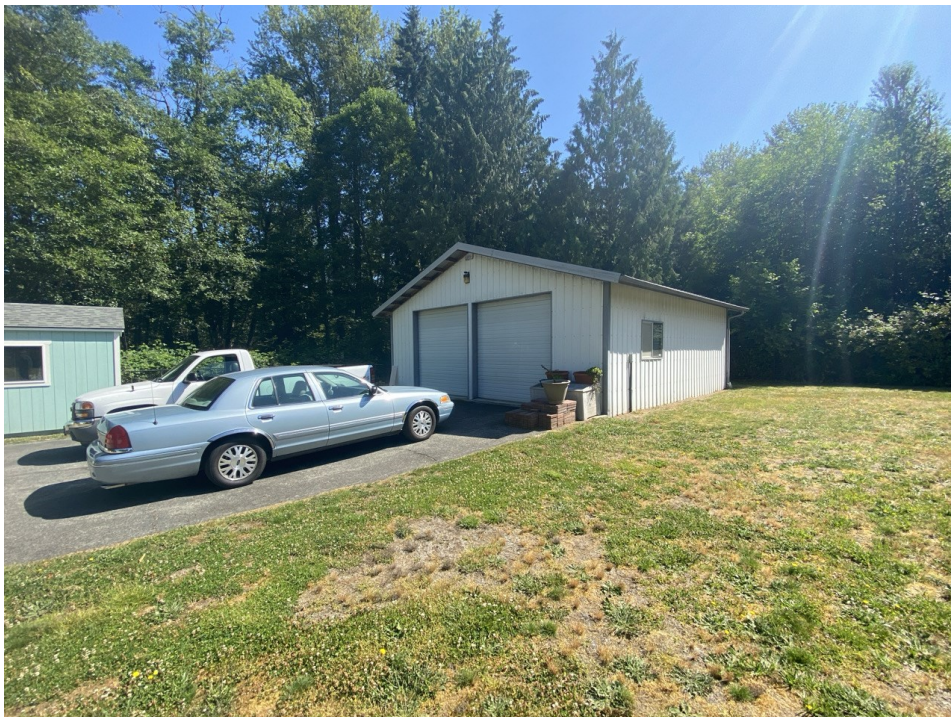
Photo 5: Eaton property garage

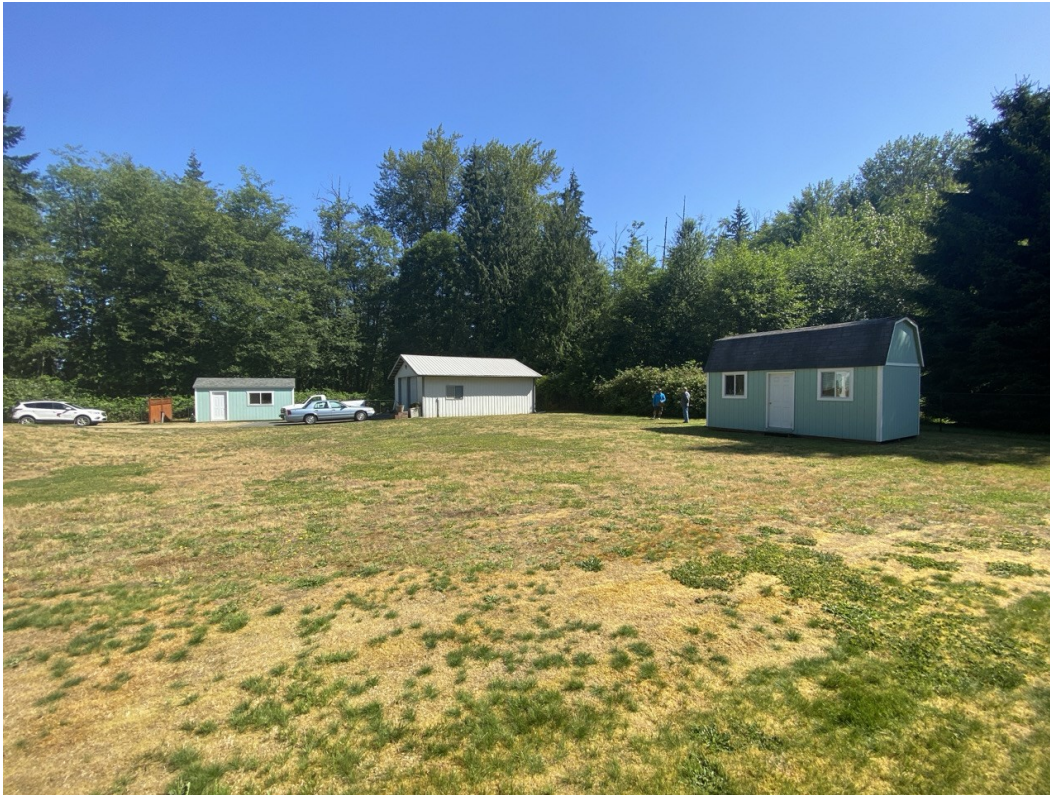
Photo 6: Eaton property fenced backyard looking North. There are four outbuildings, shed by well/fence, garage, shed on eastern edge before fence, and shed (not shown) on southern end of property.

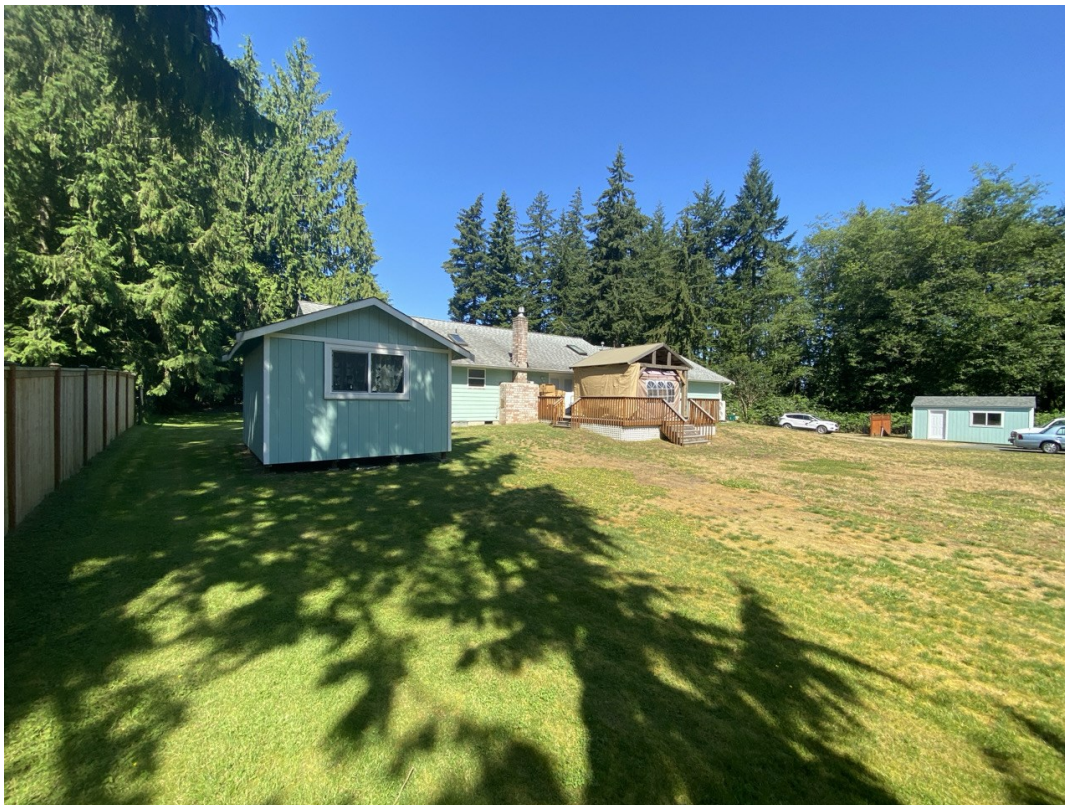
Photo 8: Eaton property fenced backyard looking west showing 4th outbuilding on southern edge of property.

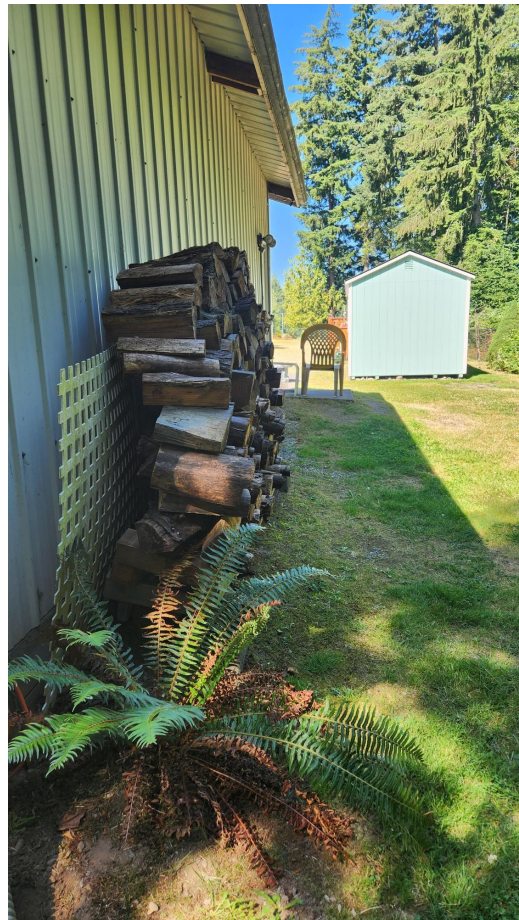
Photo 9: North side of Eaton garage. Wood pile is seen, a fire pit is located to the right of this photo, to the north of the garage

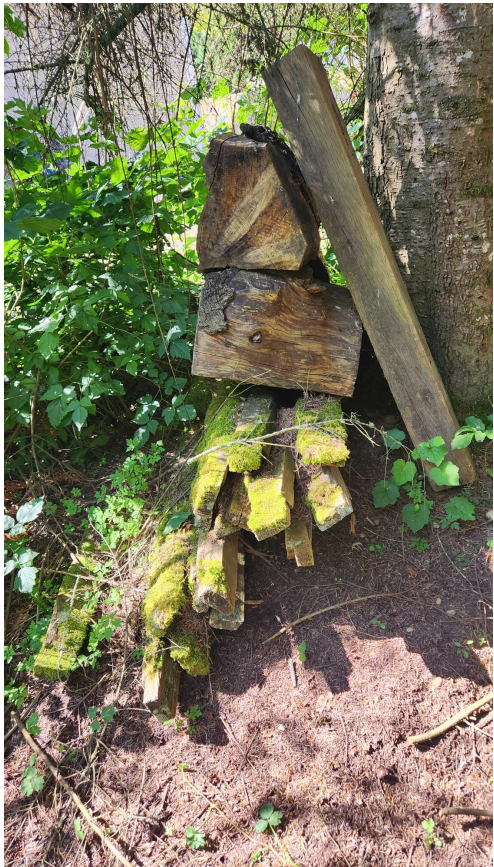
Photo 13: Benign wood pile located in forested portion of Eaton Property, east of fence on the southern end of property boundary.

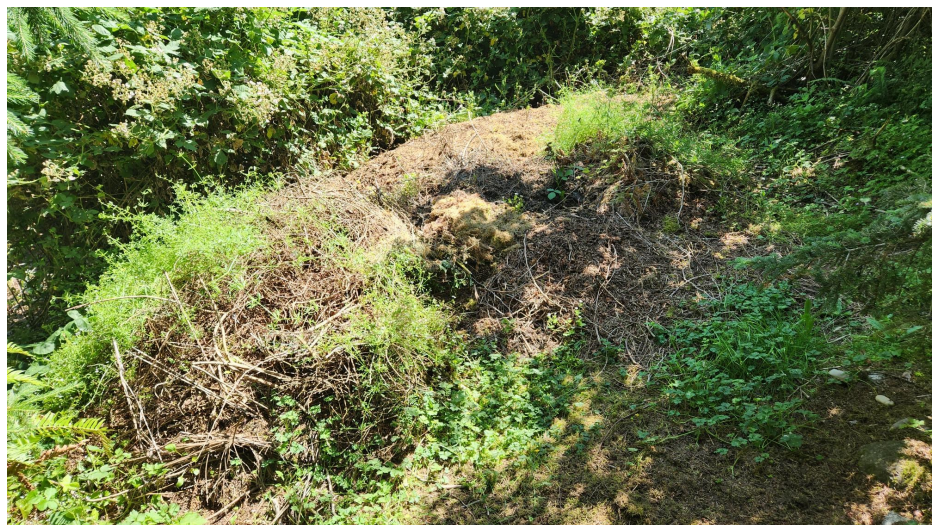
Photo 14: Pile of lawn debris, looks like grass clippings and organic yard/lawn refuse. Located just east of fence in forested part of property on the southern end.

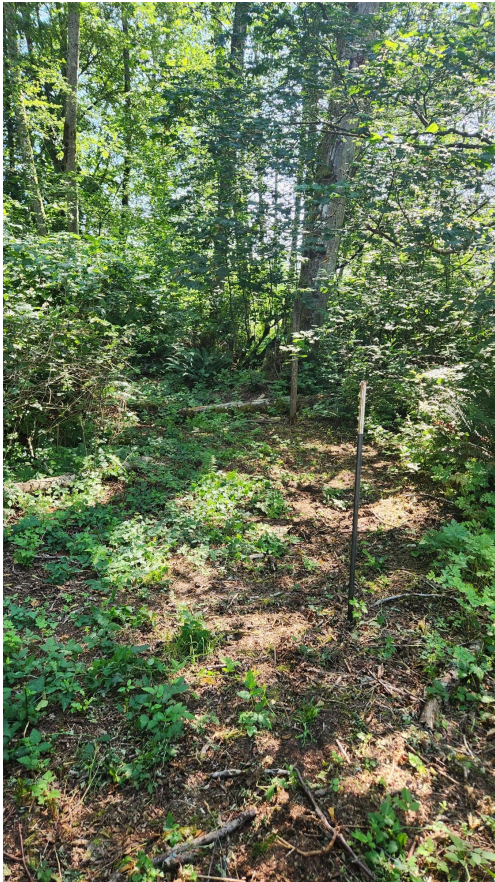
Photo 15: Eaton southern property boundary looking east, from forested portion of property.

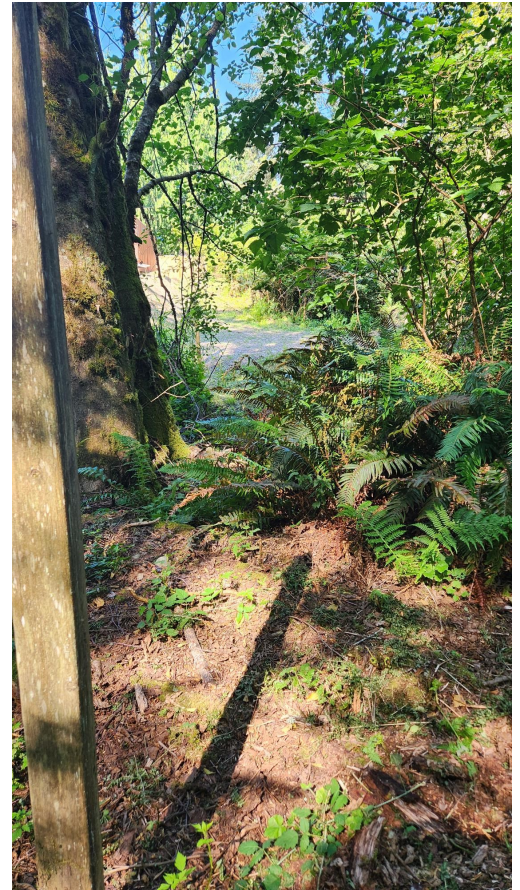
Photo 16: Eaton southern property boundary looking west, from forested portion of property, notice gravel section—there is a culvert under the gravel.

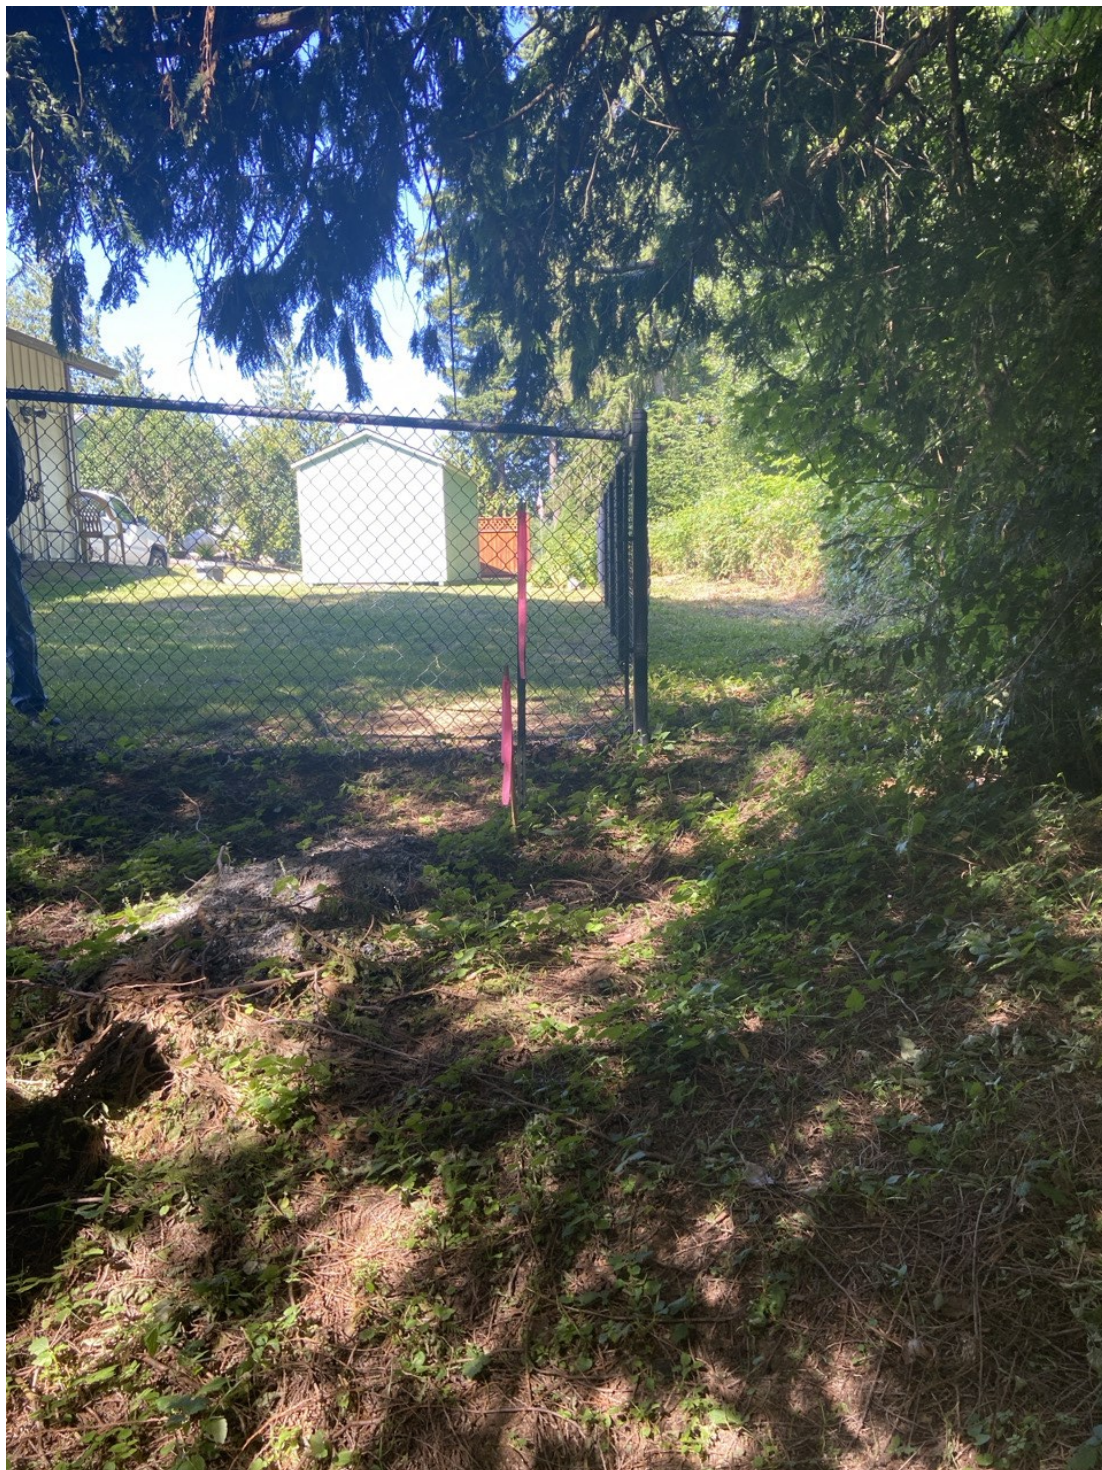
Photo 18: Eaton northern property boundary looking west.

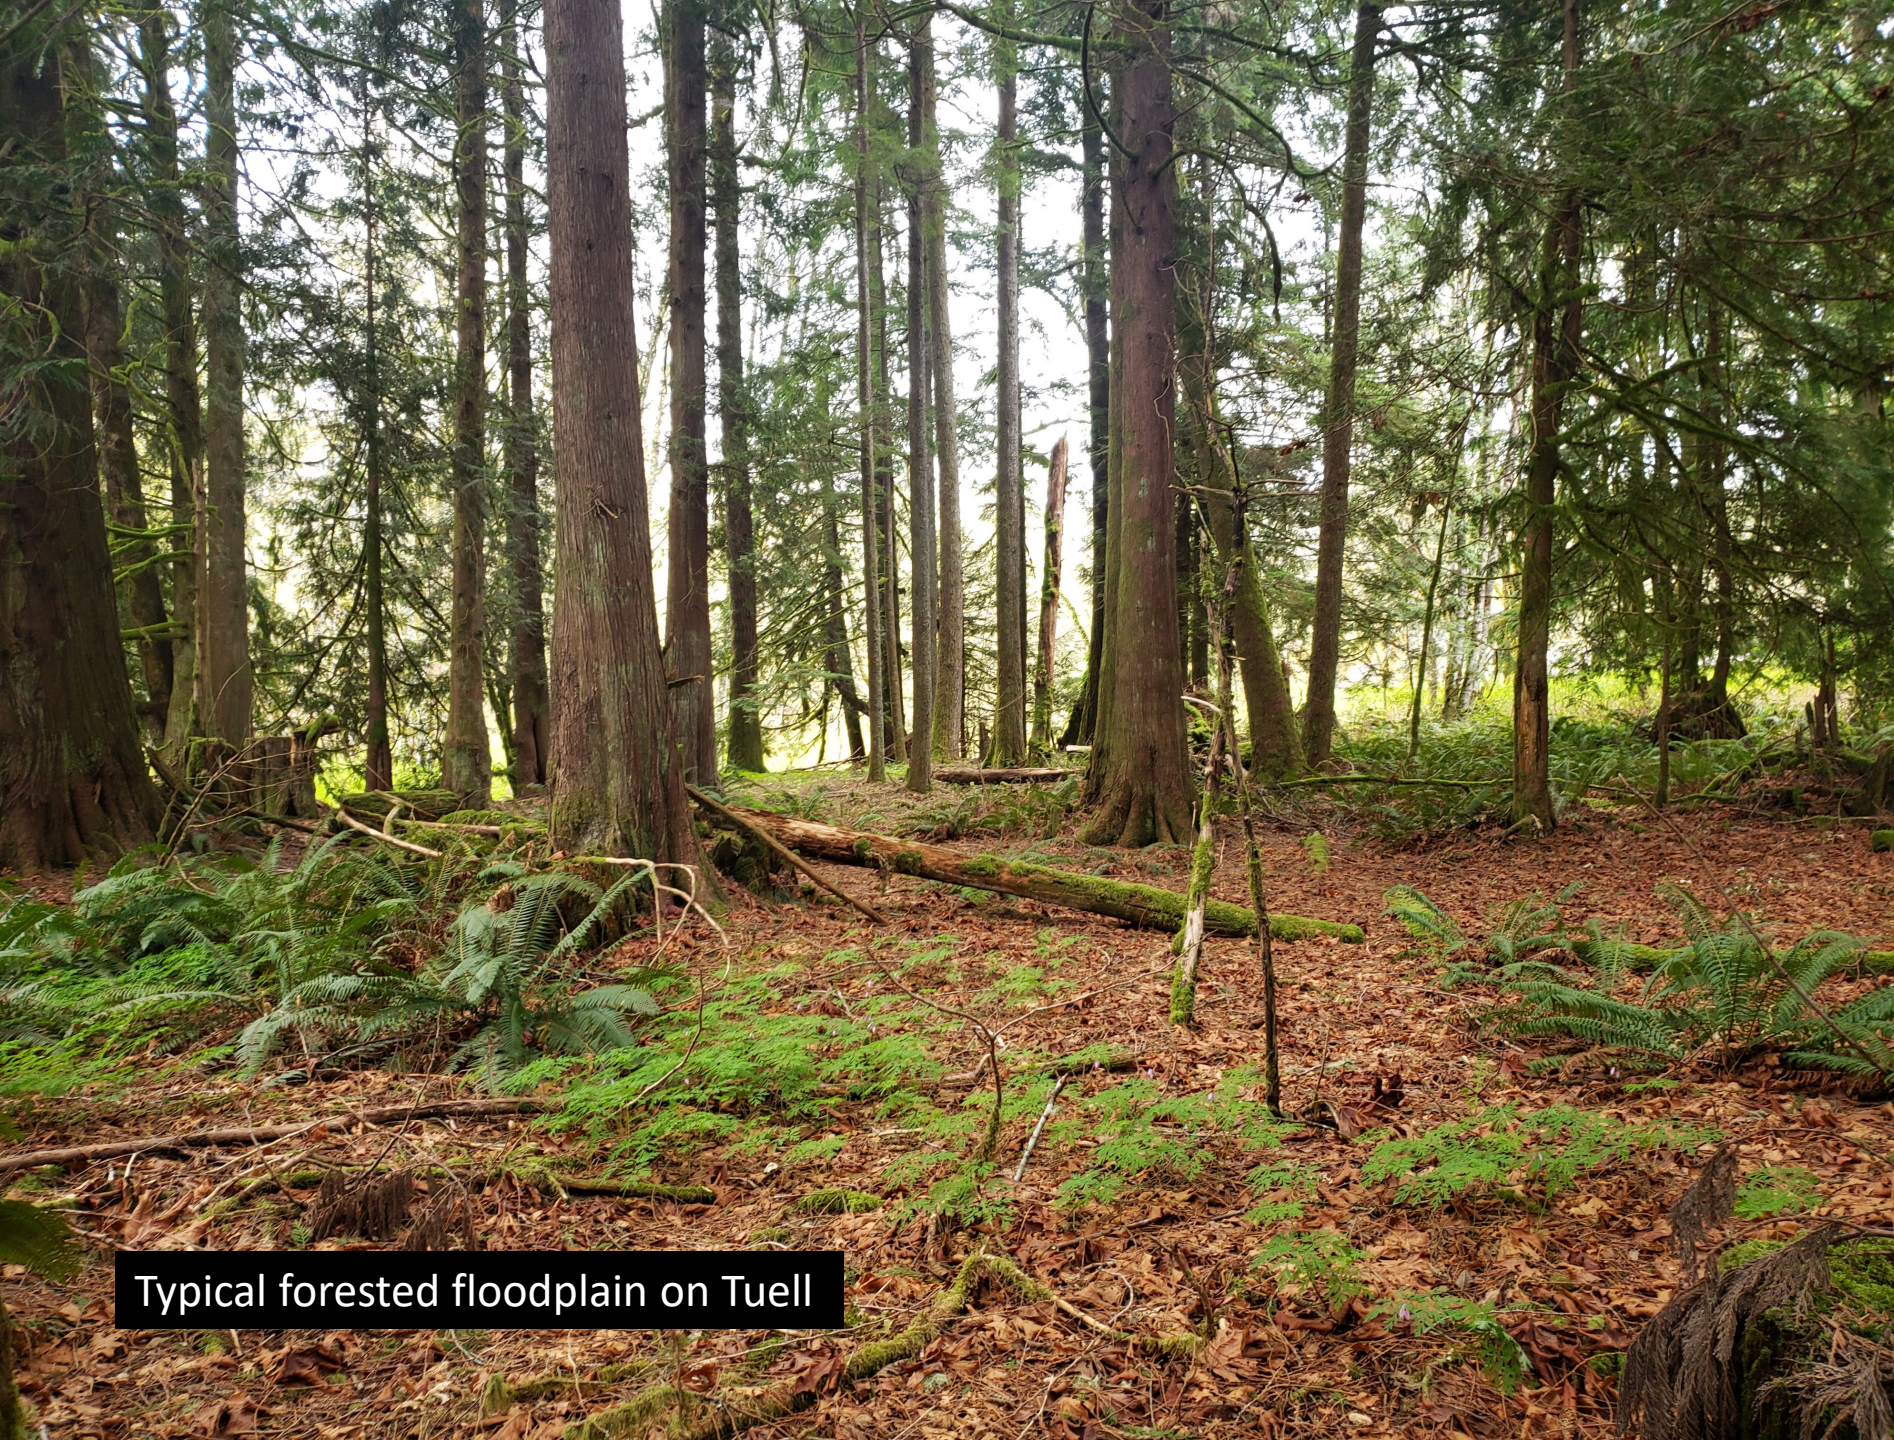
Typical forested floodplain on Tuell
