## Stillaguamish Tribal Response Program

### 2024 Public Record Packet Summary

# Local Brownfields Public Record Report

**Kunkel Property Site Assessment**

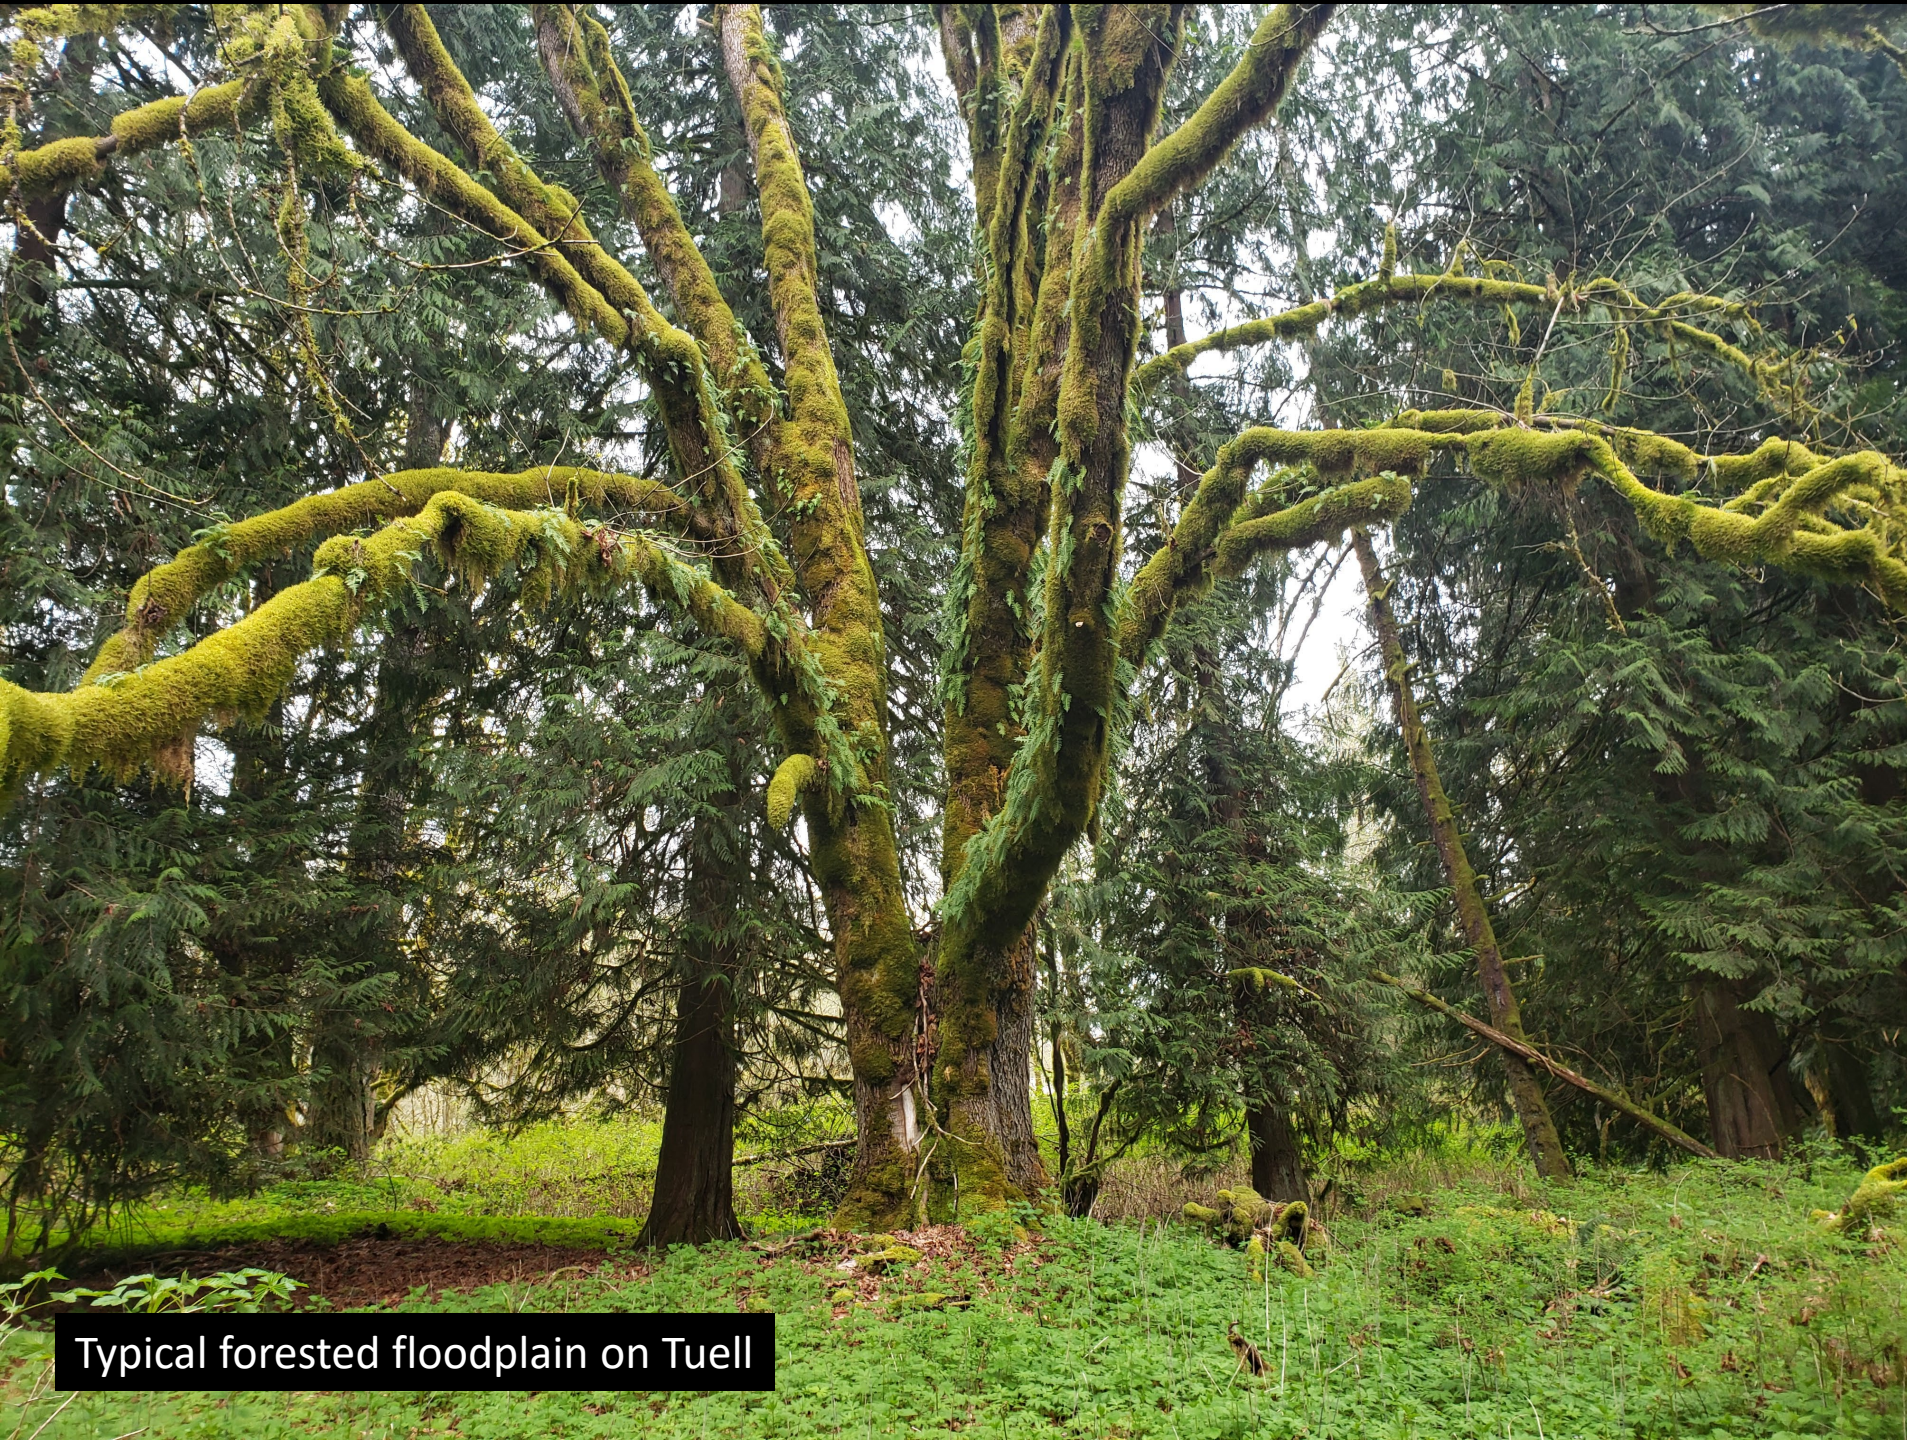
Typical forested floodplain on Tuell

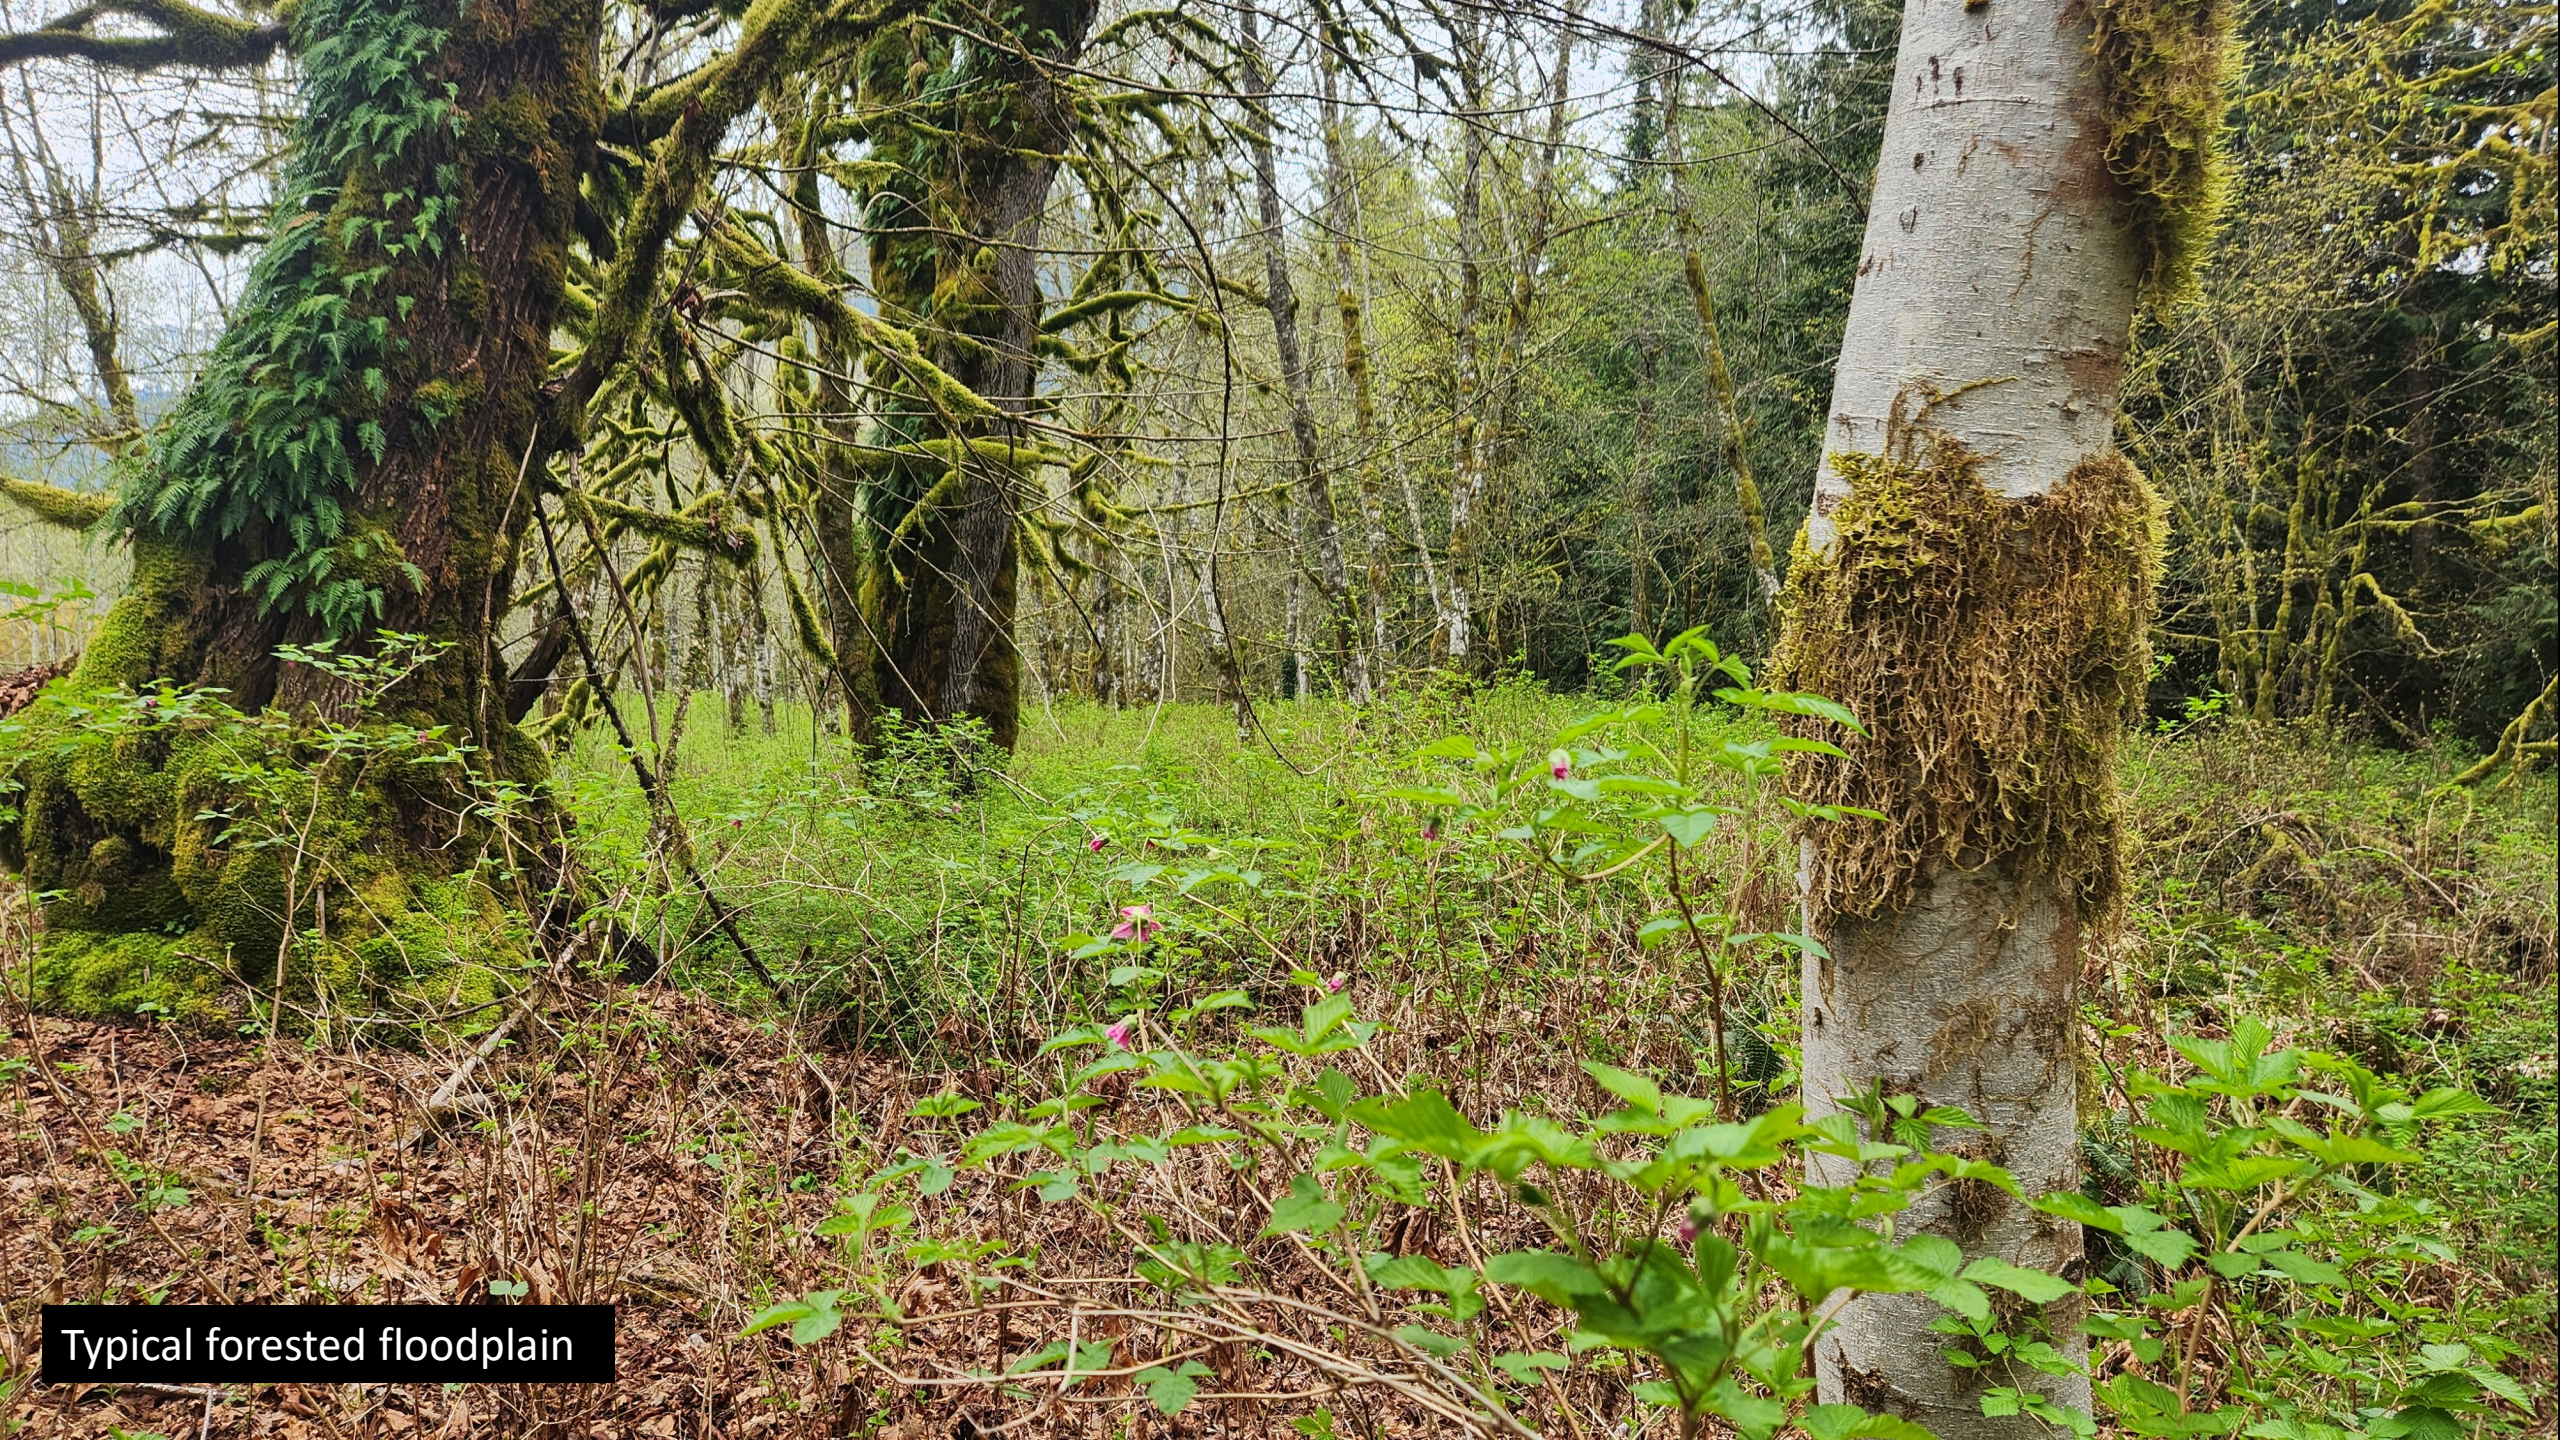
Typical forested floodplain

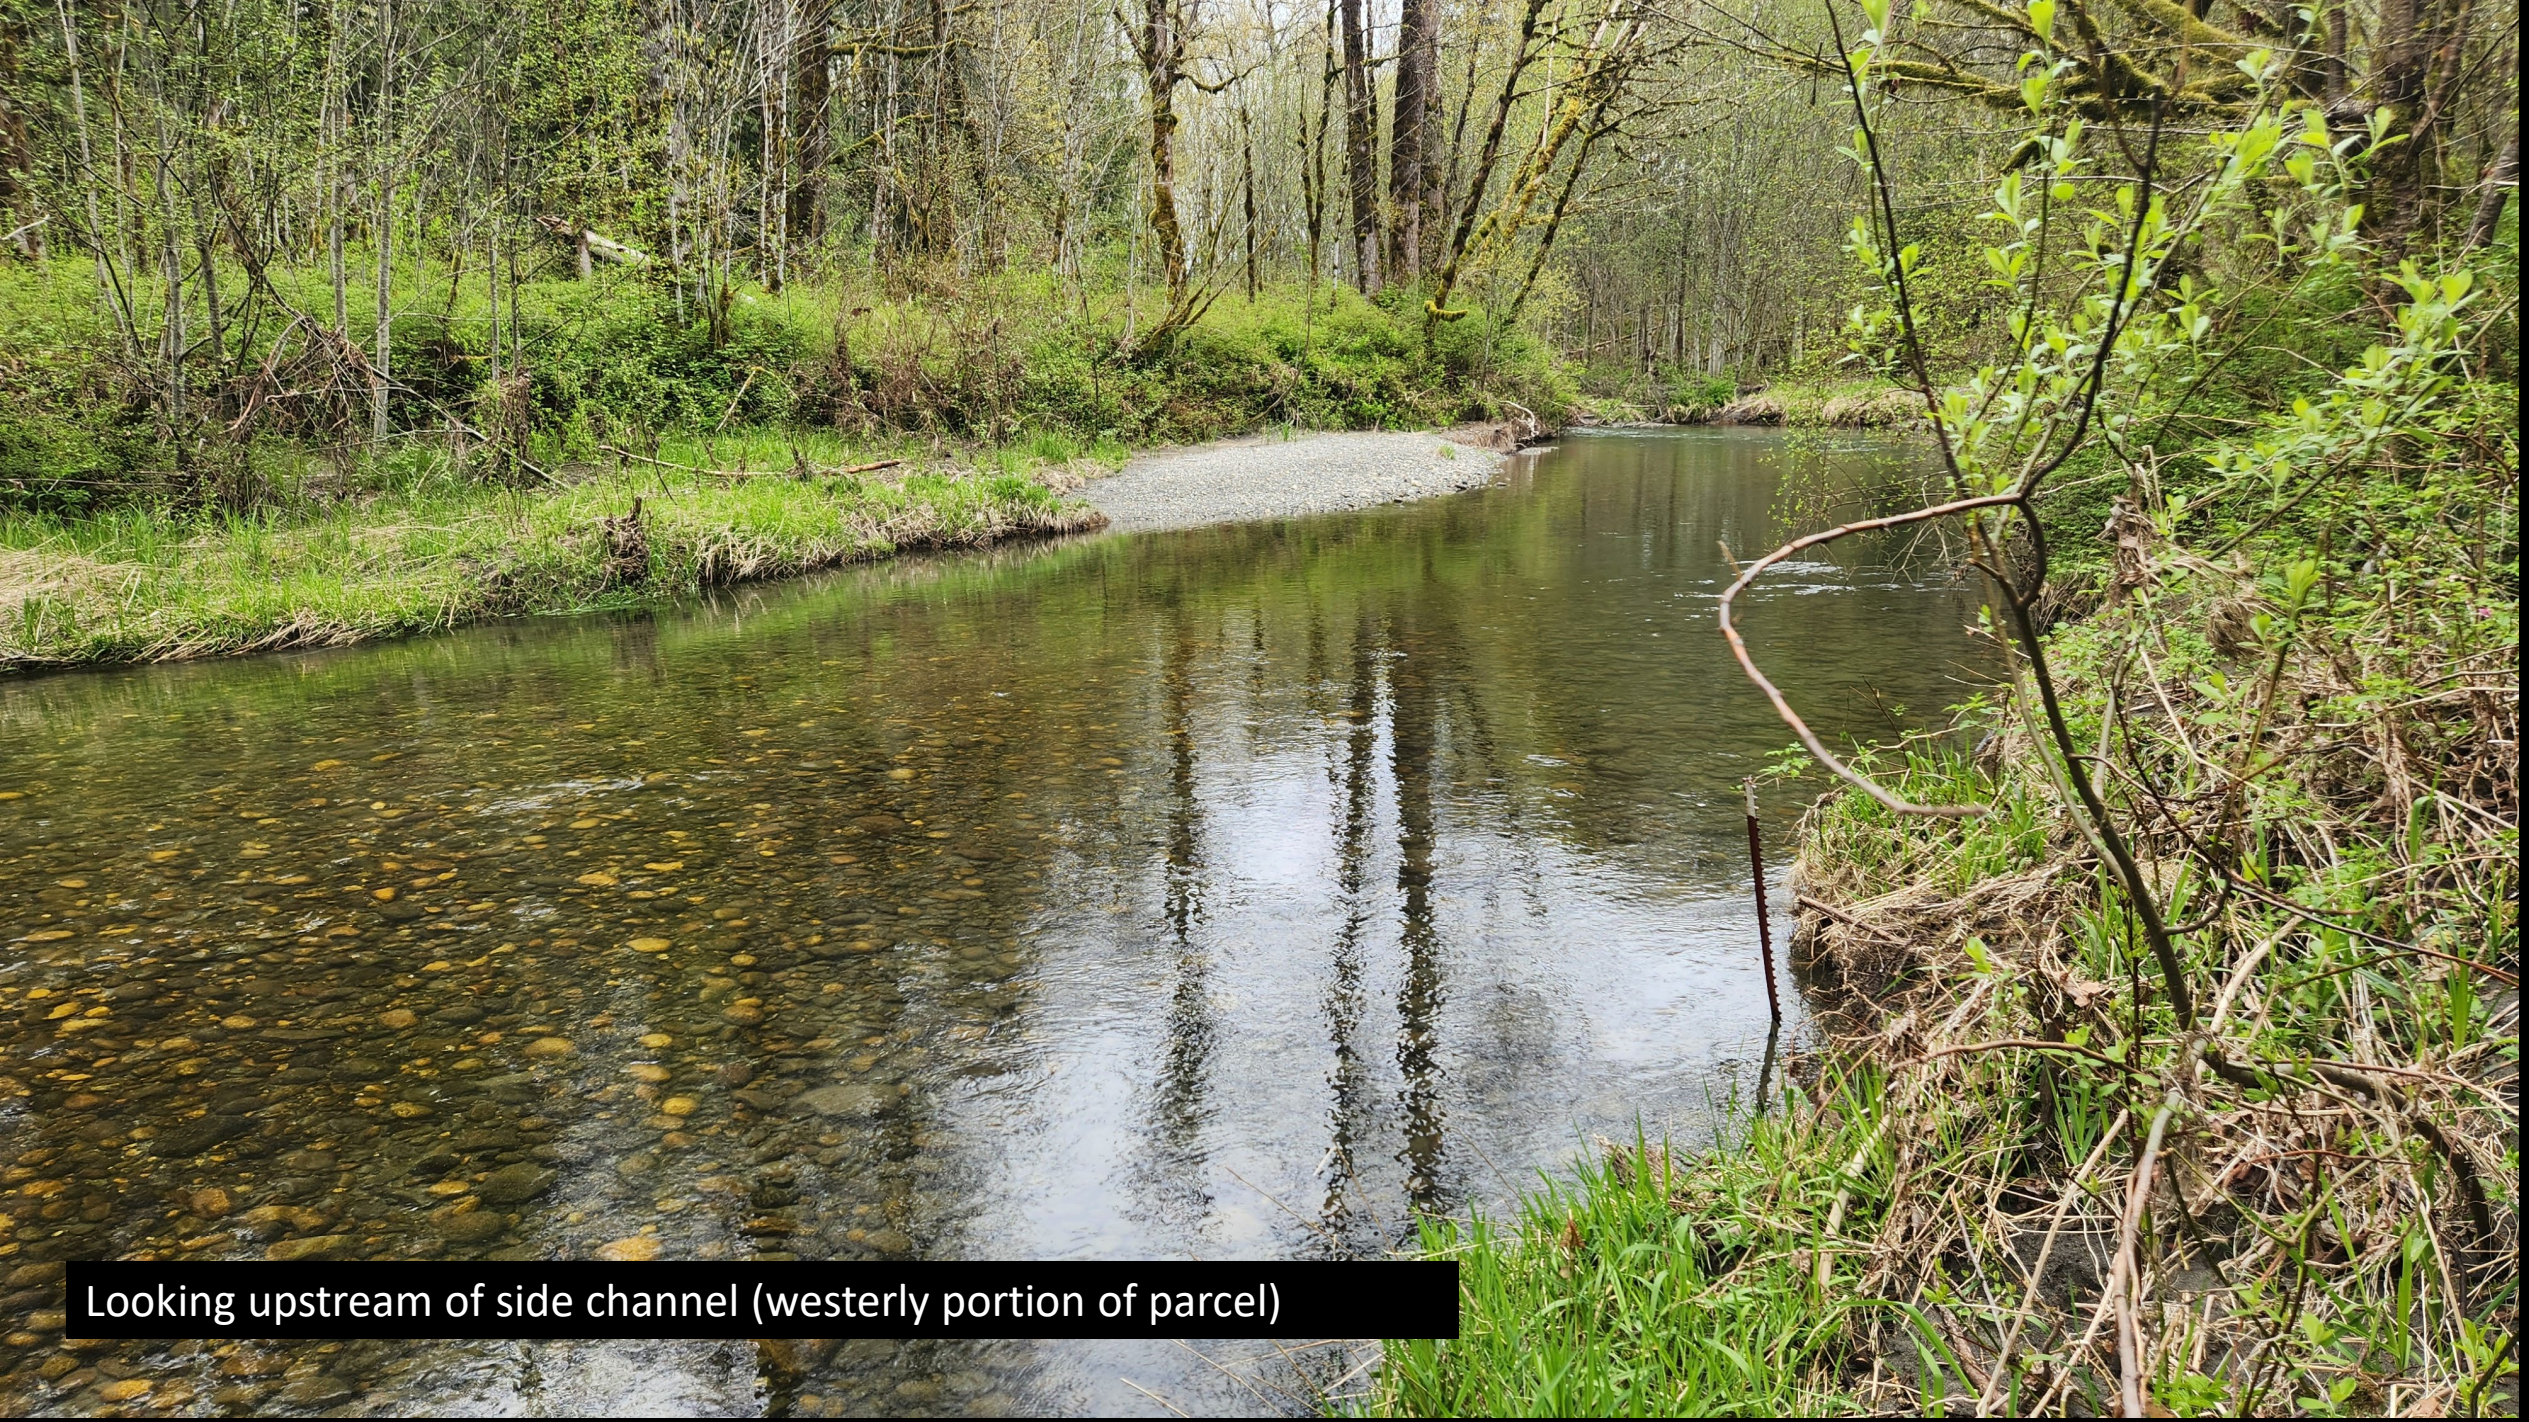
Looking upstream of side channel (westerly portion of parcel)

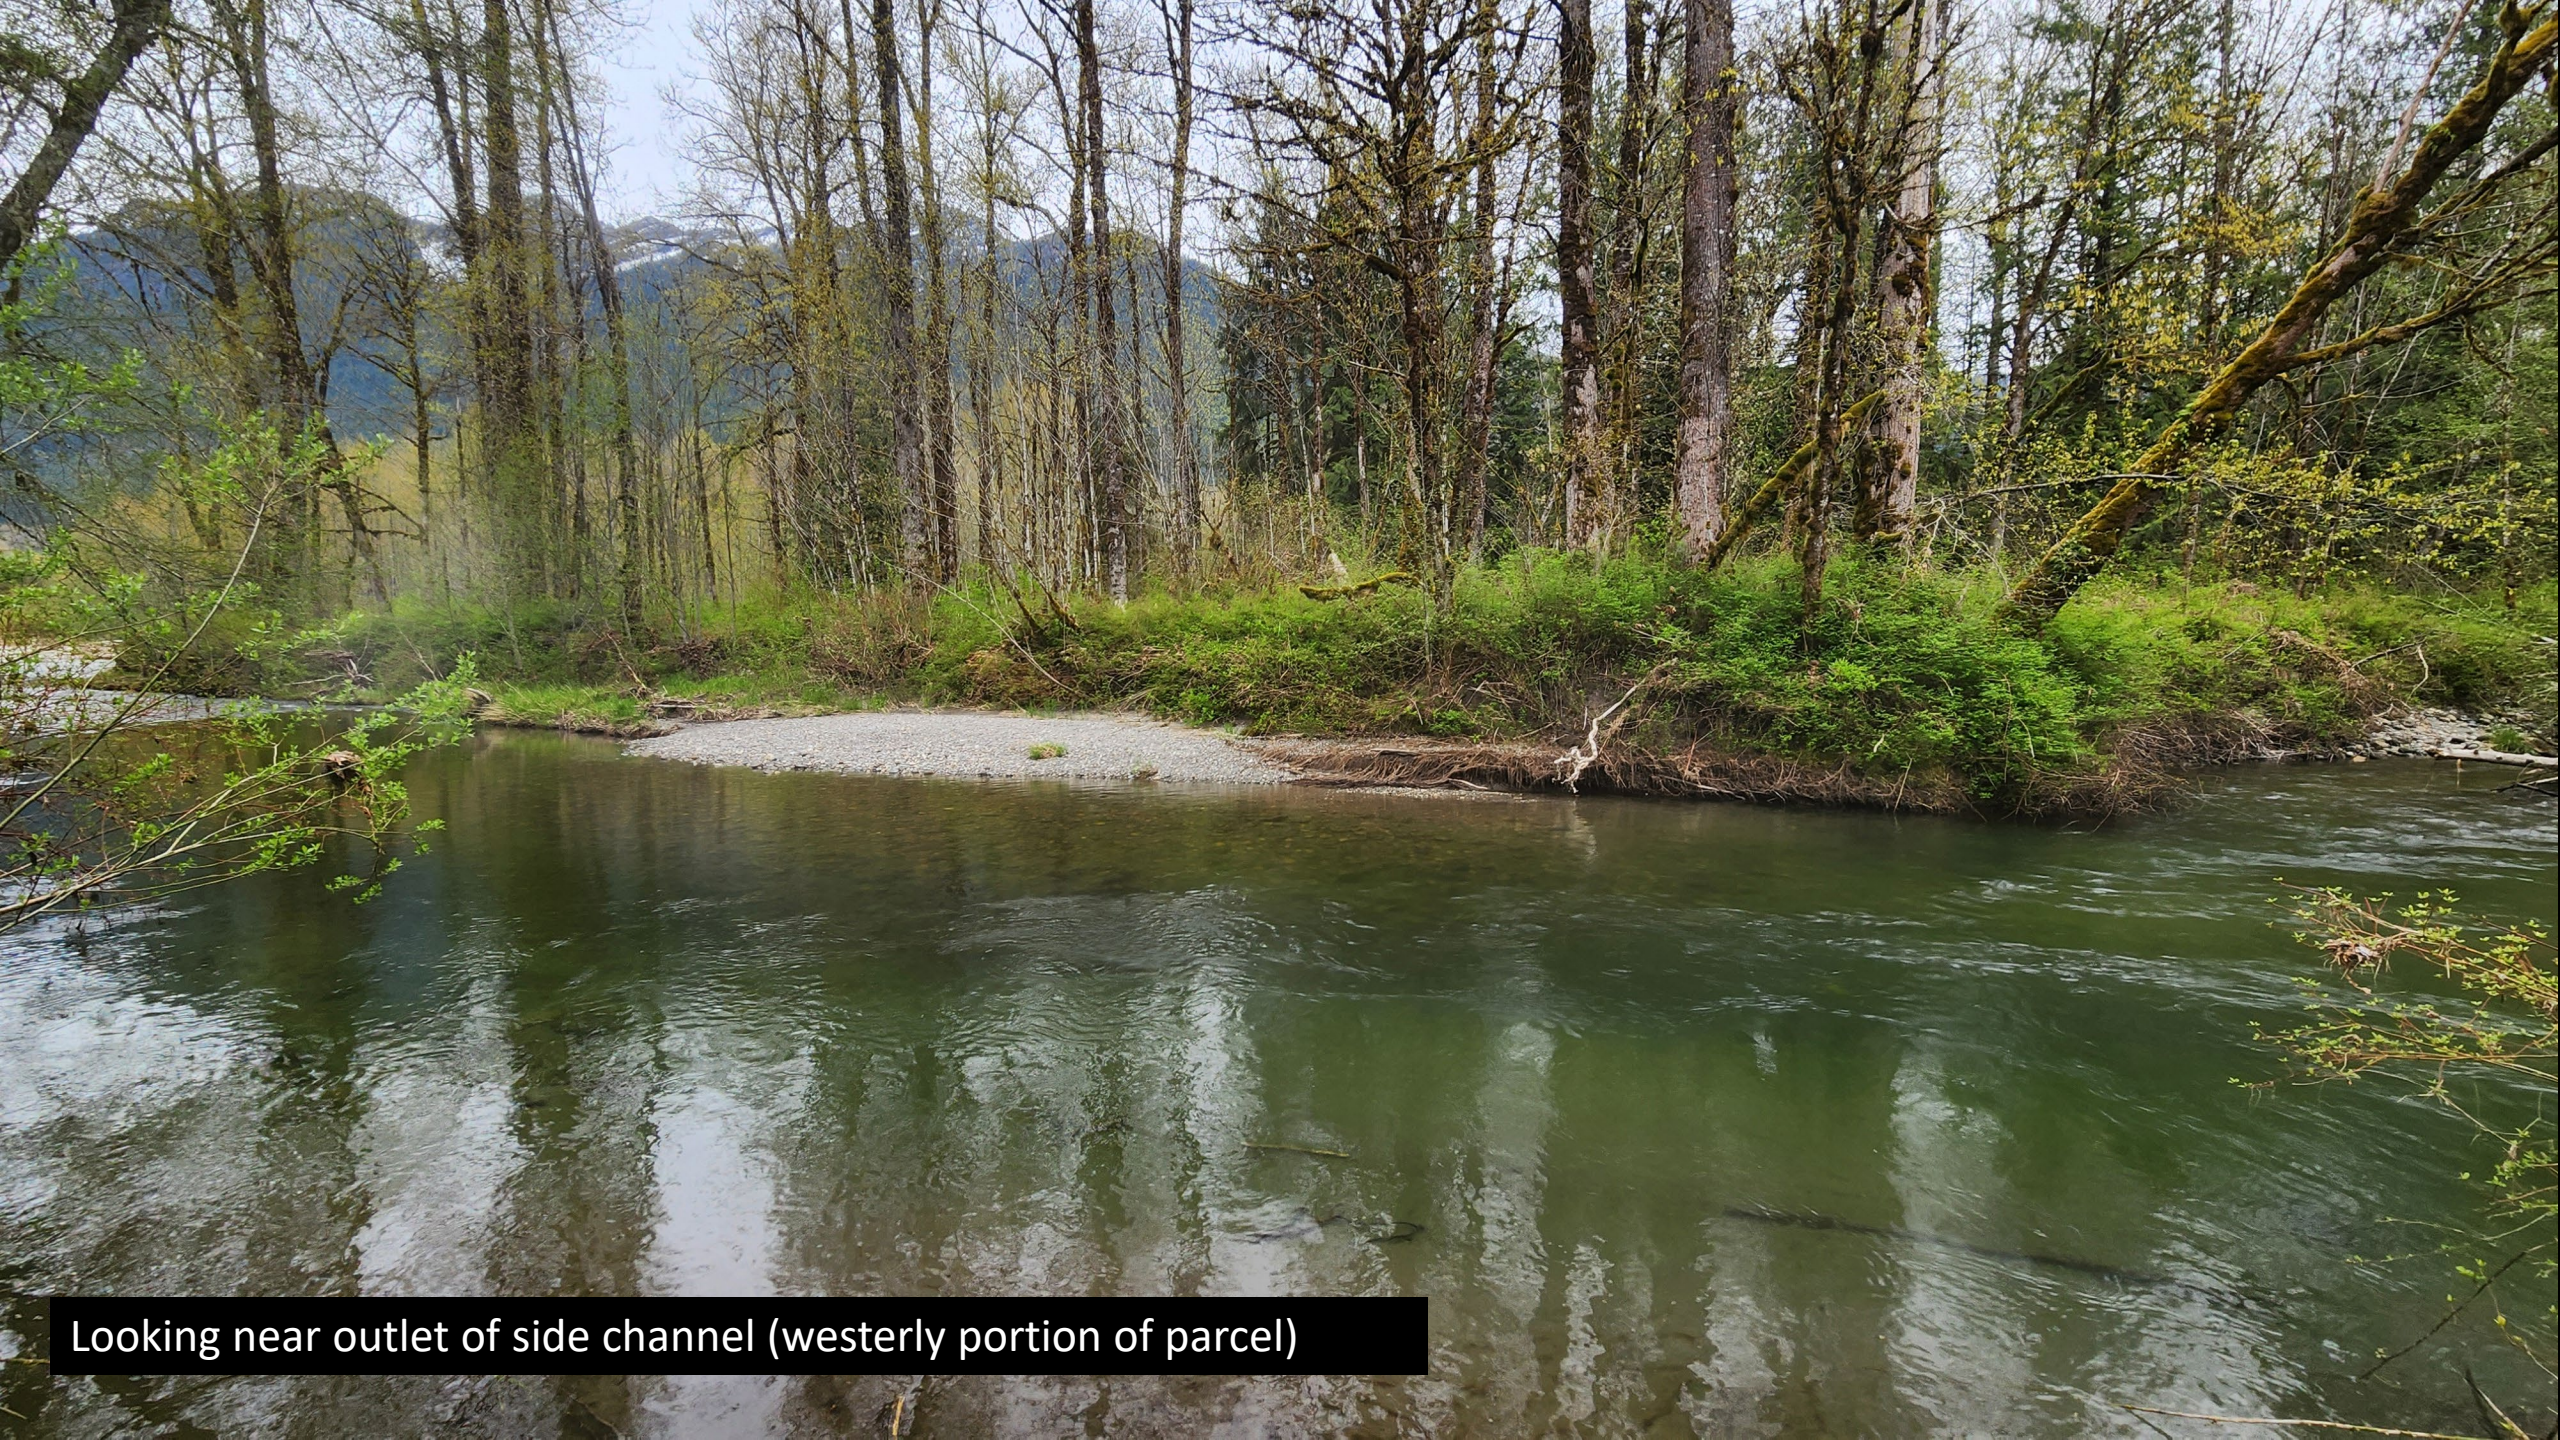
Looking near outlet of side channel (westerly portion of parcel)

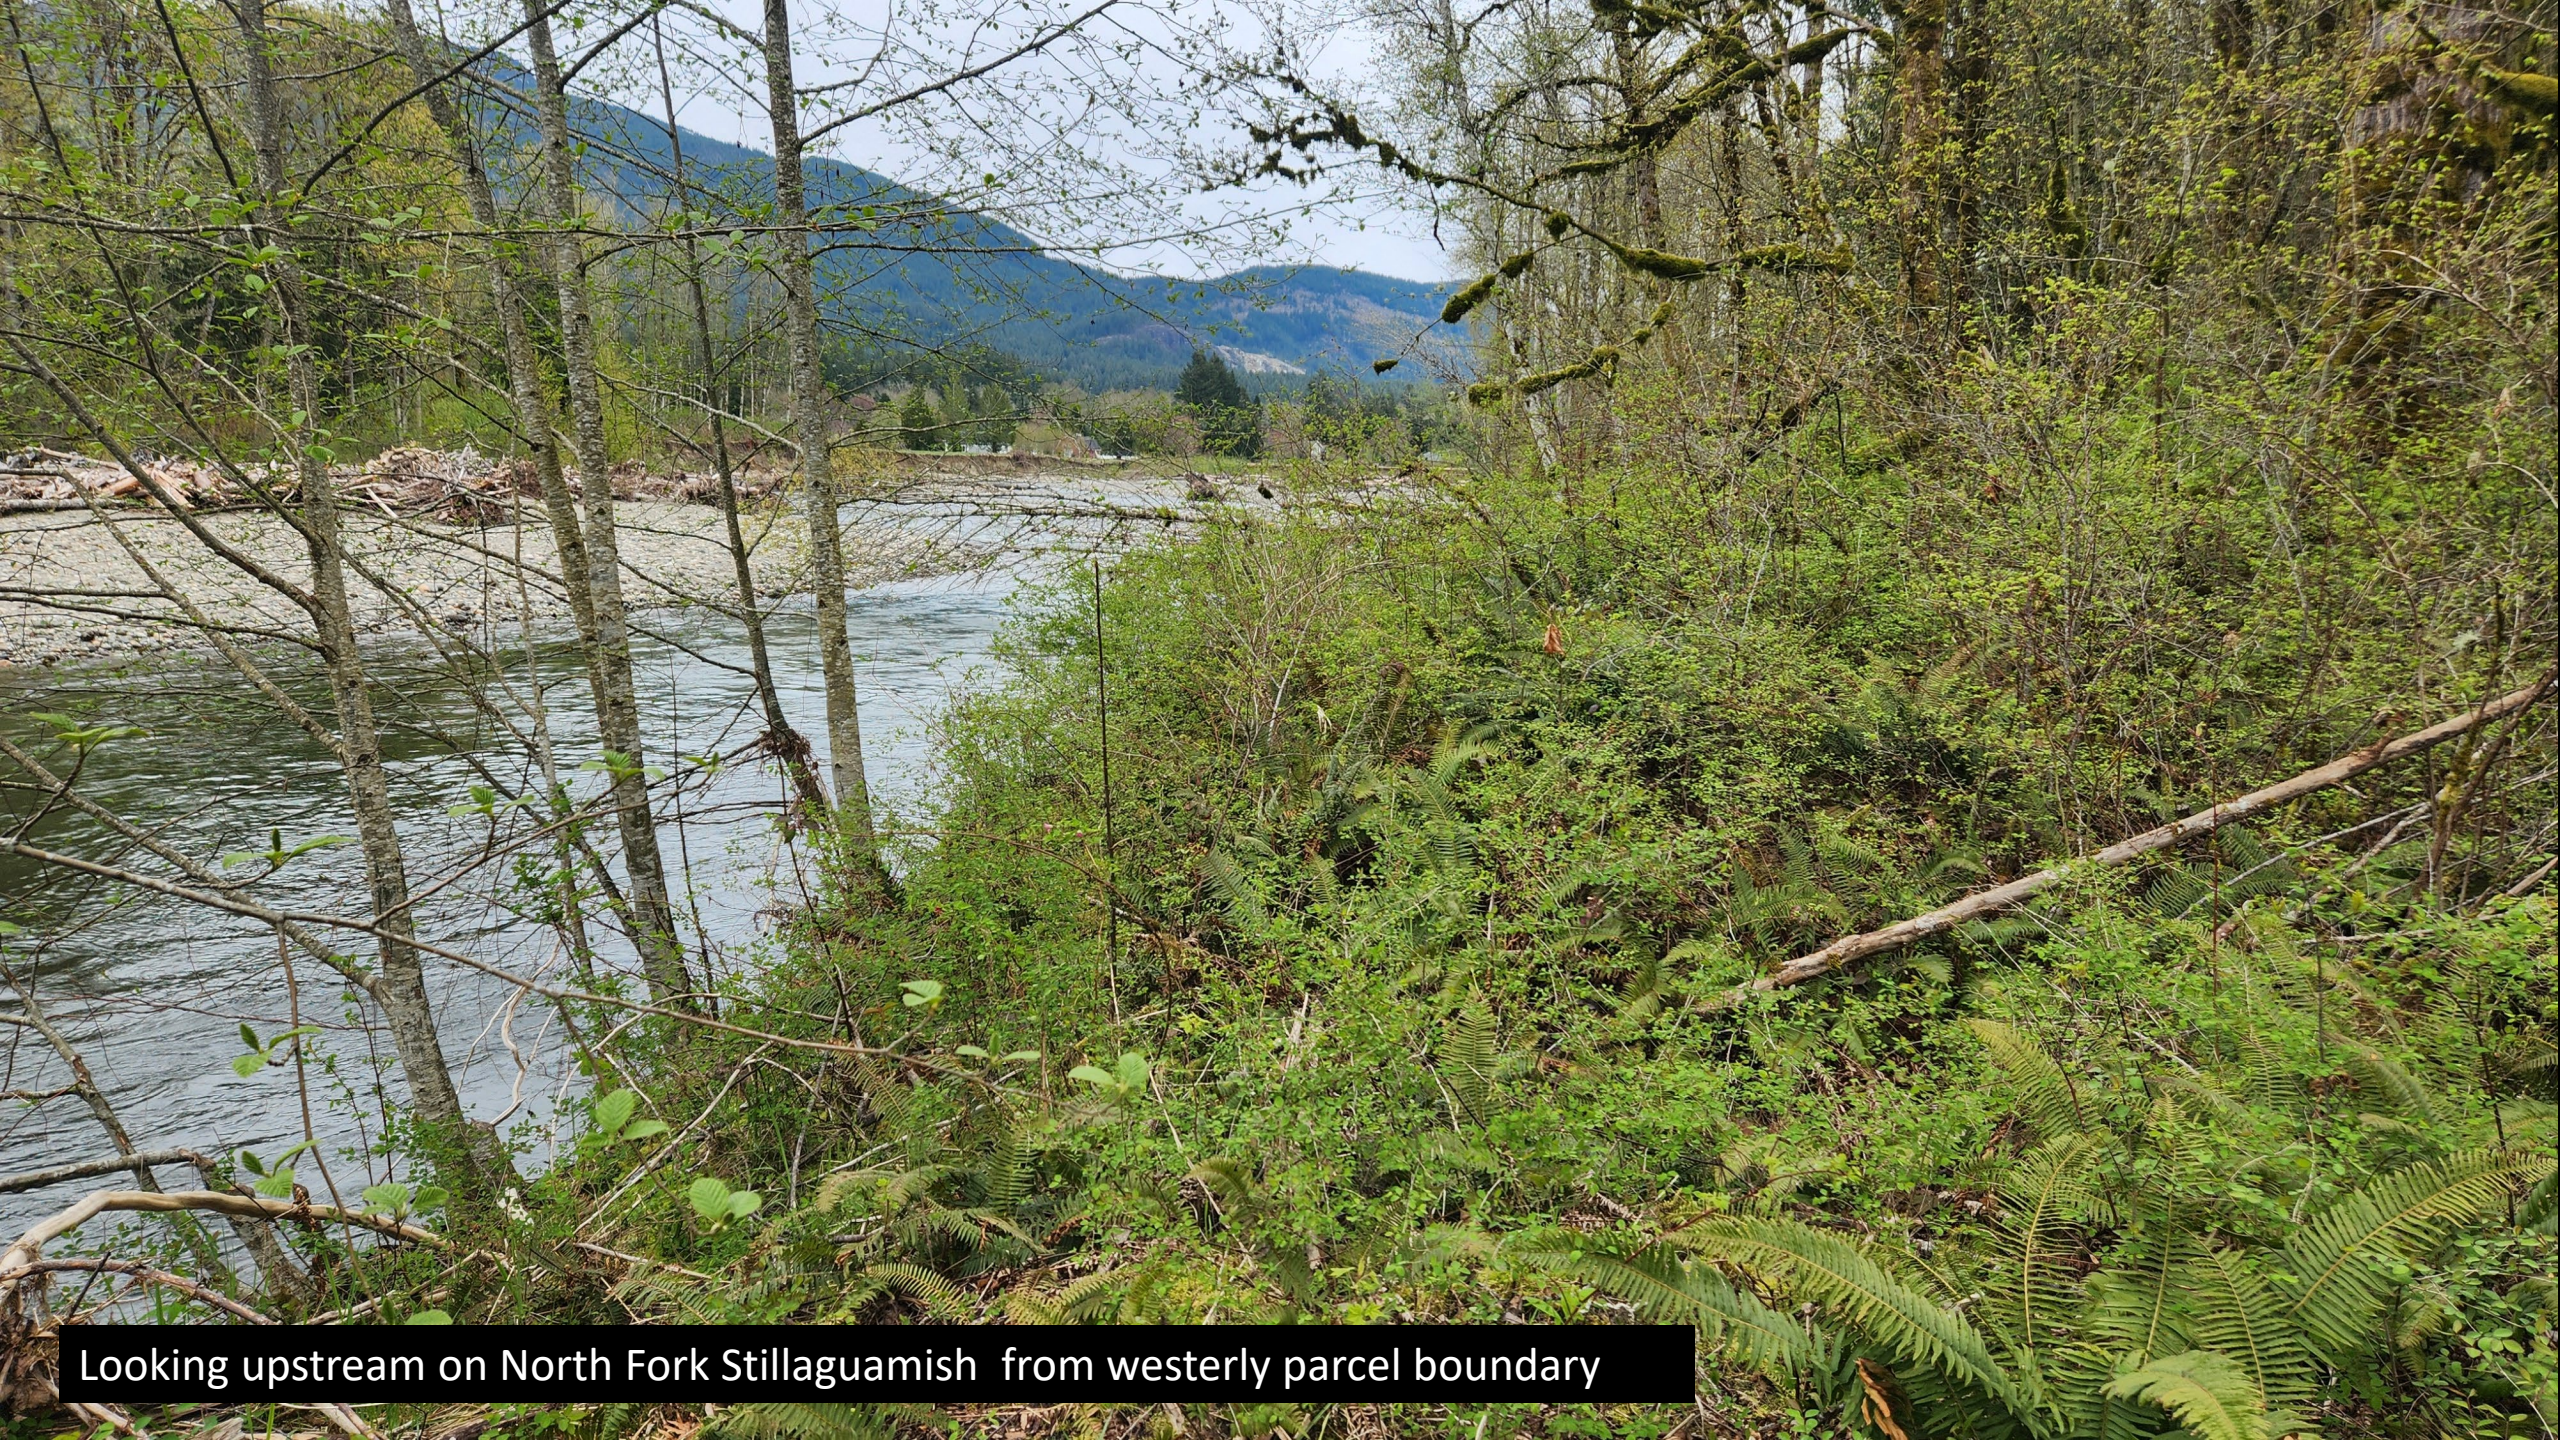
Looking upstream on North Fork Stillaguamish from westerly parcel boundary

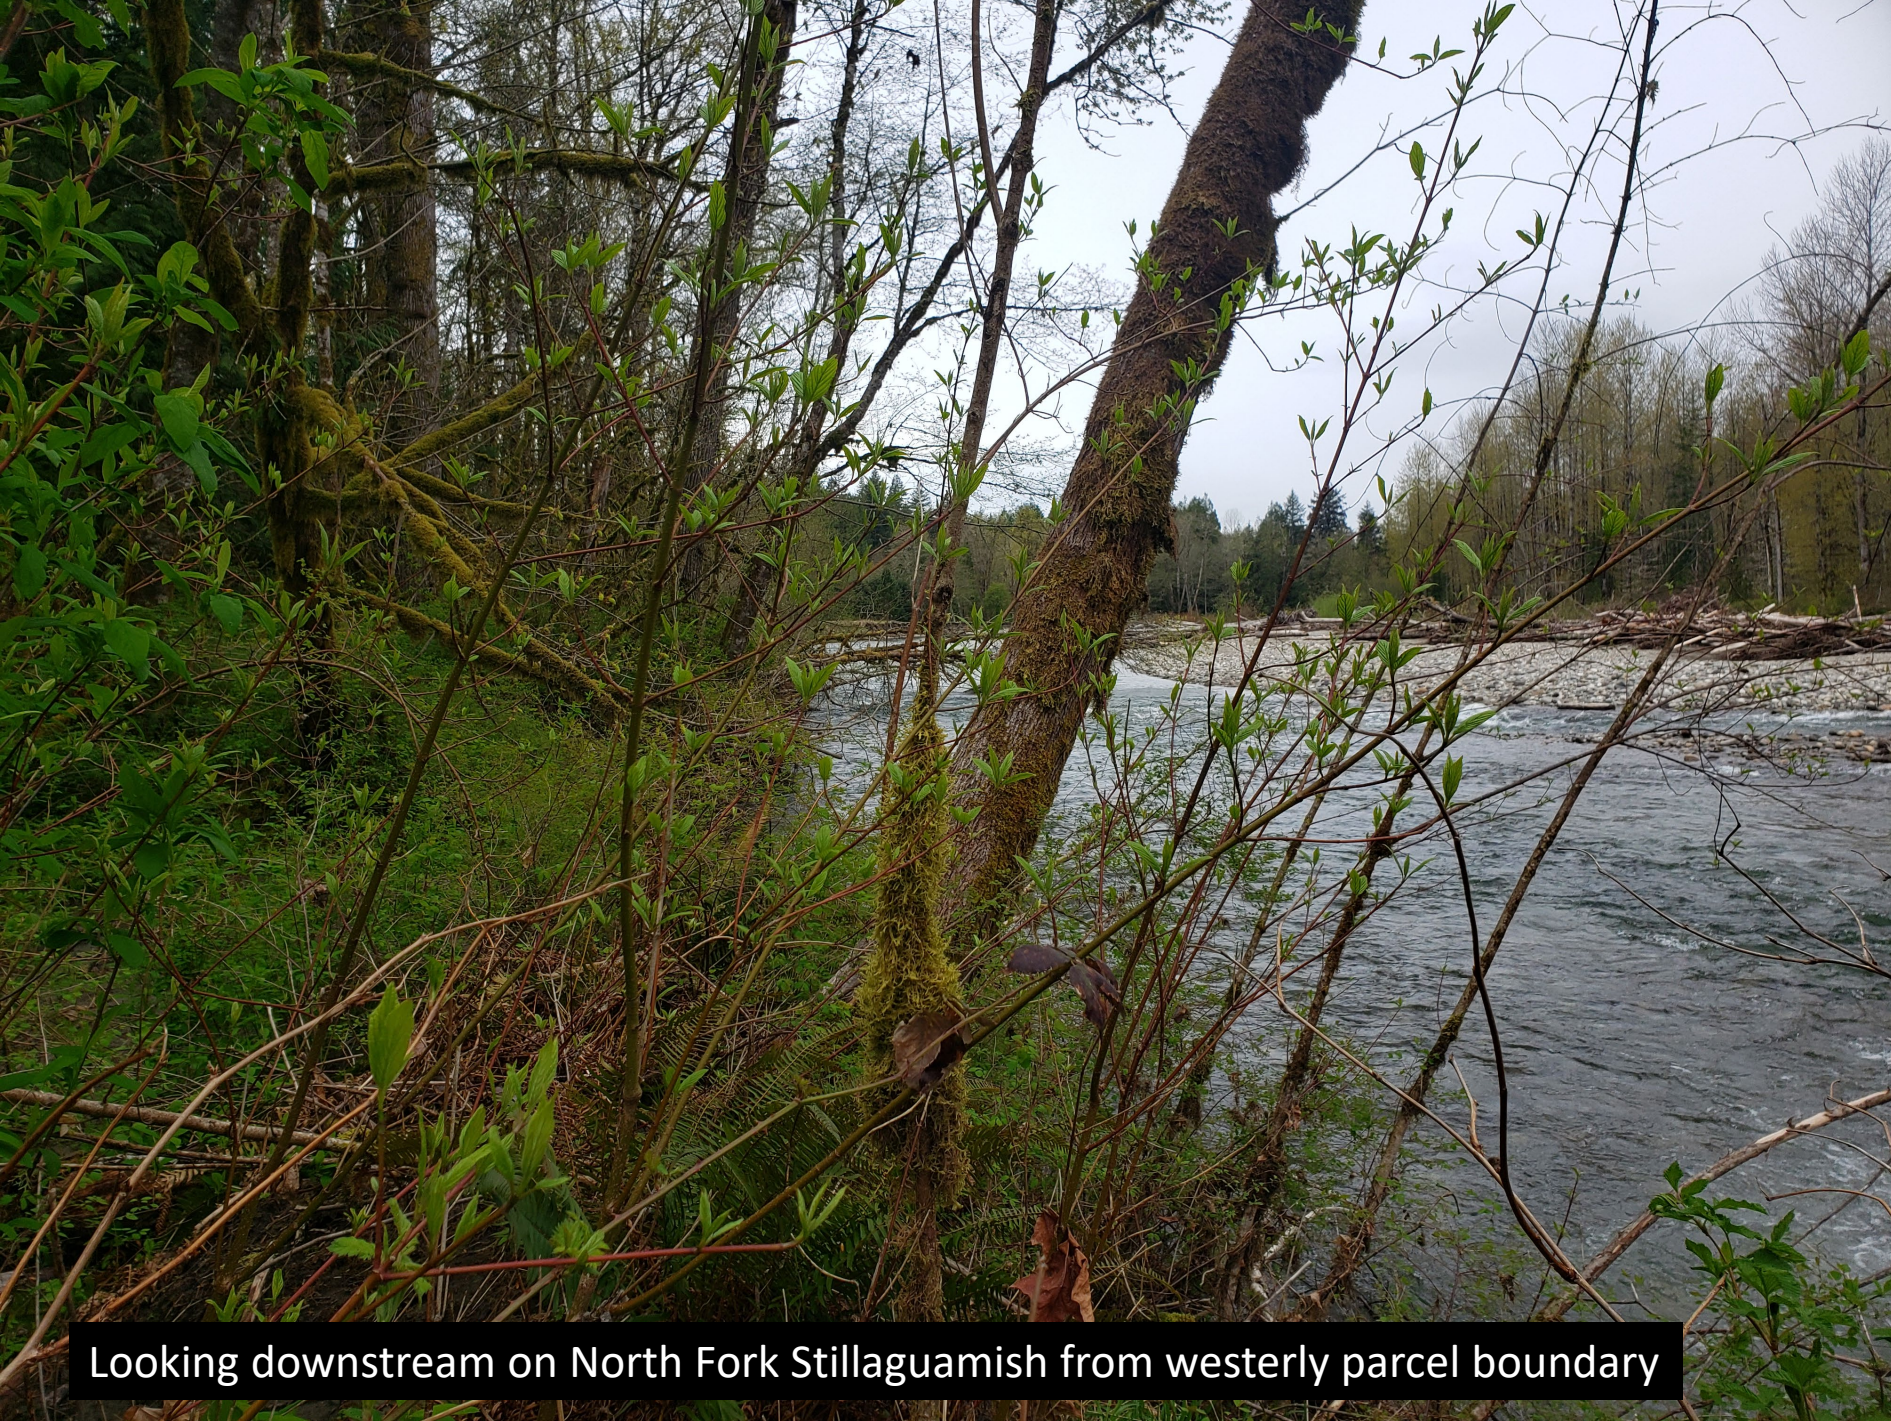
Looking downstream on North Fork Stillaguamish from westerly parcel boundary
