## Stillaguamish Tribal Response Program

### 2024 Public Record Packet Summary

# Local Brownfields Public Record Report

**Kunkel Property Site Assessment**

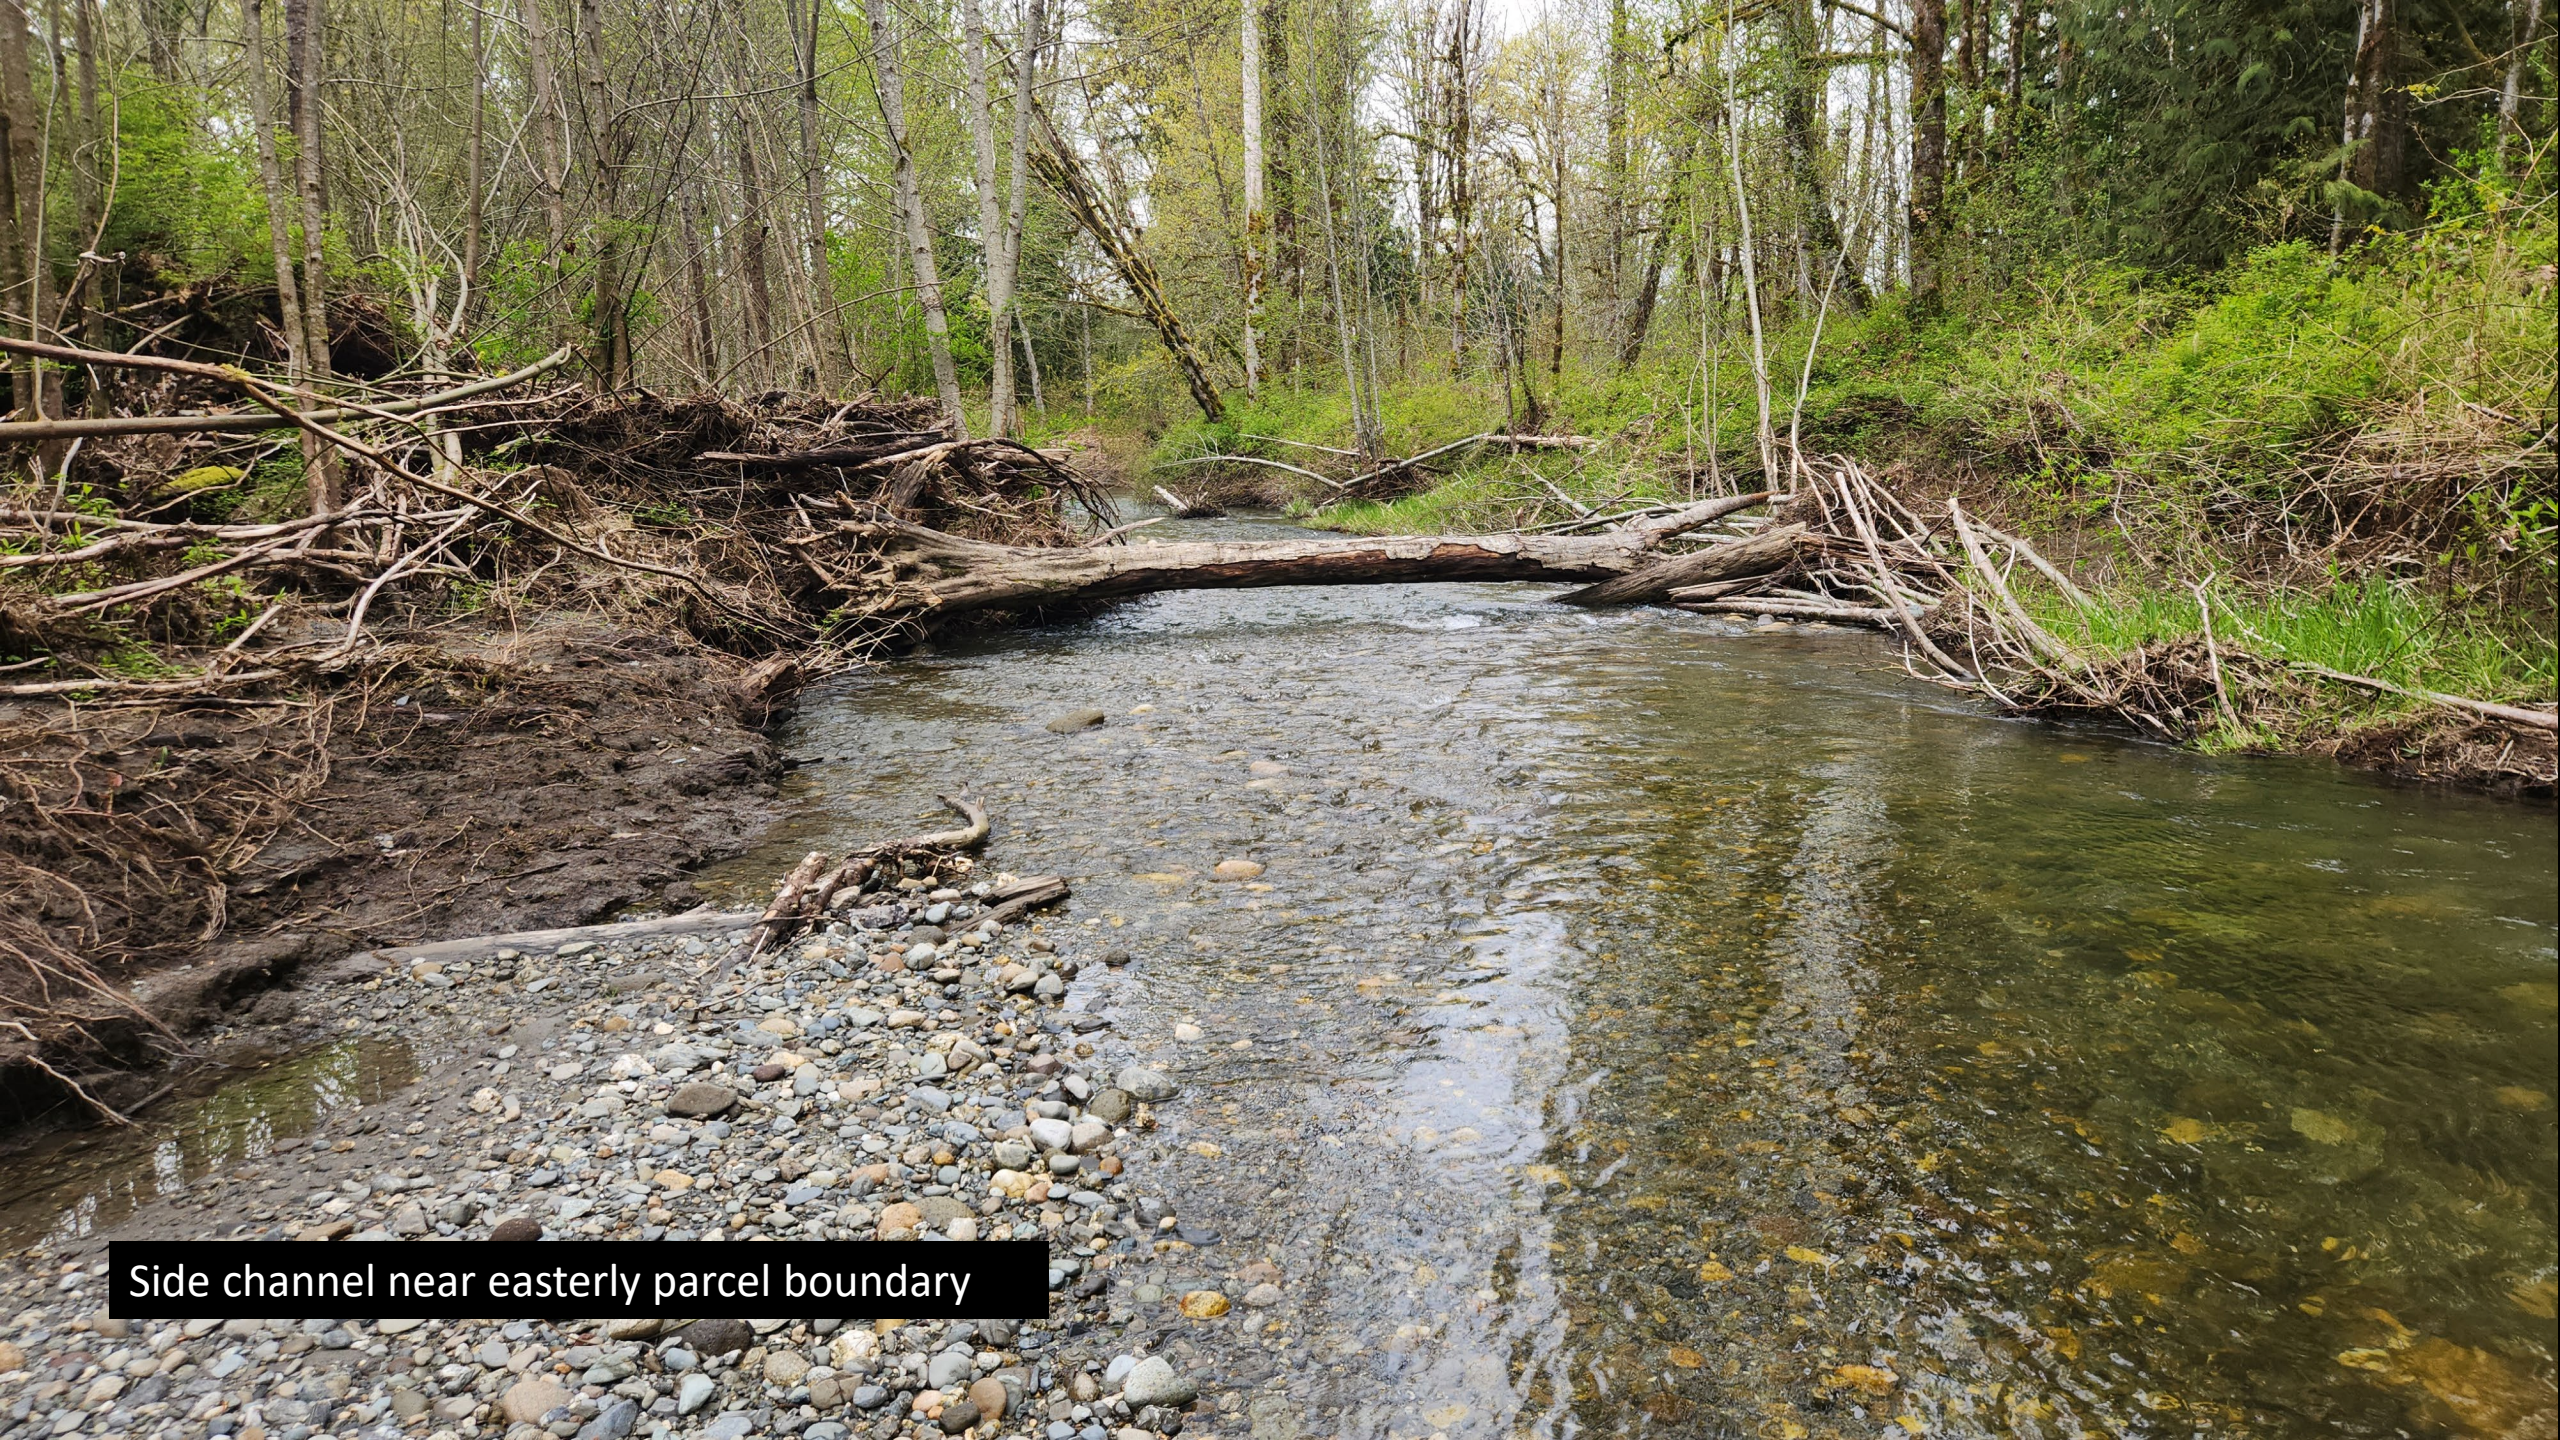
Side channel near easterly parcel boundary
