**Stillaguamish Tribal Response Program**

**2025 Public Record Packet Summary**

**Schultz Clan Property Site Assessment (Parcel 1)**

Assessment date: 10/29/2024

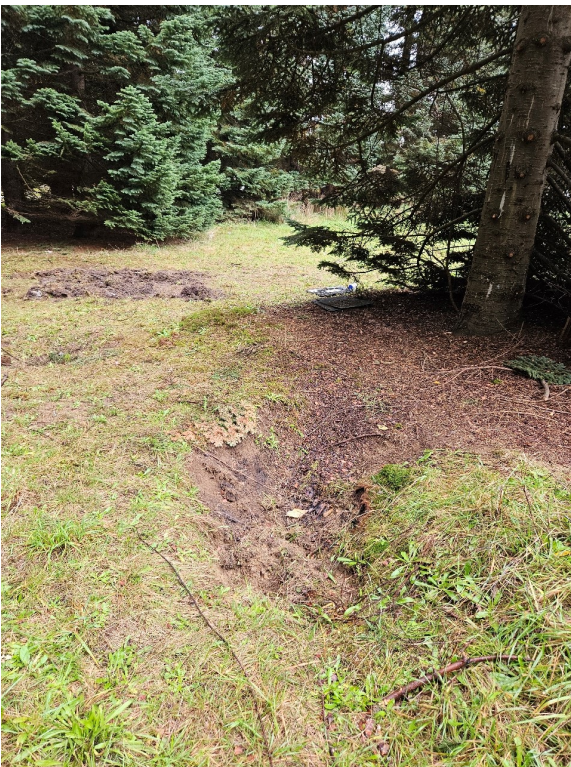
Photos 5 (Map Photo ID 131): Dig and fill areas along the forested boundary near the northern property line. Staff were unable to determine what was buried, or the purpose of the dig and fills.

**Conclusion and Recommendation:** This parcel has high concentrations of garbage and tire piles, burn pits, stained soils, broken down vehicles, human feces, and dig and fill areas. All areas mentioned above need to be properly disposed and cleaned up. Many areas need further exploration to ensure contamination is not present. **Risk Needs Further Investigation.**

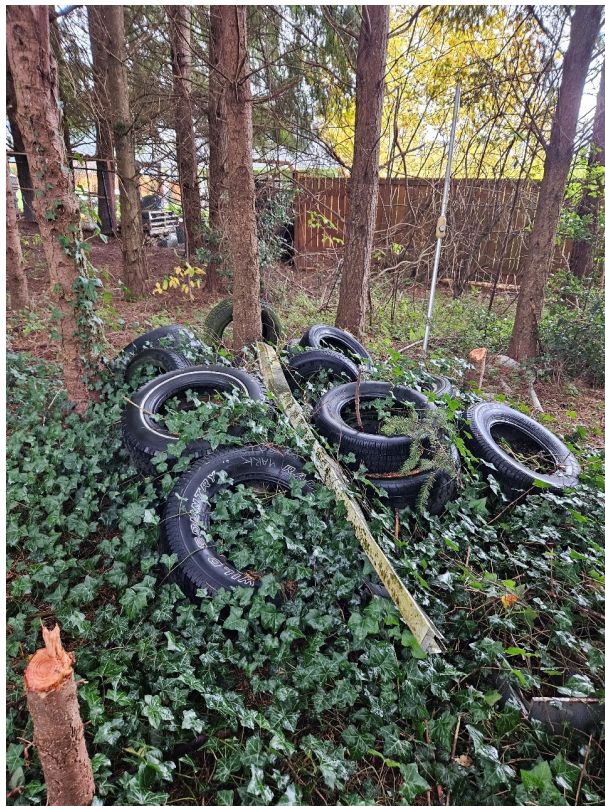
Photo 7 (Map Photo ID 133): A large pile of tires along the northern property line. Again, piles of human feces are present.

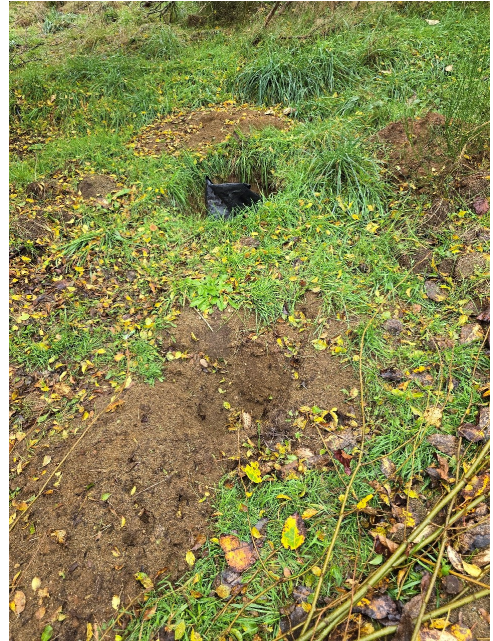
Photo 14 (Map Photo ID 140): Dig and fill areas near the center of the southern property line.

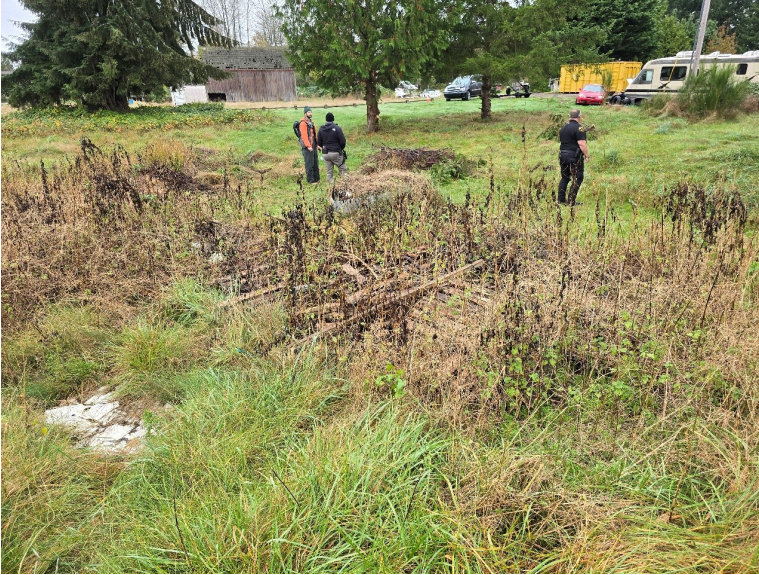
Photo 5 (Map Photo ID 126): Pile of garbage and junk next to the backyard fence.

**Conclusion and Recommendation:** This parcel was mostly clean and doesn't appear to have any significant environmental concerns. The two trailers should be investigated for soil contamination, the trash piles should be cleaned up, and the old chimney pipe should be investigated to ensure its not connected to a subsurface pile of unknowns. **Low Level of Risk that can be Mitigated.**

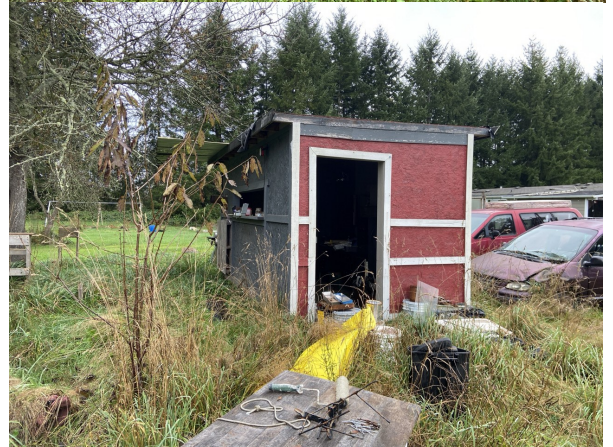
Photos 17 & 18 (Map Photo ID 167): The other shed, seen from two angles. This shed was filled with paint supplies. No spills were apparent.

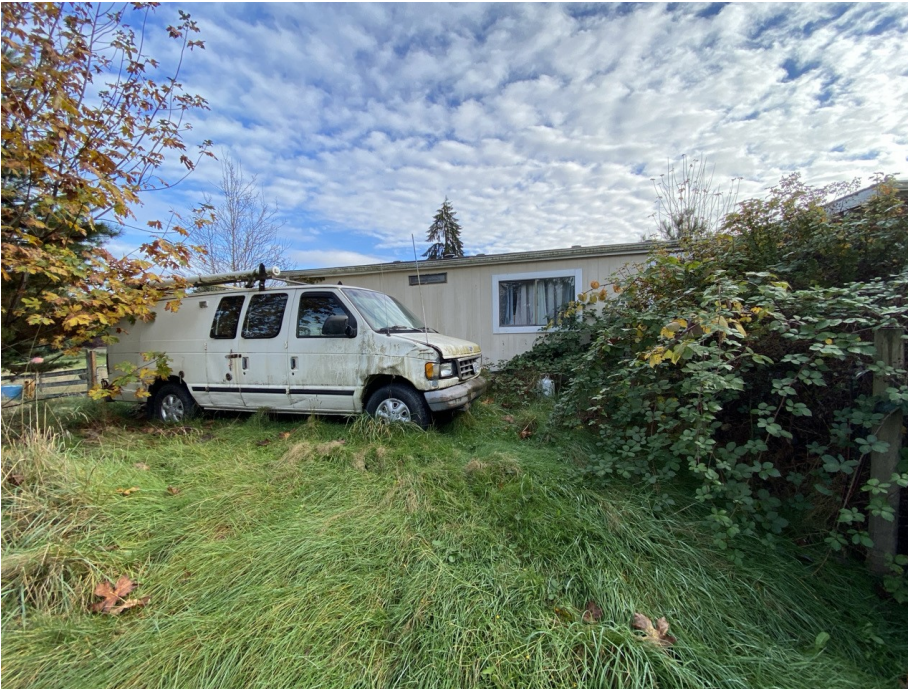
Photo 3 (Map Photo ID 203): The backside of the primary residence with the a likely broken down van. Photo taken looking east.

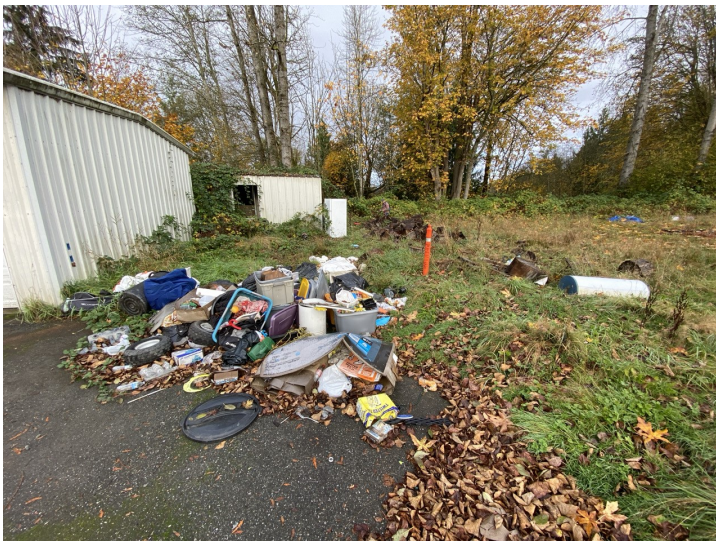
Photo 7 (Map Photo ID 185): A pile of junk outside the garage/shop

**Conclusion and Recommendation:** This parcel was mostly clean and doesn't appear to have any significant environmental concerns. All piles of junk should be removed and investigated for soil contamination. The large blackberry bush along the eastern property line should be investigated to ensure hidden junk, structures, or cars aren't hidden. **Low Level of Risk that can be Mitigated.**

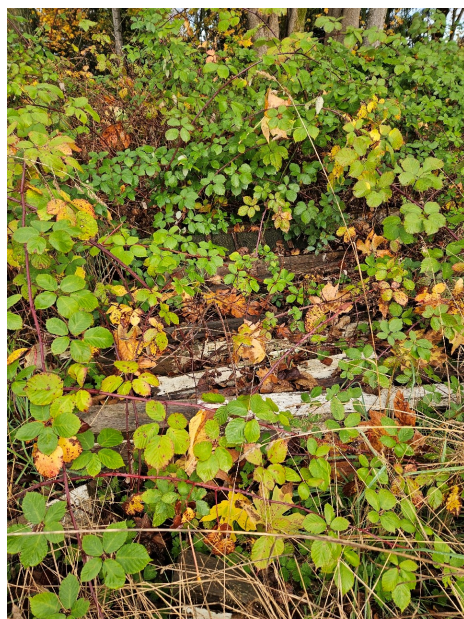
Photo 10 (Map Photo ID 183): A pile of dimensional lumber in the forest line on the north side of the shop.

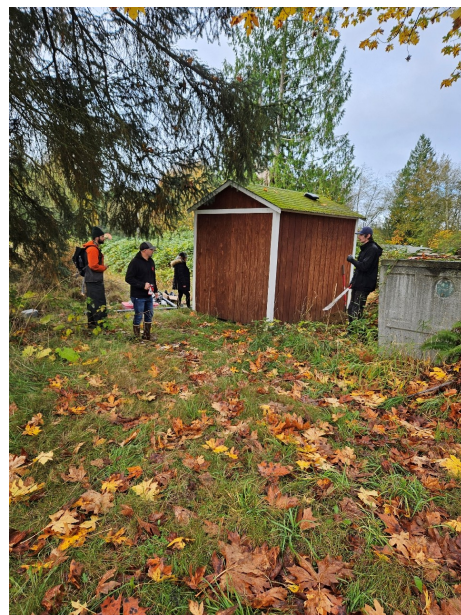
Photo 11 (Map Photo ID 179): Current construction of the new well pump house. The previously used concrete cistern can be seen on the right. The new well is located directly south on the neighboring parcel, across 246th St NE.

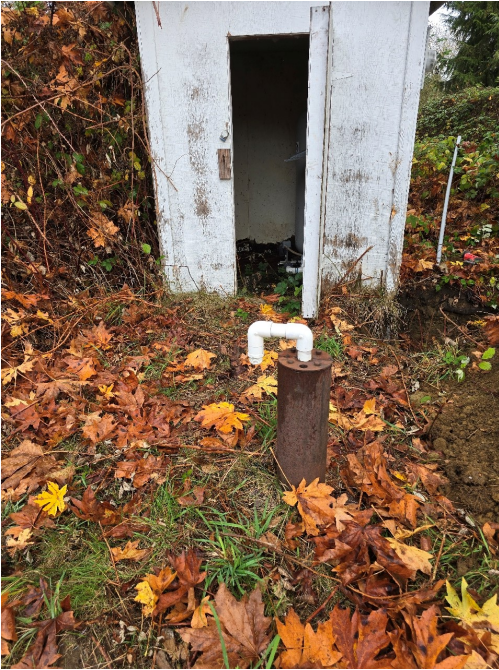
Photo 12 (Map Photo ID 180): Old well house and well, just west of the new well/pump house.

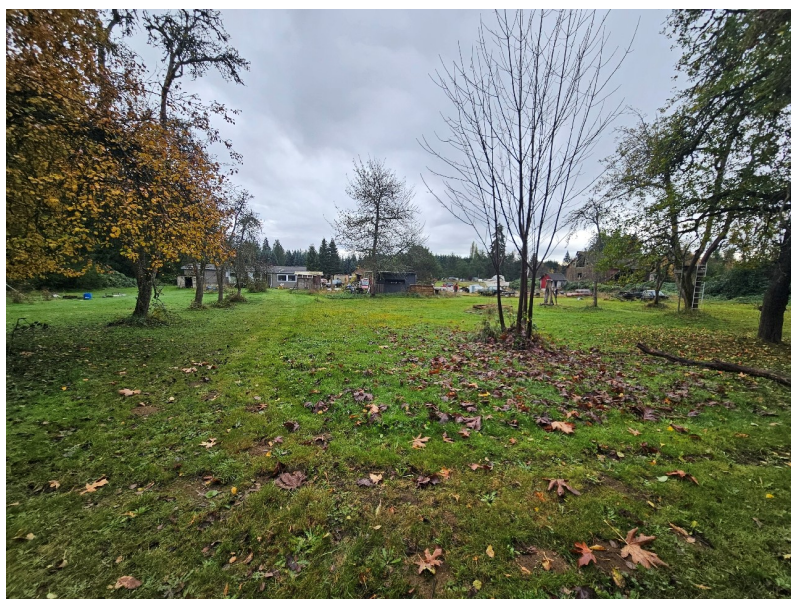
Photo 19 (Map Photo ID 170): Overview of the cleared, southern portion of the property. Photo taken at the forest line, looking south. The forest to the north slopes steeply downhill towards Pilchuck Creek.

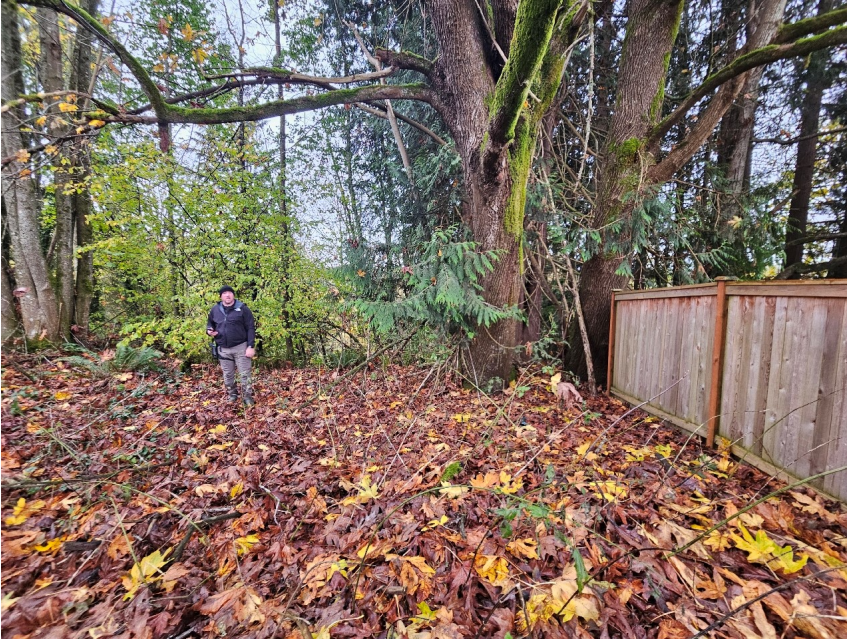
Photo 20 (Map Photo ID 166): The northeast corner of the property.

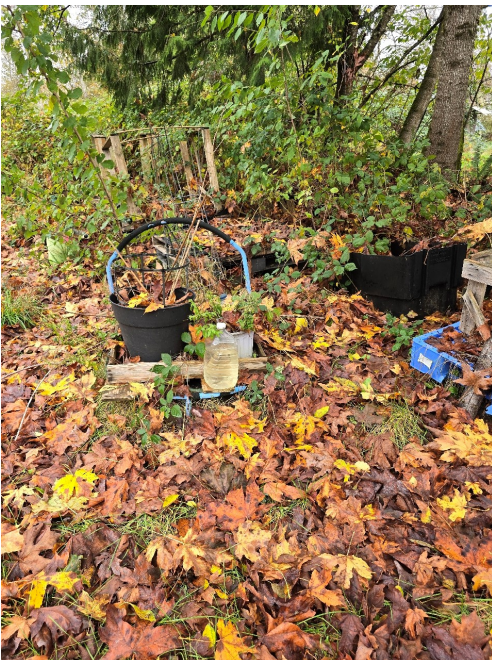
Photo 2 (Map Photo ID 219): Various junk under a cedar tree in the front yard of the house.

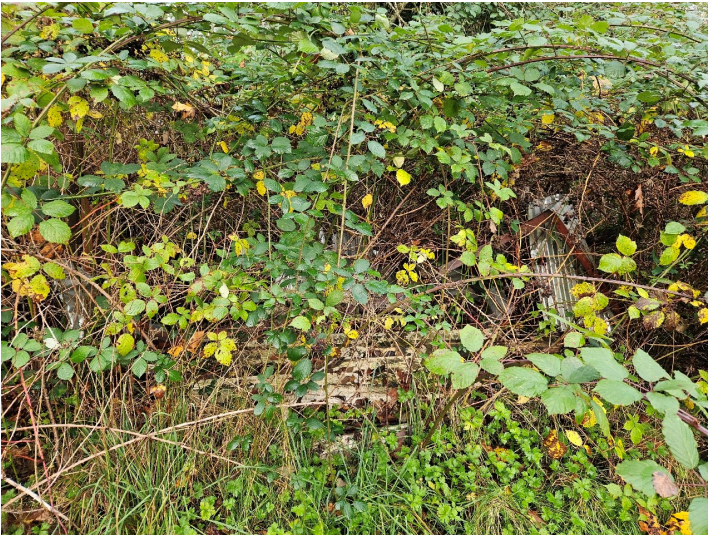
Photo 3 (Map Photo ID 191): Various metal pieces, lumber, and junk along the eastern property line.

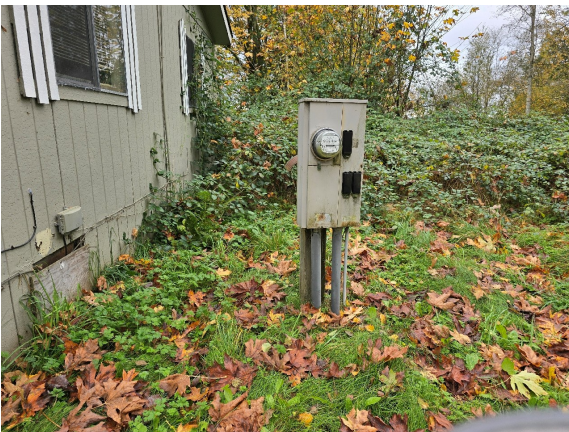
Photo 4 (Map Photo ID 223): Electric meter on the north side of the house.

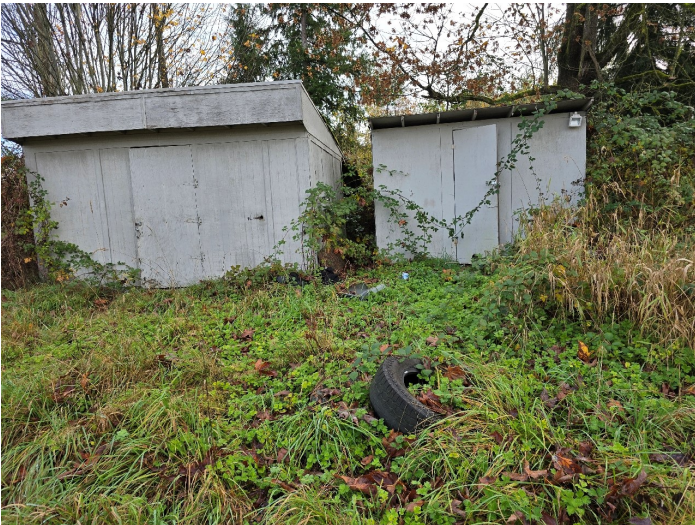
Photos 4 (Map Photo ID 215 ): Just south of the house, two storage sheds filled with junk and old chemicals.

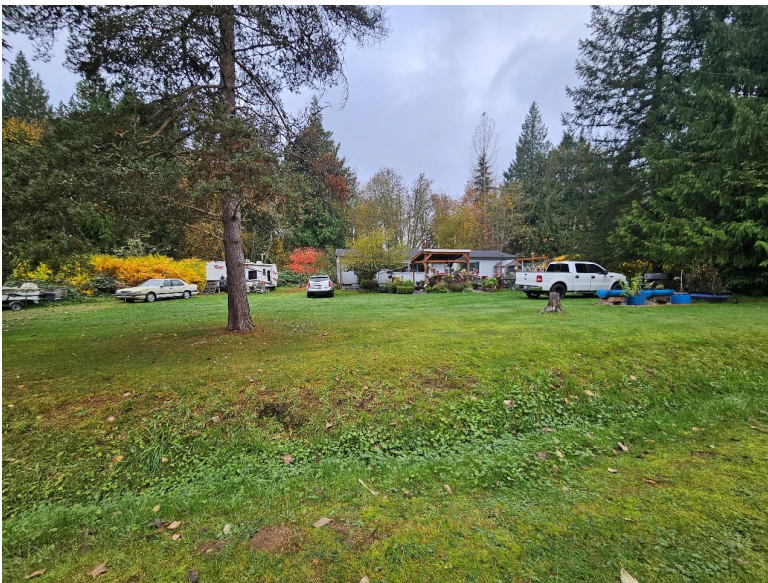
Photo 1 (Map Photo ID 228): Overview of the property as viewed from 246th St NE.

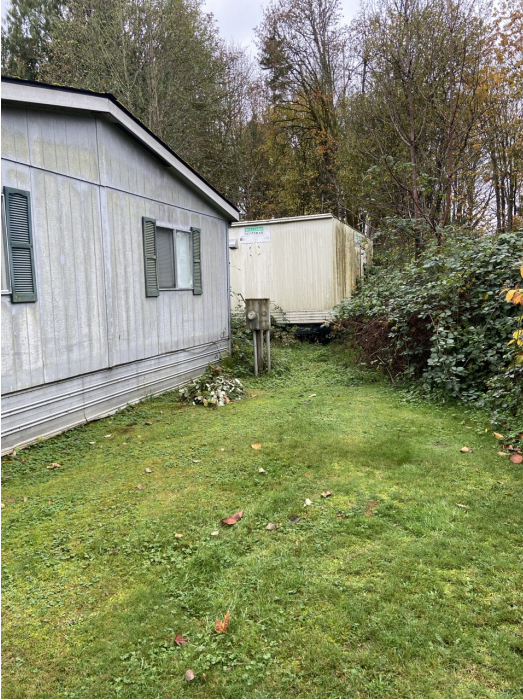
Photo 3 (Map Photo ID 236): Electric meter, north side of the house, and a trailer in the background.

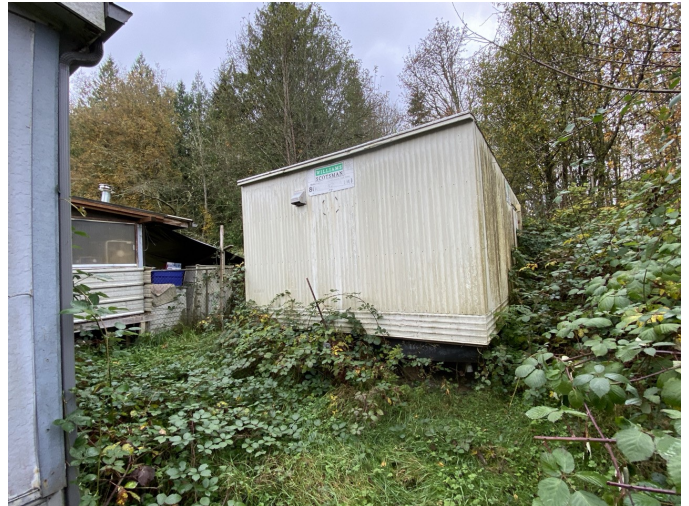
Photo 4 (Map Photo ID 237): Trailer located behind (west) of the house. An attached house patio can be seen to the left.

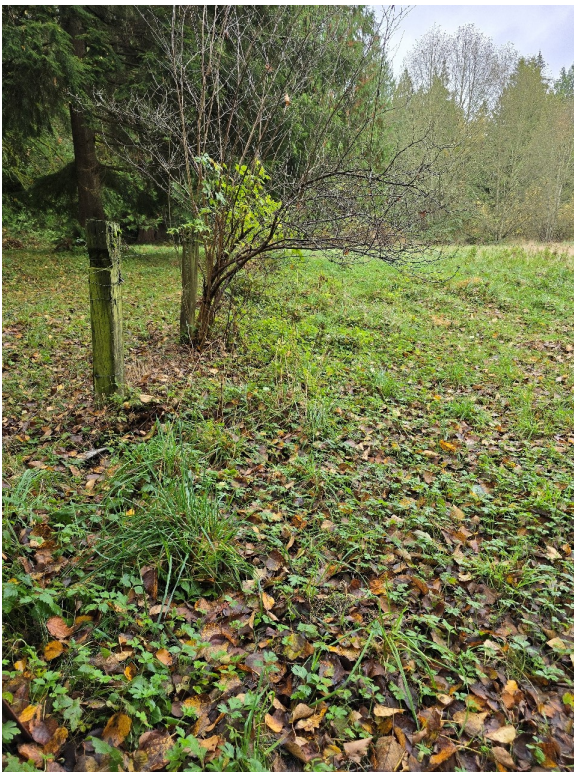
Photo 13 (Map Photo ID 238): The southeast corner of the property, looking west down the southern property line.

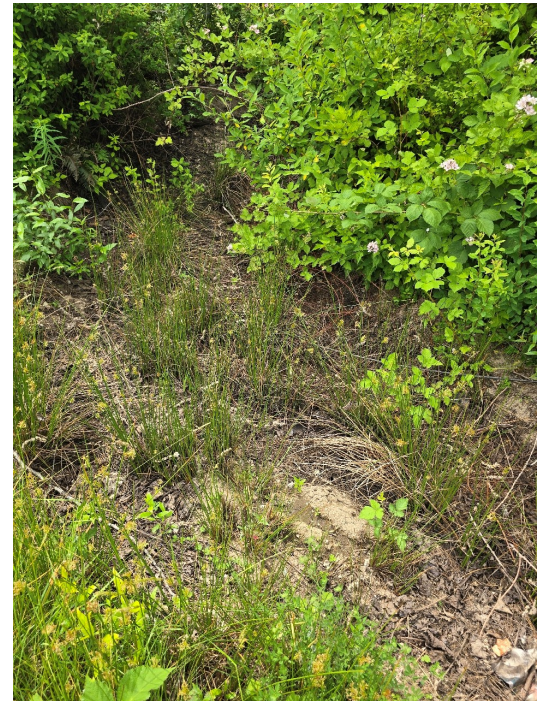
Photo 2 (map photo ID 243): A low spot that is likely inundated with water during some parts of the year, found along the property line adjacent to Dahl Road.

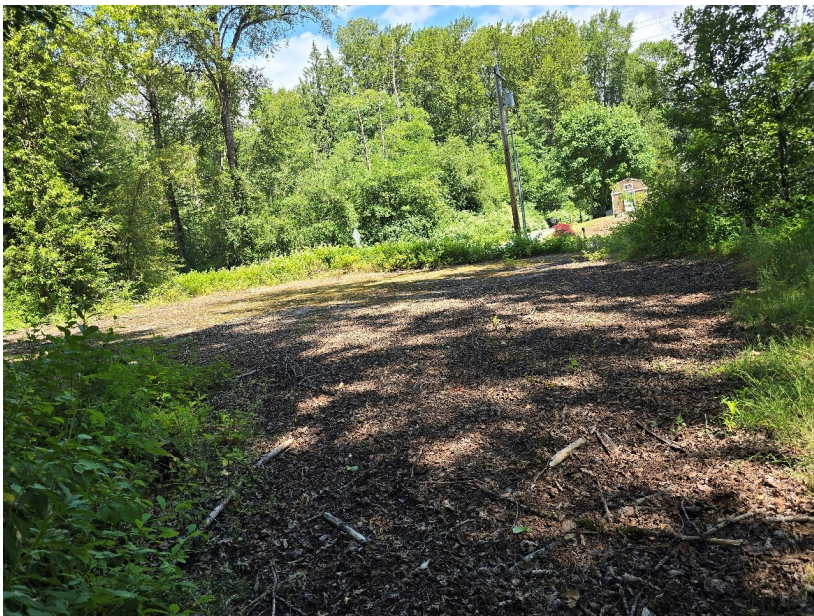
Photo 5 (map Photo ID 248): Cleared area looking east, adjacent to Dahl Road.

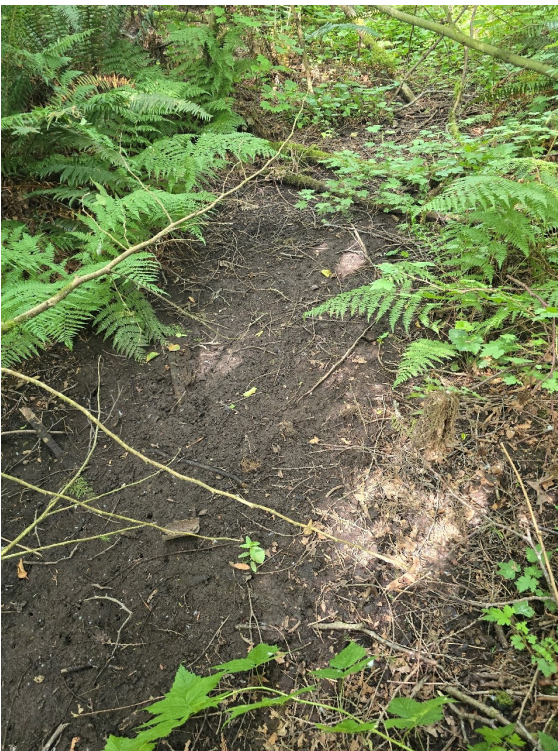
Photo 12 (map Photo ID: 252): A wetland ditch along the northern property line, near the corner of Dahl Road and 268th St NW.

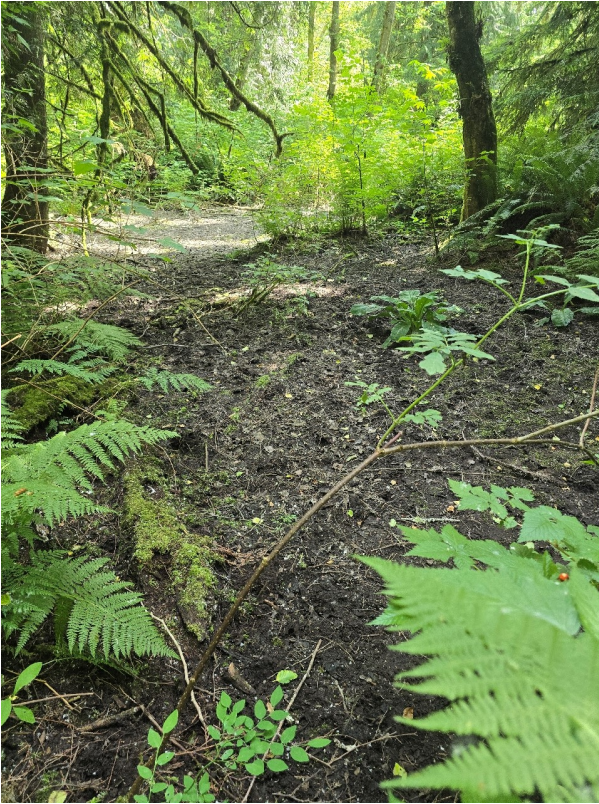
Photo 14 (map Photo ID: 254): A 761 square foot wetland found near the center of the property. This area is likely inundated with water during the wet season, Fall through Spring.
