Property Assessment Checklist for Hazardous Substances Certification

Zoe Property Site Assessment

Address: 22732 19th Dr. NE, Arlington, WA 98223

Hoback Property Site Assessment

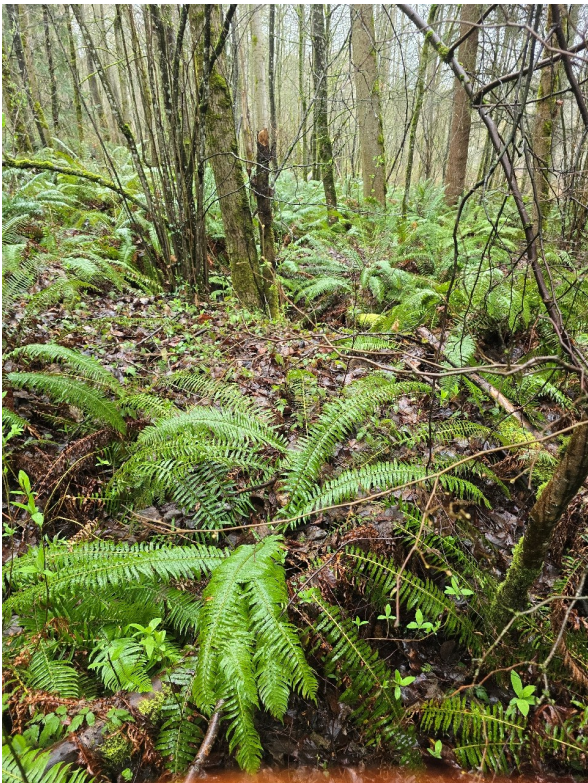
Photo 19 (Map Photo ID 298): Water seepage/spring near the western property line, about halfway down the hill. Water flows through a ravine down to the river.

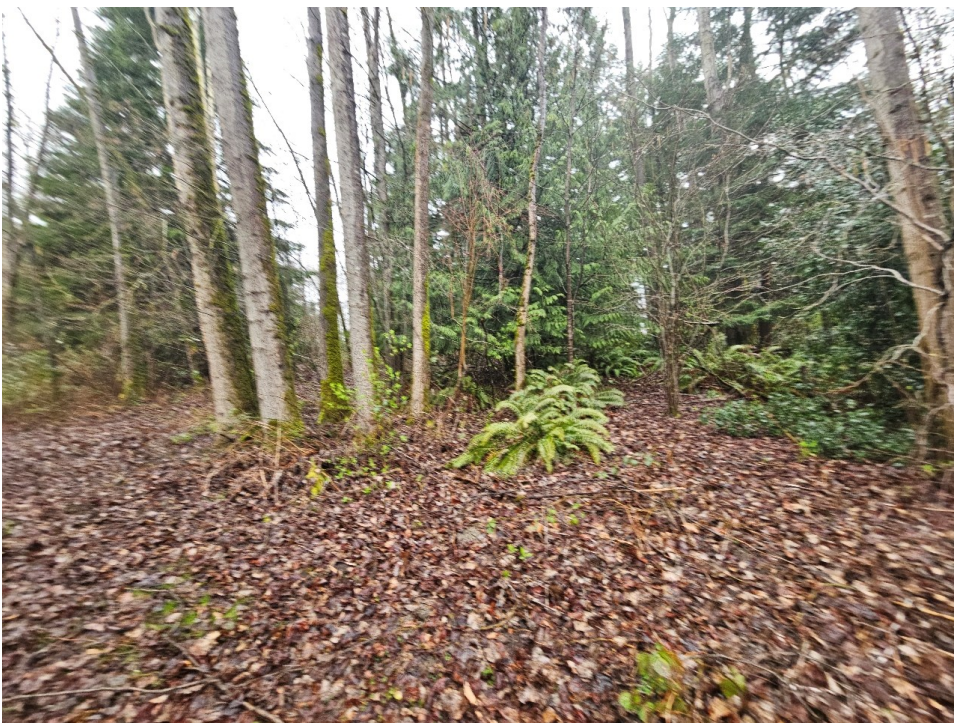
Photo 22 (Map Photo ID 293): Sitting spot overlooking the river near the base of the hill, looking south.

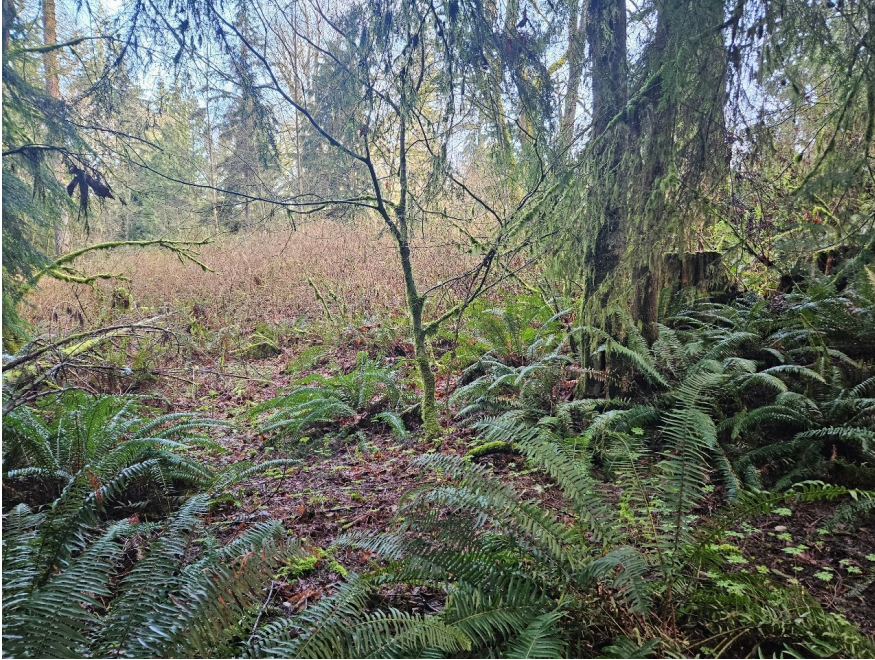
Photo 9 (Map Photo ID 311): Southwest corner of the property, looking northeast (and uphill) towards the residence. This section of forest was dominated by cedar trees and slopes down to the west to a gully and creek.

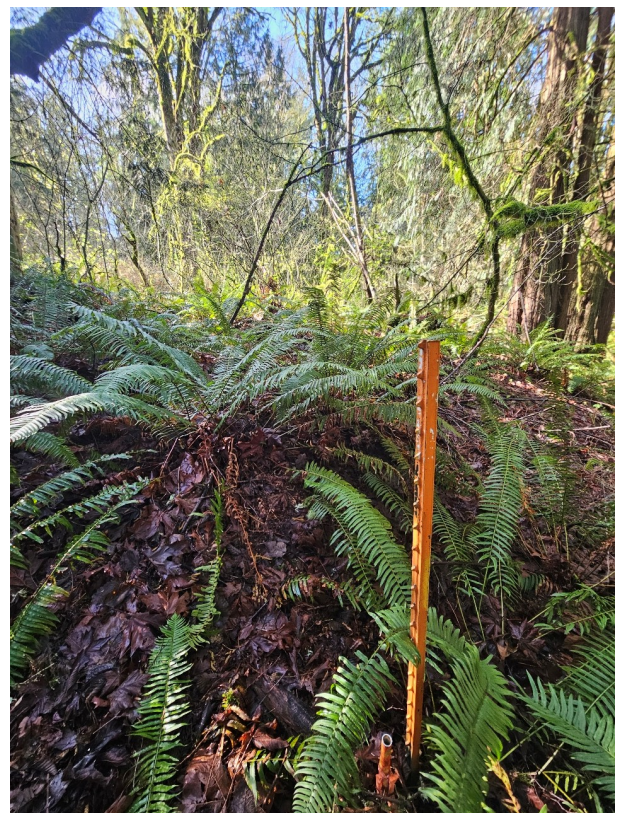
Photo 11 (Map Photo ID 307): Northwest corner of the property, looking to the south.

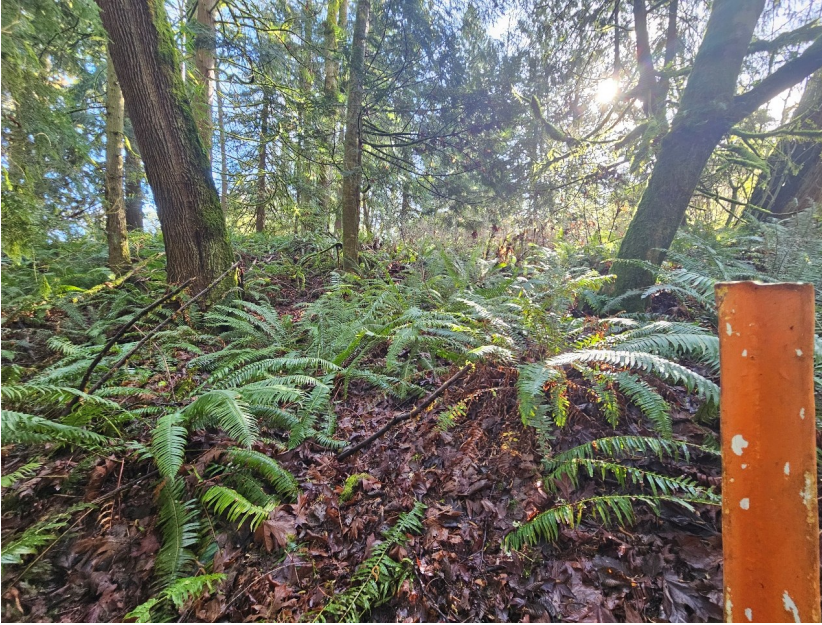
Photo 12 (Map Photo ID 307): Northwest corner of the property, looking to the northeast (and uphill) towards the main residence.

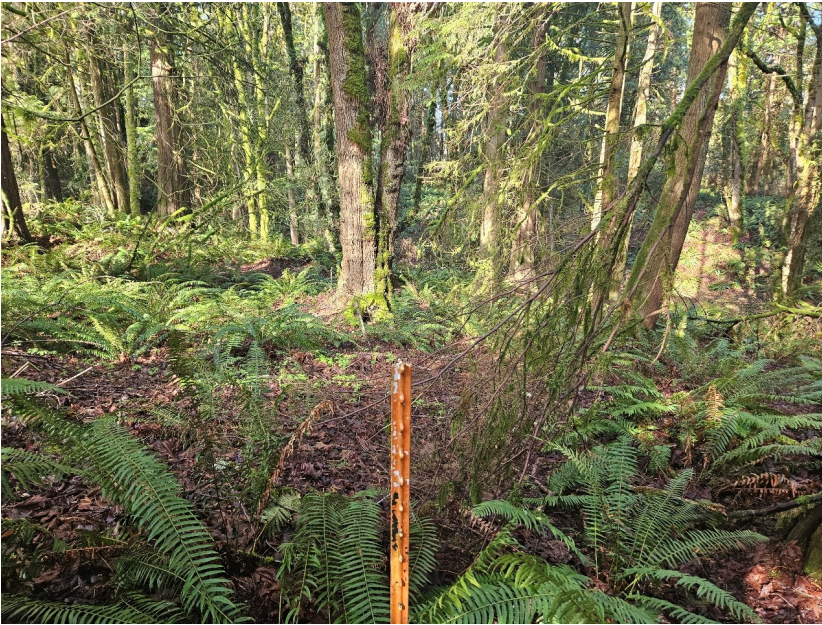
Photo 13 (Map Photo ID 307): Northwest corner of the property, looking to the west (and downhill) towards the gulley and creek on the neighboring property.

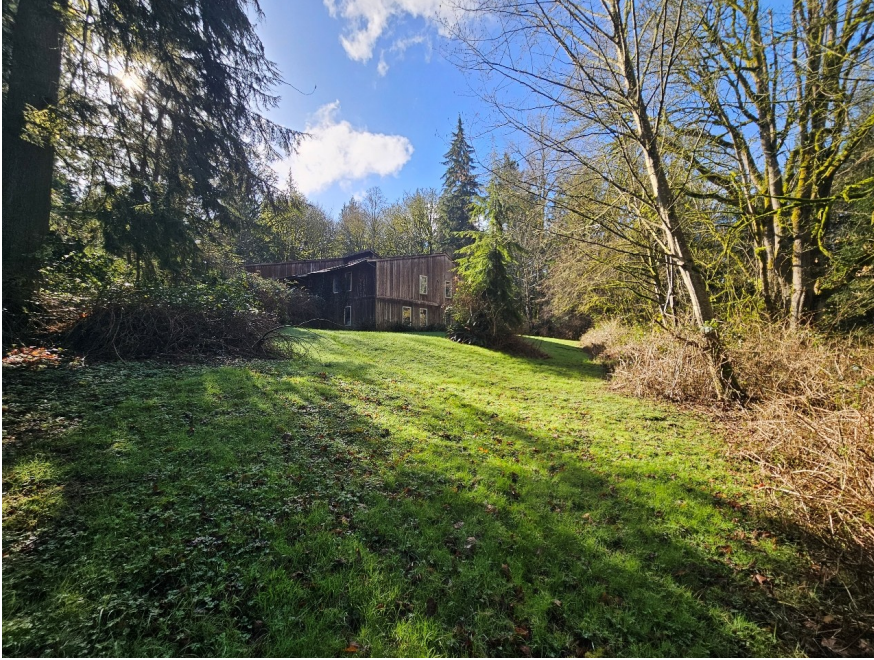
Photo 14 (Map Photo ID 306): Northern side of the residence, looking southeast.
