**Stillaguamish Tribal Response Program**

**2025 Public Record Packet Summary**

**Schultz Clan Property Site Assessment (Parcel 1)**

Assessment date: 10/29/2024

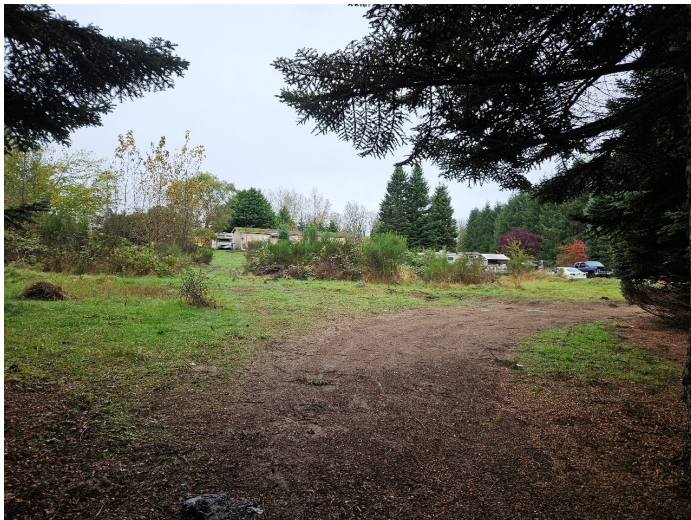
Photo 1 (Map Photo ID 121): Entrance onto the parcel from 19th Ave NE. This parcel was inhabited by squatters for more than a year, trashing the majority of the property.

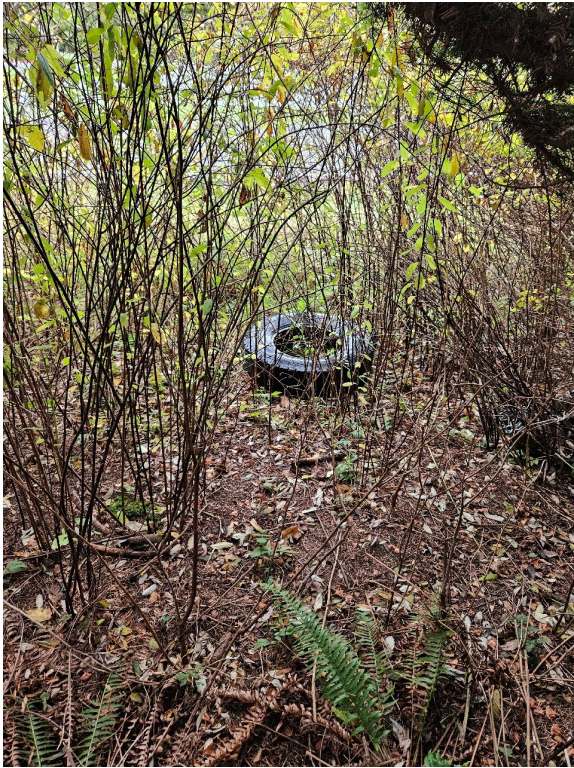
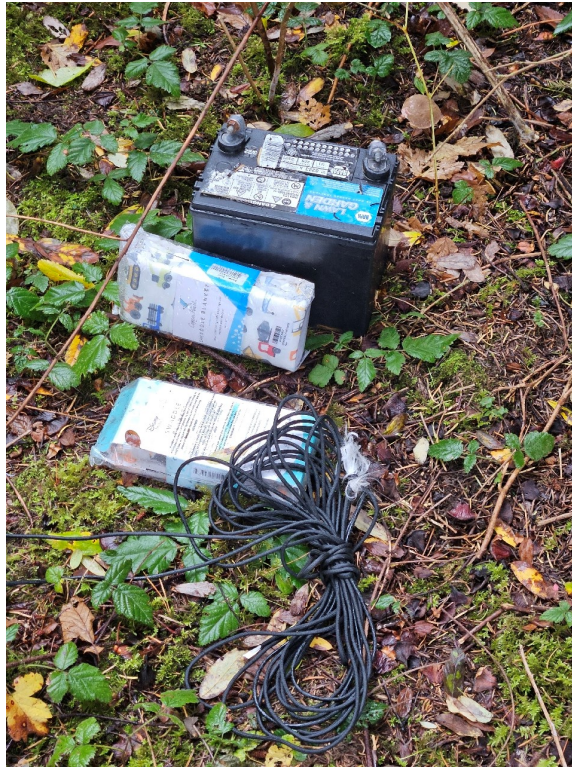
Photos 3&4 (Map Photo IDs 123 & 124): Tires, a battery, and garbage along the 19th Ave NE property line.

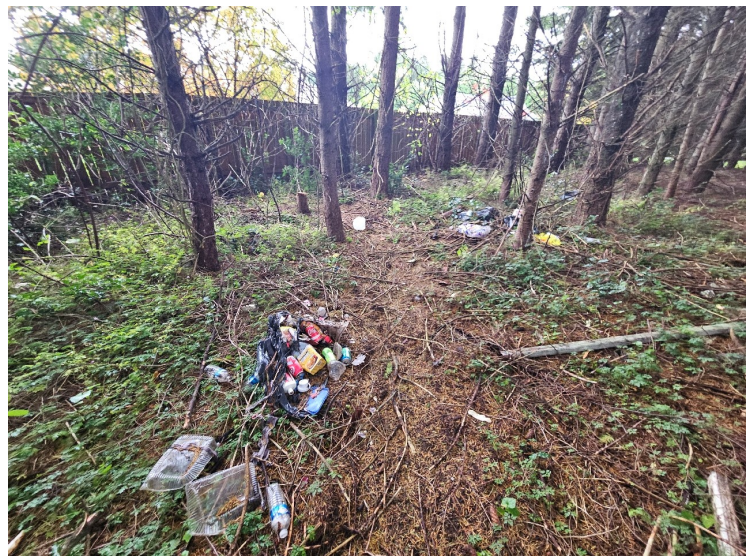
Photos 6 (Map Photo ID 136): Garbage piles are strewn through the forested section of the northern property line, in addition to numerous piles of human feces.

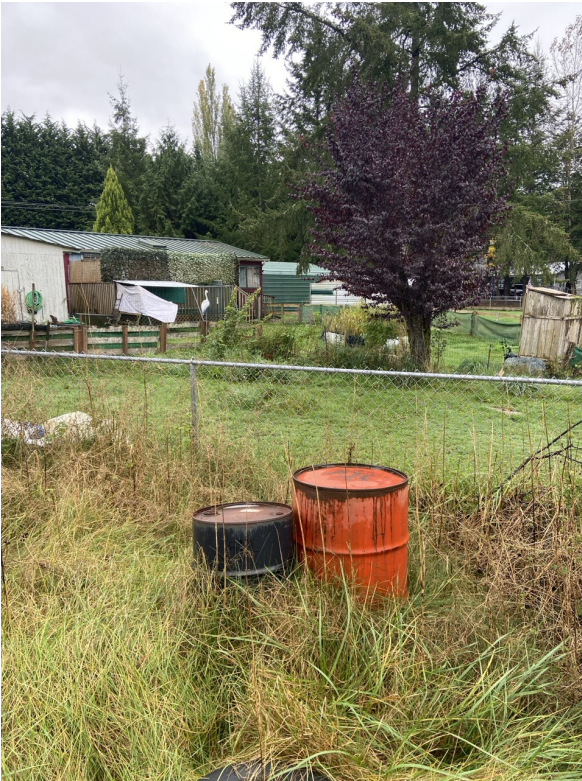
Photo 4 (Map Photo ID 127): Empty drums along the backyard fence of the mobile home. The barrels did not appear to be compromised. A tired was also located nearby (approximately where the photo was taken).

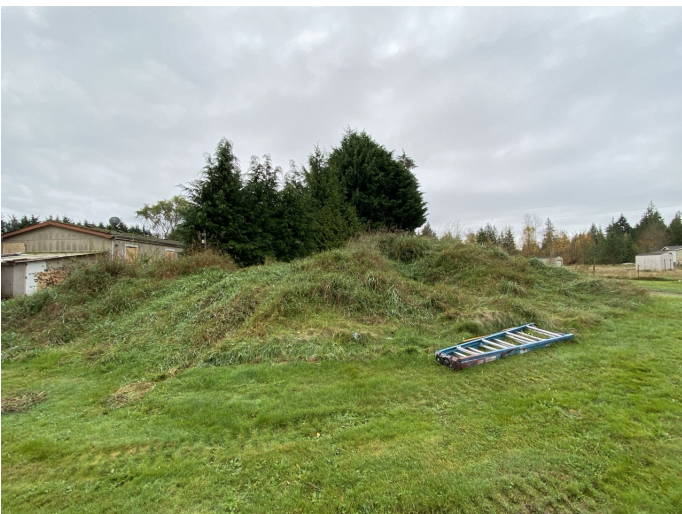
Photo 2 (Map Photo ID 149): A mound seen near the southeast corner of the property. No visible garbage was visible, but seems odd—could need further investigation.

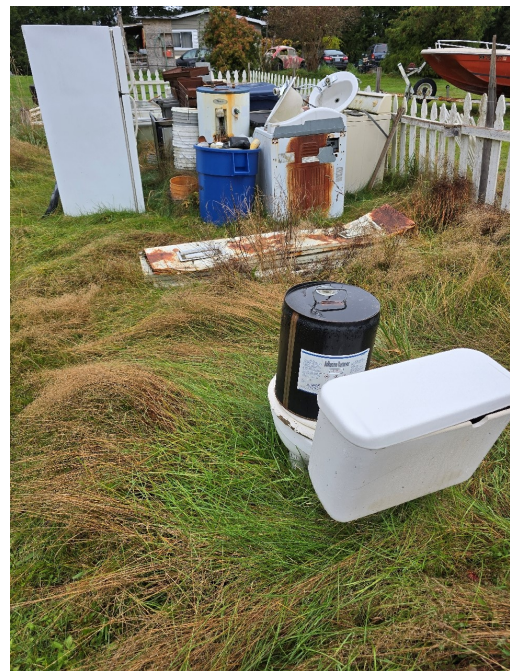
Photo 6 (Map Photo ID 156): Another view of the junk shown in Photo (5), including: household appliances, chemicals, etc.

**Conclusion and Recommendation:** This parcel was mostly clean and doesn't appear to have any significant environmental concerns. All piles of junk should be removed and investigated for soil contamination, especially the areas with household appliances, chemicals, and paint cans. **Low Level of Risk that can be Mitigated.**

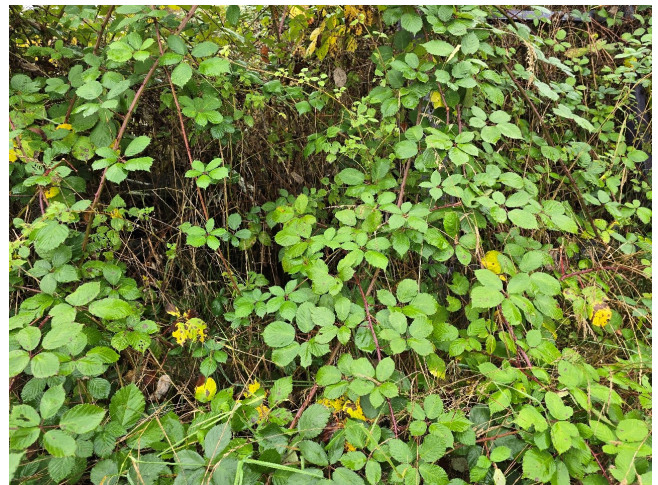
Photo 10 (Map Photo ID 169): Various junk hidden within thick blackberry bushes along the southern property line towards the southwest corner of the property.

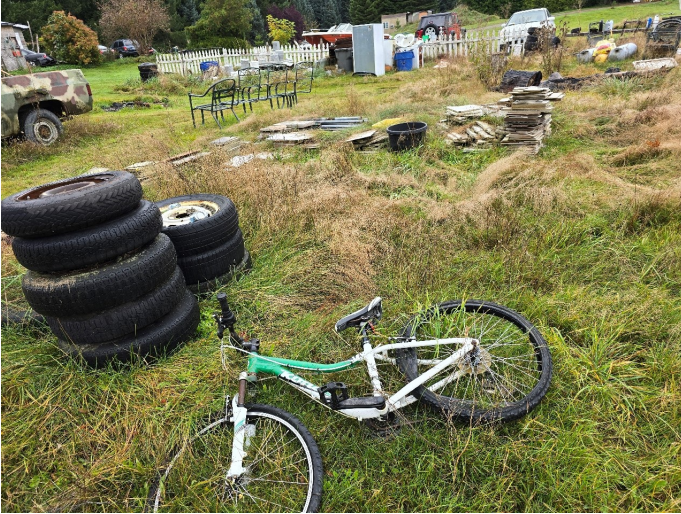
Photo 11 (Map Photo ID 171): Another view of the large pile of junk near the southern property line.

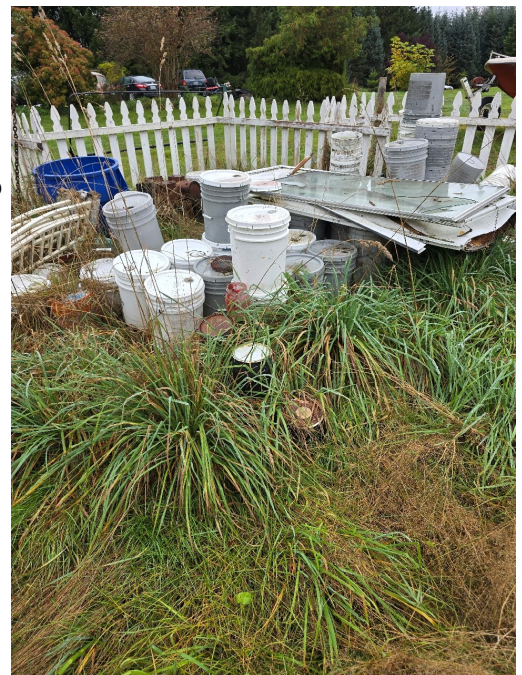
Photo 14 (Map Photo ID 158): A large pile of old, 5-gallon paint cans and other junk. Photo taken near the burn pit in Photo (13).

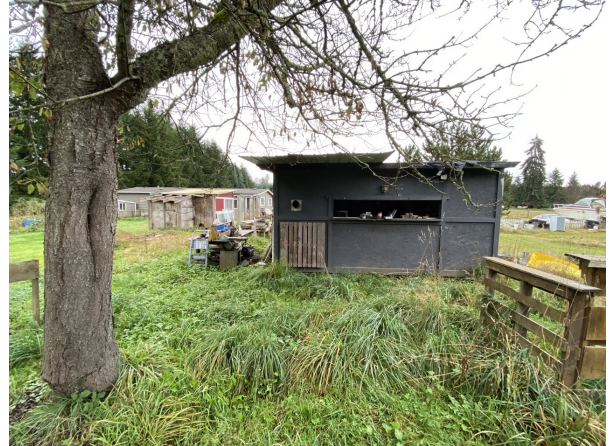
Photos 17 & 18 (Map Photo ID 167): The other shed, seen from two angles. This shed was filled with paint supplies. No spills were apparent.

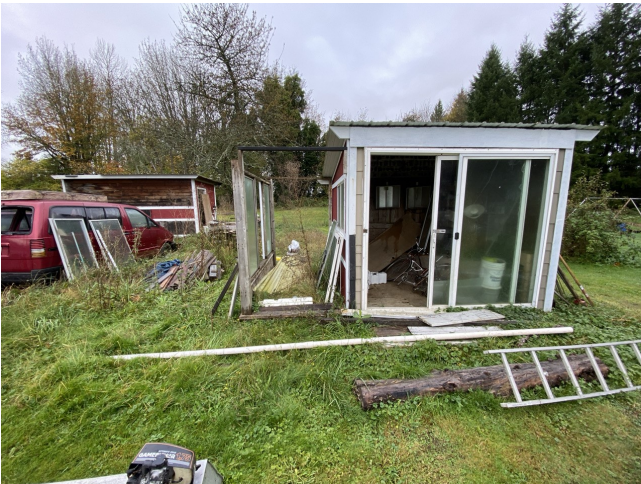
Photo 16 (Map Photo ID 167): One of two sheds on the west side of the house. Piles of junk were also present.

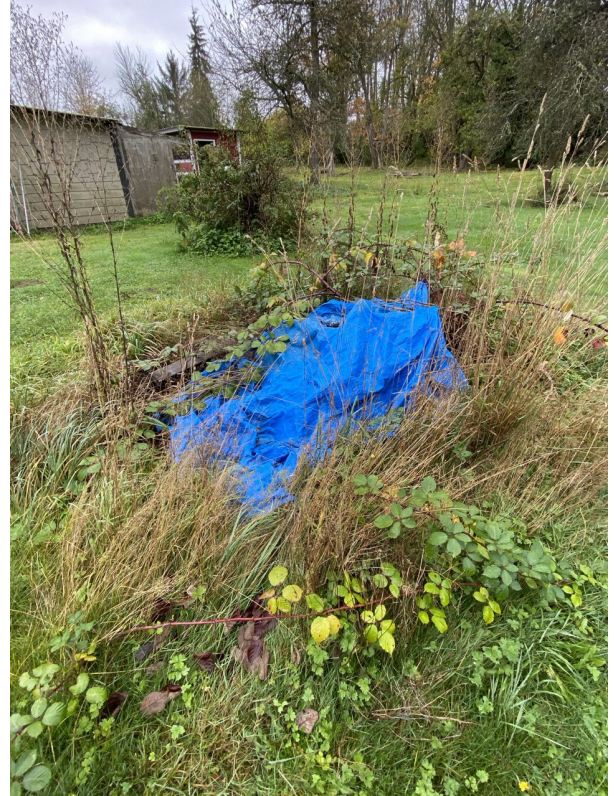
Photo 20 (Map Photo ID 164): A tarp covering garden area, either for insulation or for covering junk. Staff were unable to investigate further.

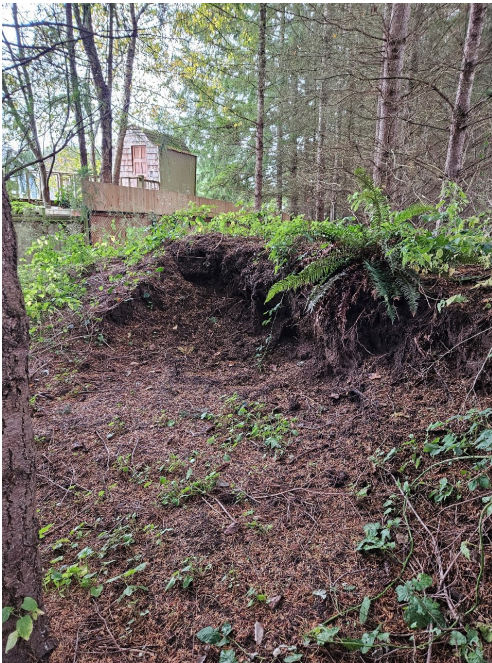
Photo 22 (Map Photo ID 154): A dug area along the northern property line. It appears soil was harvested for somewhere else on the property.

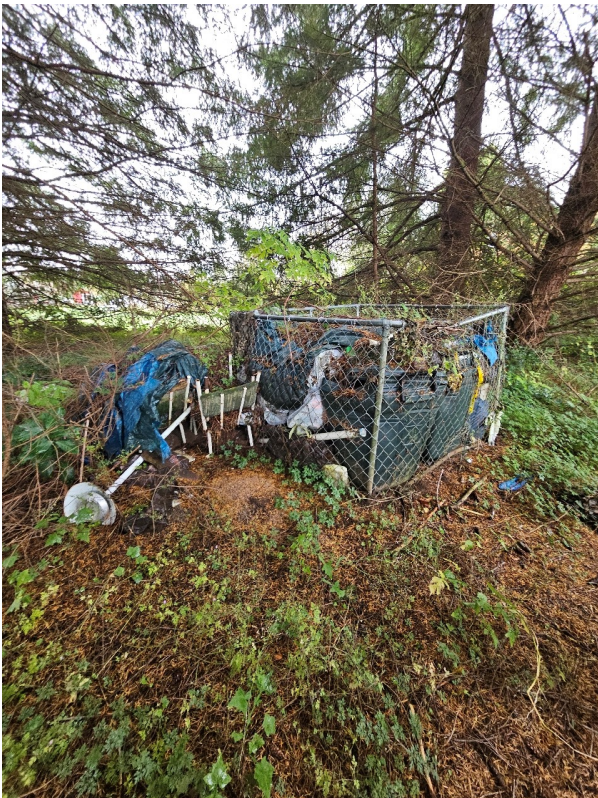
Photo 24 (Map Photo ID 155): A pile of garbage near the center point of the northern property line.

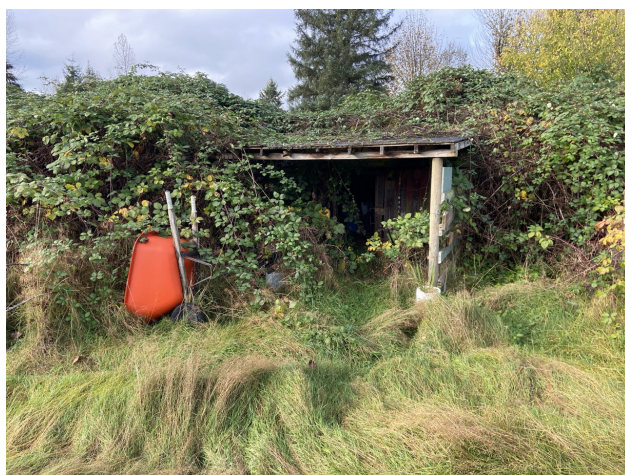
Photo 6 (Map Photo ID 204): A small garden shed with a tractor (overtaken by blackberries), located just south of the house.

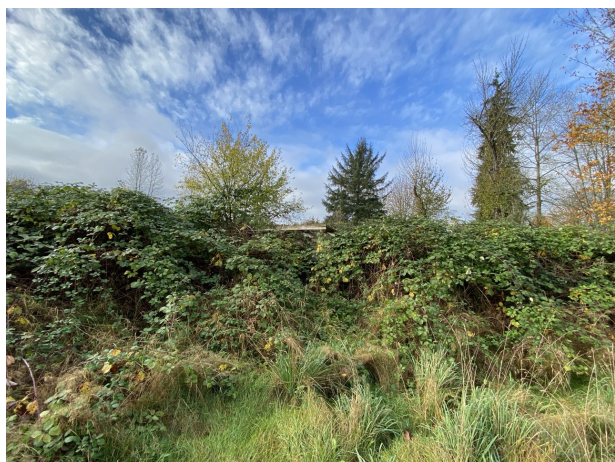
Photo 7 (Map Photo ID 200): Another small structure overtaken by the blackberry bush seen in Photo (6).

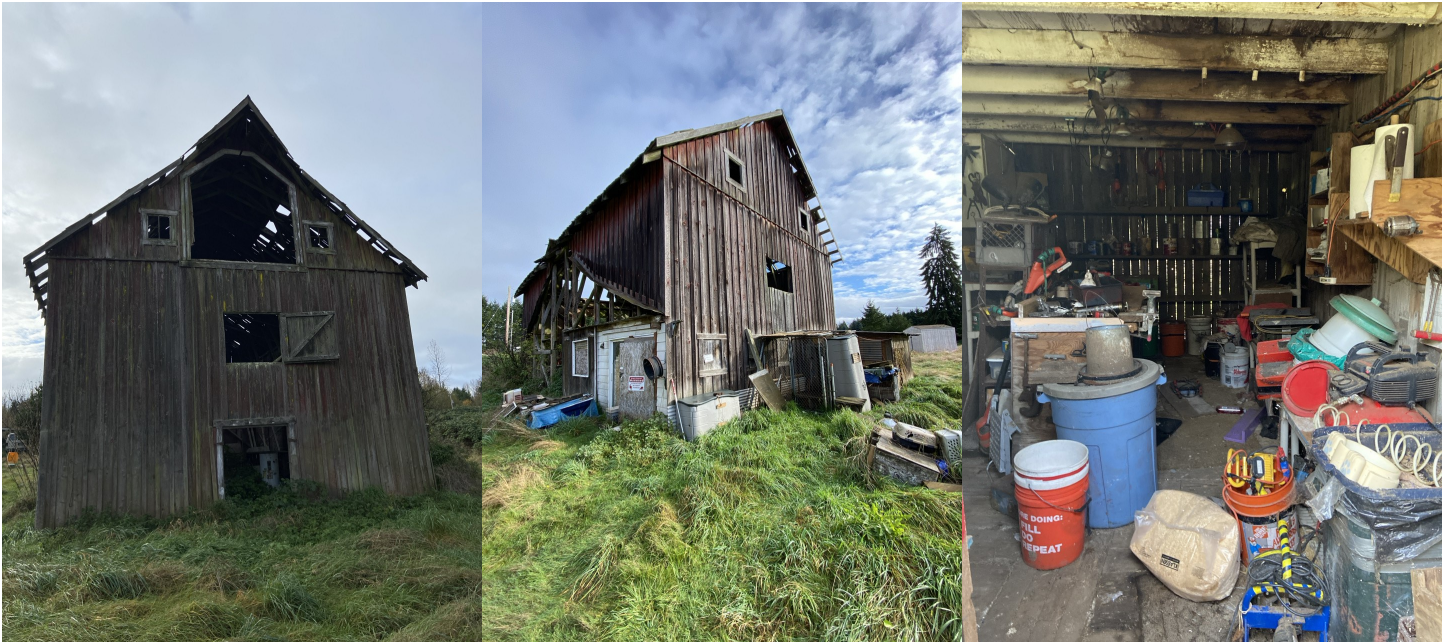
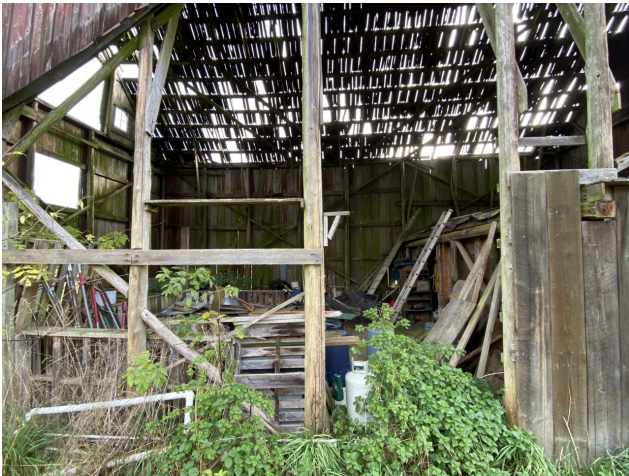
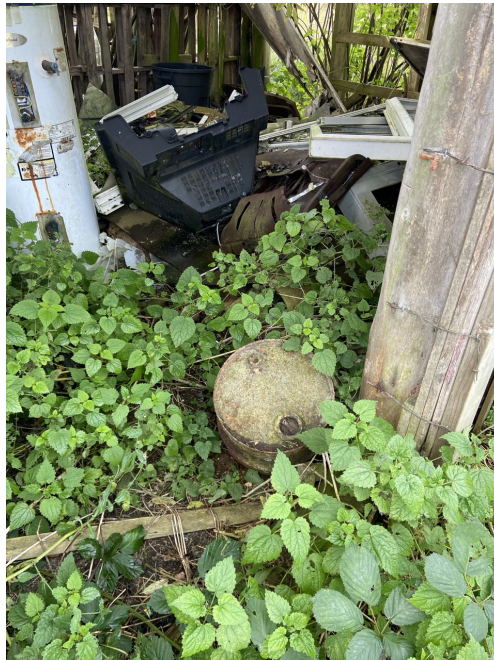
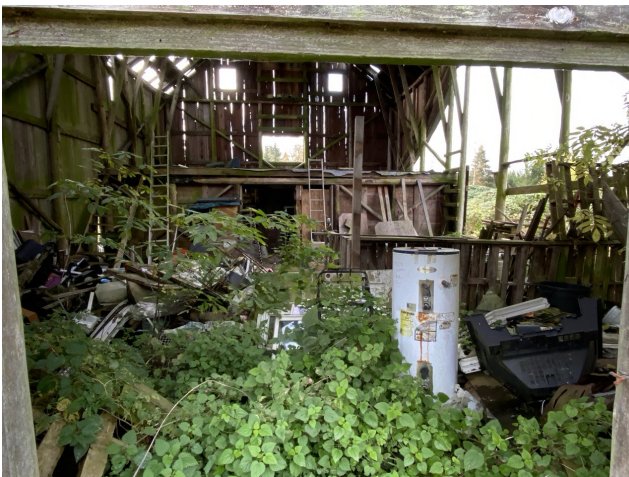
Photo 8 (Map Photo ID 198): Trash pile just north of Photo (7).

**Conclusion and Recommendation:** This parcel was mostly clean and doesn't appear to have any significant environmental concerns. All piles of junk should be removed and investigated for soil contamination, especially the areas with household appliances and chemicals. **Low Level of Risk that can be Mitigated.**

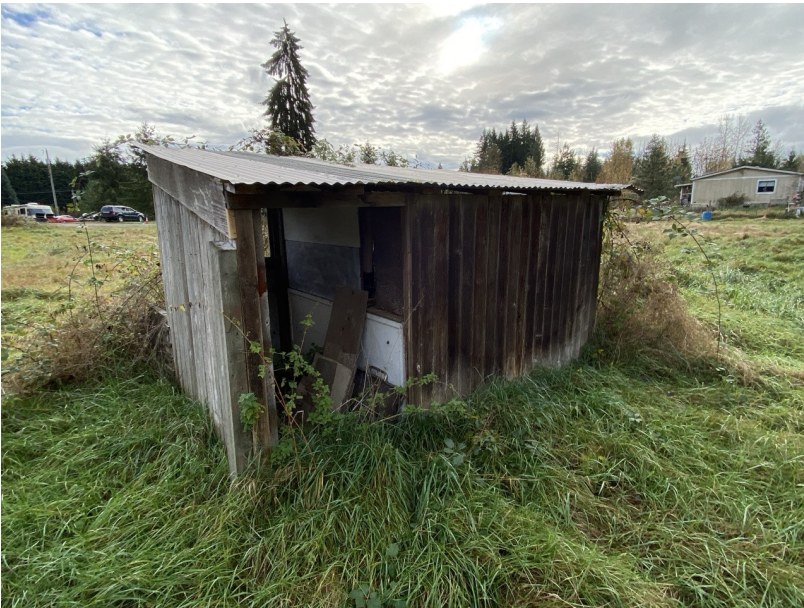
Photo 15 (Map Photo ID 199): An abandoned livestock trailer found northwest of the barn.

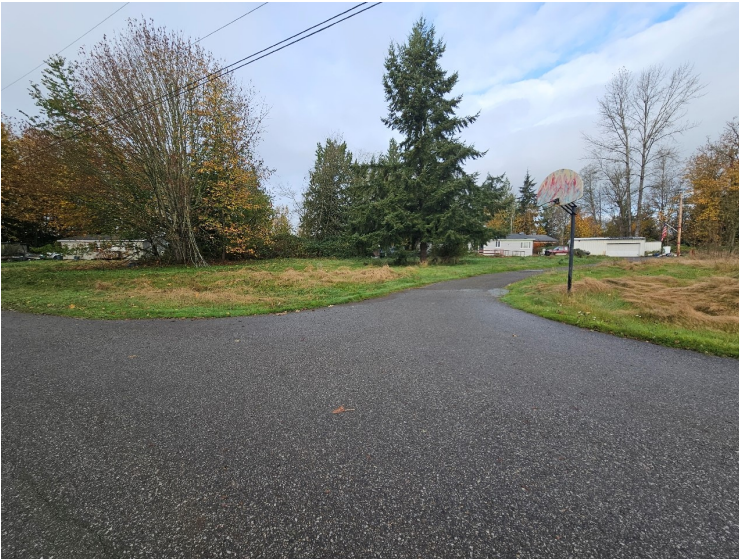
Photo 1 (Map Photo ID 193): The entrance onto the parcel off 246th NE.

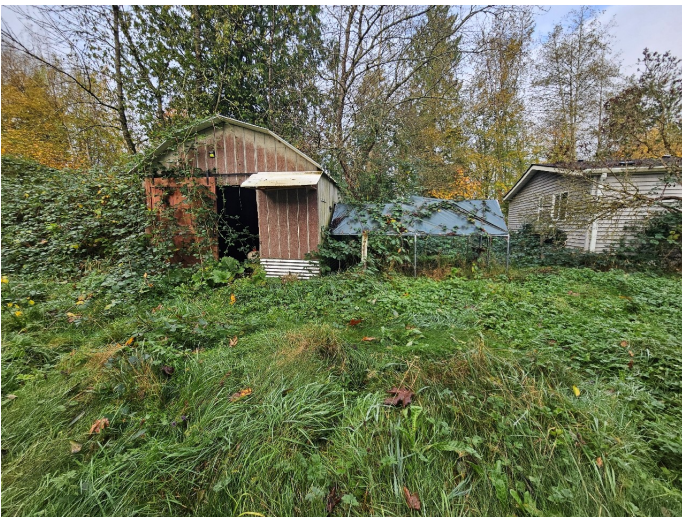
Photo 4 (Map Photo ID 188): Chicken coop near the western property line.

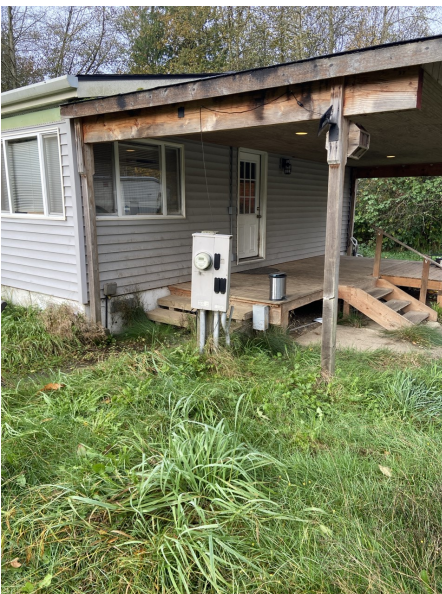
Photo 4 (Map Photo ID 187): Electric meter on the northeast corner of the main residence.

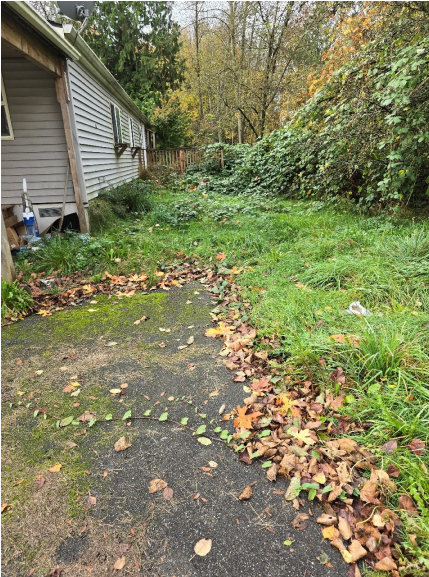
Photo 5 (Map Photo ID 186): Northside of the the main residence.

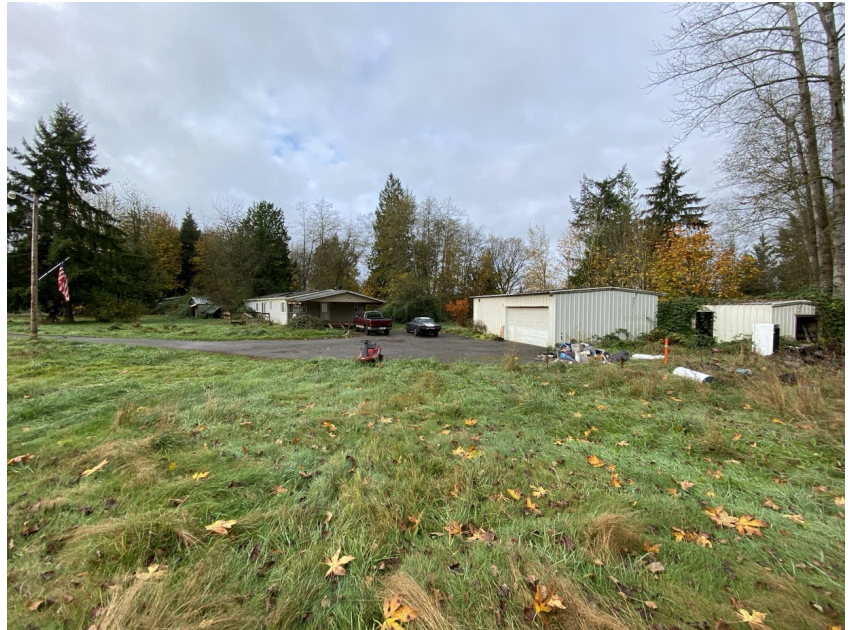
Photo 6 (Map Photo ID 181): Overview of the property, with a shop/garage in the midground and main residence in the background.

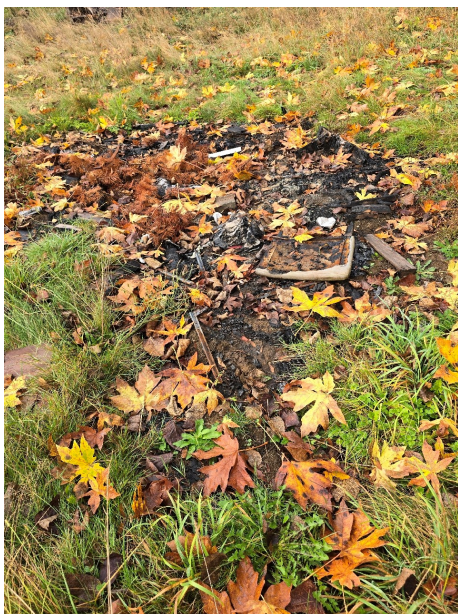
Photo 8 (Map Photo ID 182): Burn pile located just east of the garage/shop.

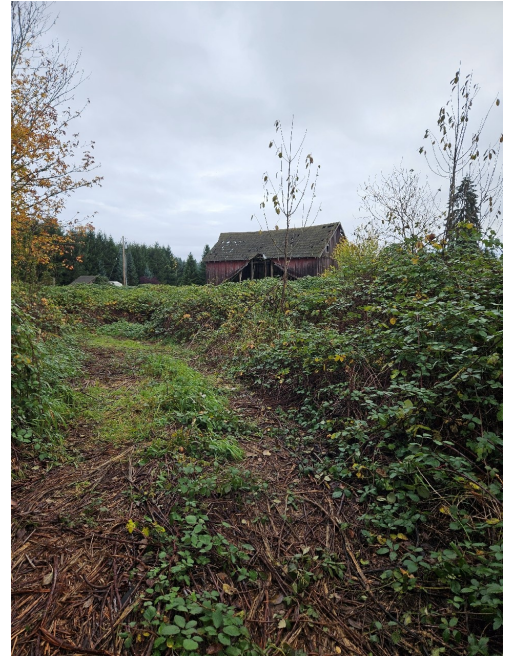
Photo 13 (Map Photo ID 175): Large blackberry patch which could conceal junk, vehicles, or other. This area should be investigated further. Photo taken looking east near the eastern property line.

**Conclusion and Recommendation:** This parcel was mostly clean and doesn't appear to have any significant environmental concerns. All piles of junk should be removed and investigated for soil contamination. The large blackberry bush along the eastern property line should be investigated to ensure hidden junk, structures, or cars aren't hidden. **Low Level of Risk that can be Mitigated.**

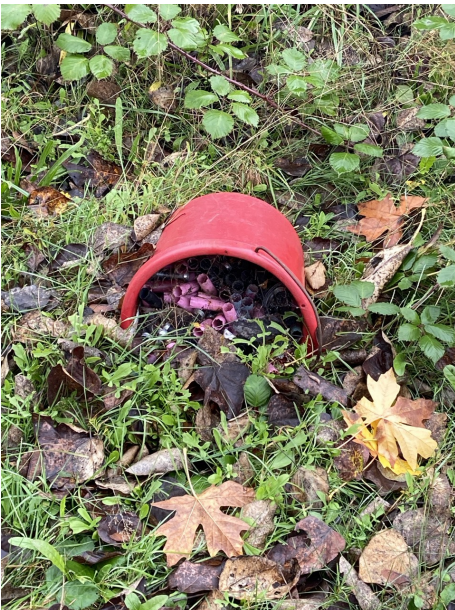
Photo 14 (Map Photo ID 178): Bucket of shotgun shells just north of the new pump house.

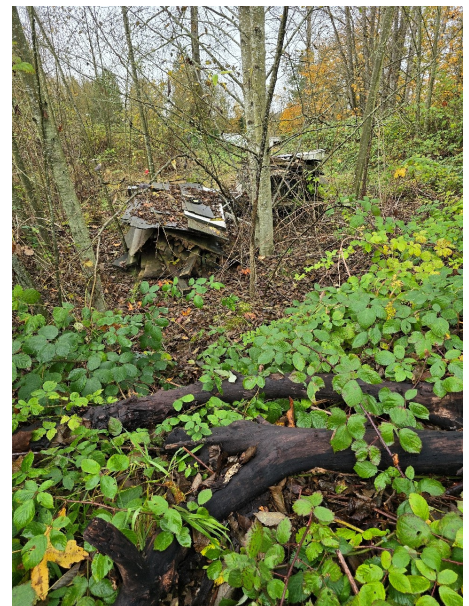
Photo 15 (Map Photo ID 174): Various junk spread throughout the forest along the eastern property line.

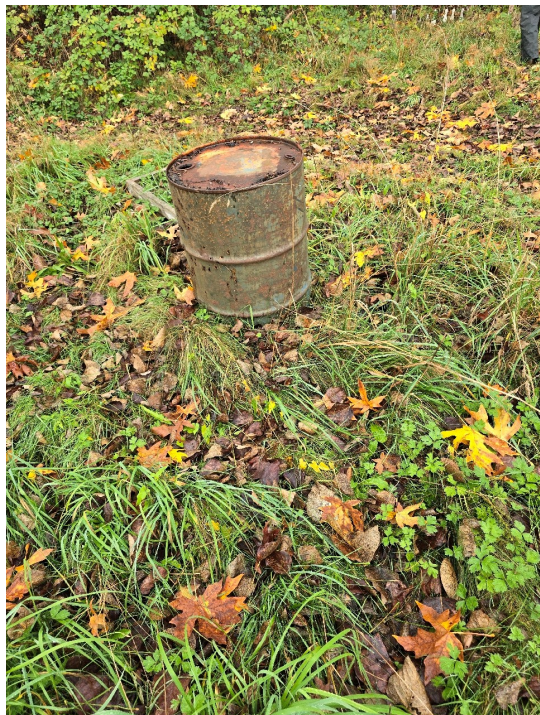
Photo 16 (Map Photo ID 176): Empty 55-gallon drum near the center of the property.

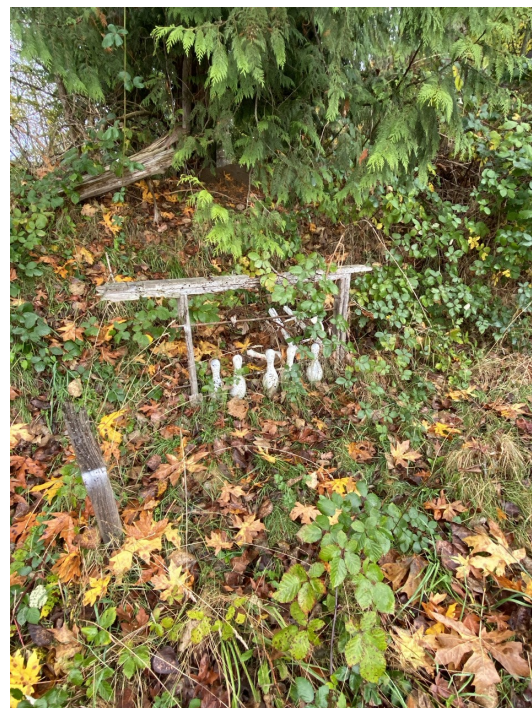
Photo 17 (Map Photo ID 177): Shooting back-stop near the center of the property.

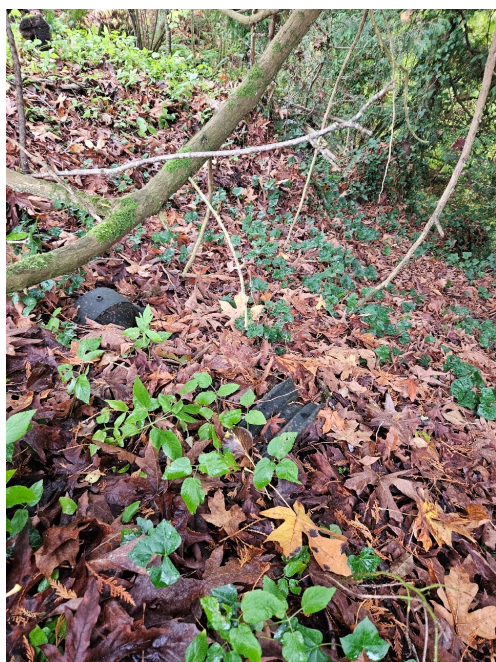
Photo 18 (Map Photo ID 172): Old car/truck axel in the forest along the eastern property line.

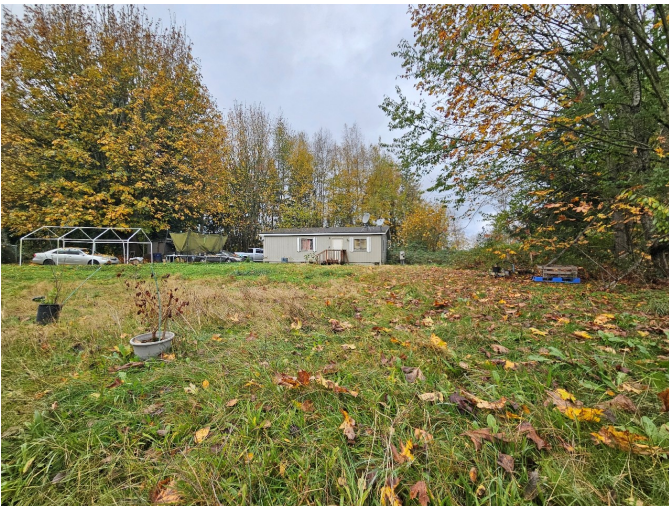
Photo 1 (Map Photo ID 218): Overview of the property as viewed from the front yard off 246th St NE.

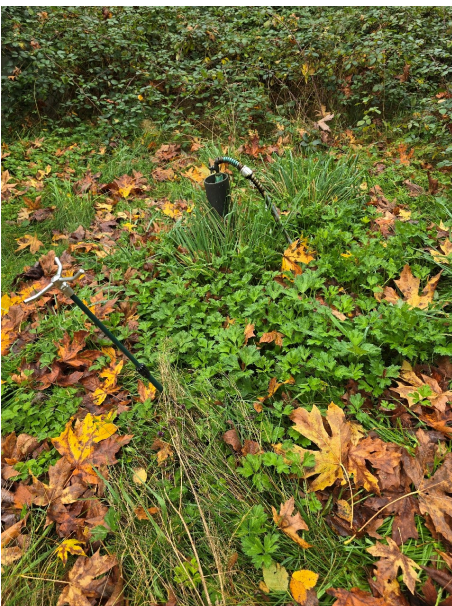
Photo 5 (Map Photo ID 222): Outdoor spigot on the north side of the house.

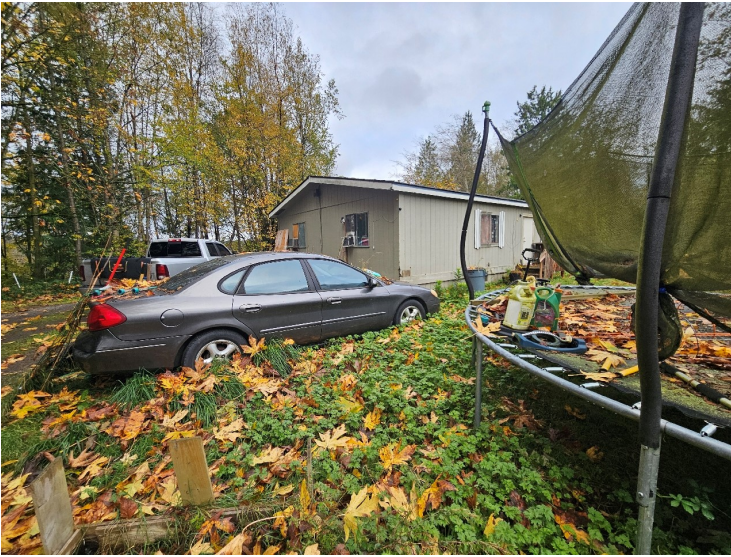
Photo 6 (Map Photo ID 220): Southern corner of the house. Lawn chemicals were seen stored on the trampoline.

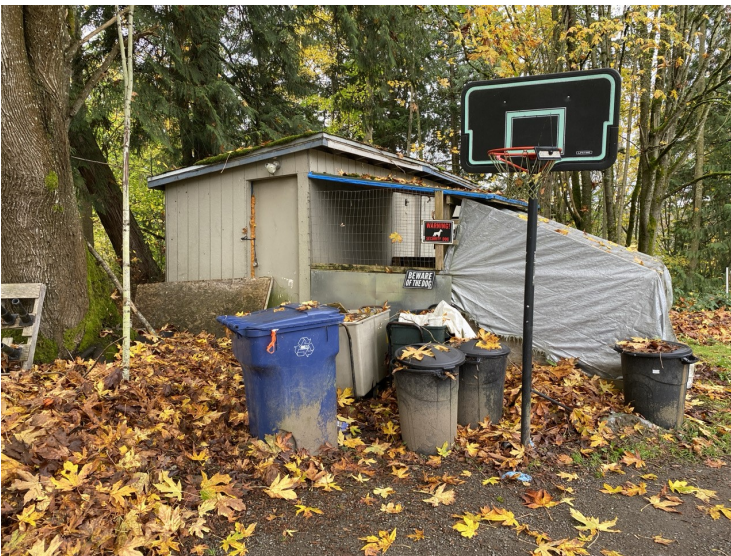
Photo 7 (Map Photo ID 221): Western driveway of the house, looking north. A small shed/dog kennel can be seen in the background.

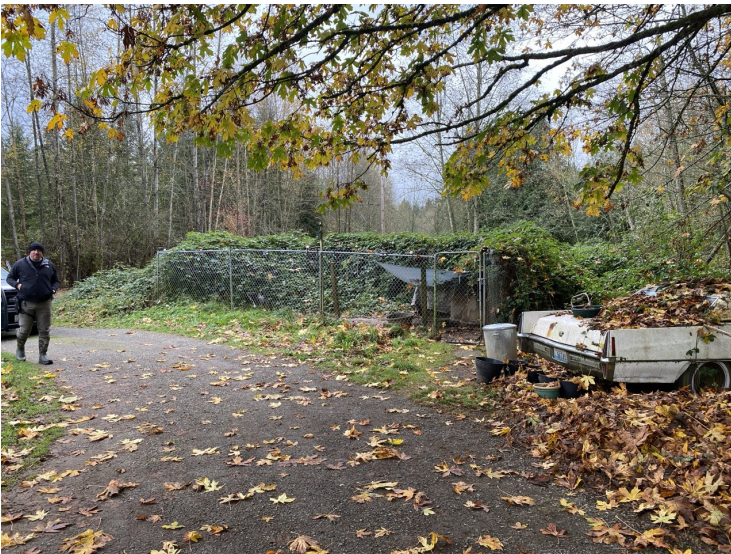
Photo 8 (Map Photo ID 221): Western driveway of the house, looking south. A broken down car and another larger kennel can be seen in the background.

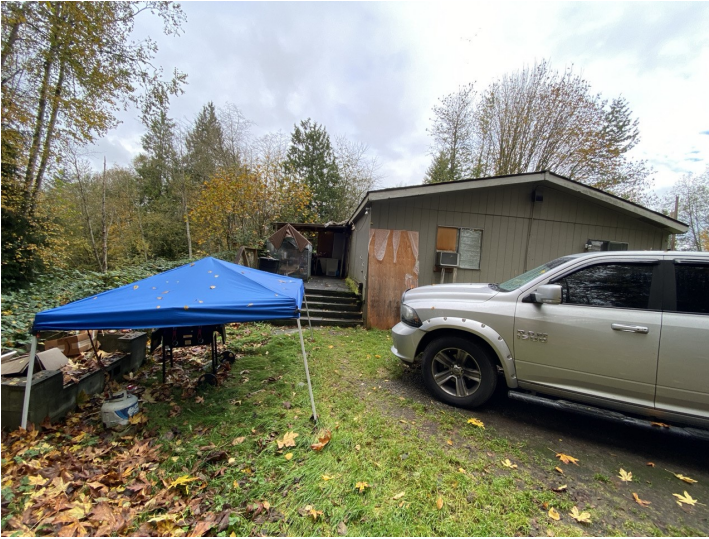
Photo 9 (Map Photo ID 224): Terminus of the driveway and a look at the northwestern side of the house. A pop-up canopy grill station can be seen.

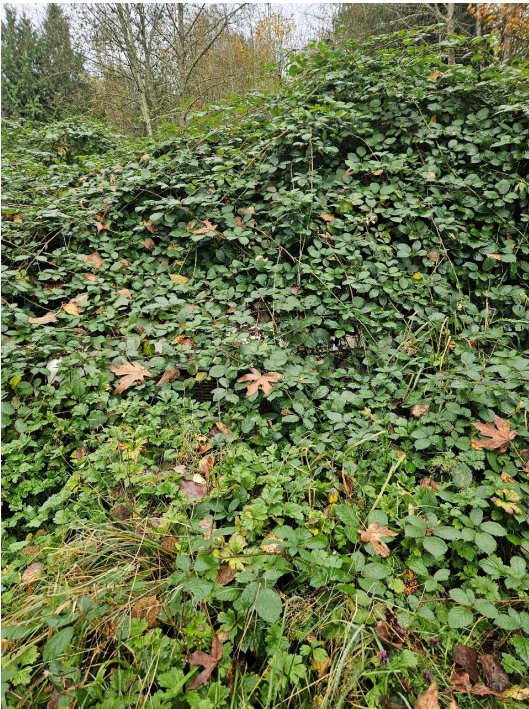
Photo 10 (Map Photo ID 226): A car hidden under blackberries near the driveway entrance.

**Conclusion and Recommendation:** This parcel was mostly clean and doesn't appear to have any significant environmental concerns. All piles of junk should be removed. The large blackberry bush along the driveway should be investigated for junk and the broken down car should be removed and soil should be investigated for contamination. **Low Level of Risk that can be Mitigated.**

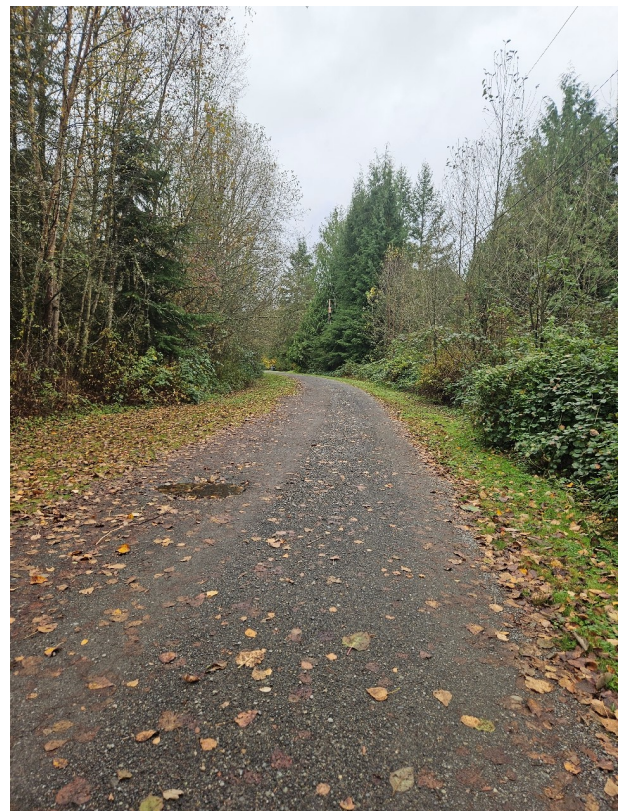
Photo 11 (Map Photo ID 227): Looking down the property line that runs (right) along 246th St NE.

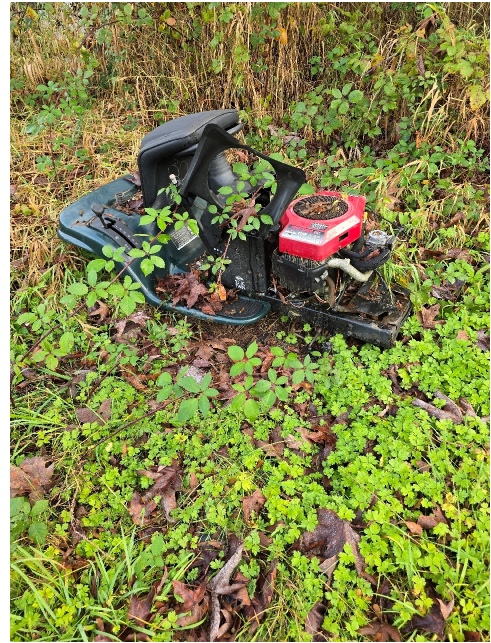
Photos 6 (Map Photo ID 213): A broken down riding lawnmower just south of the two storage sheds.

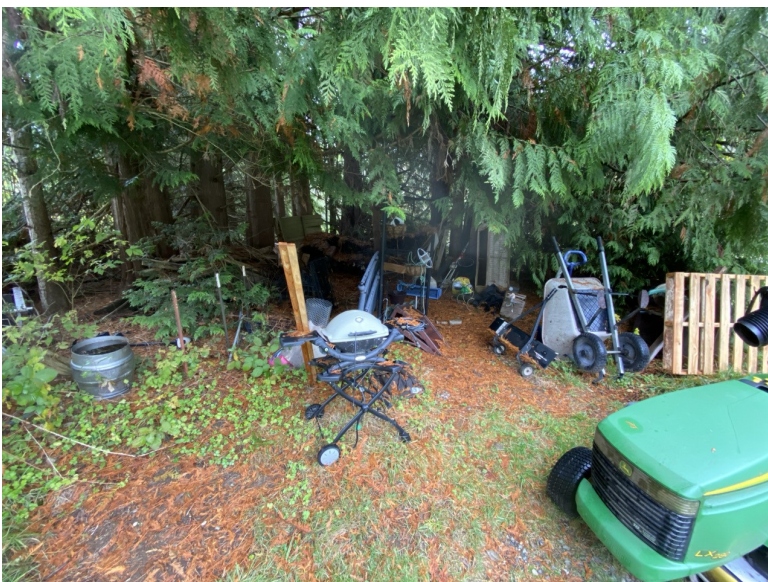
Photo 2 (Map Photo ID 233): Lawn equipment and various refuse under a cedar tree in the front yard of the house.

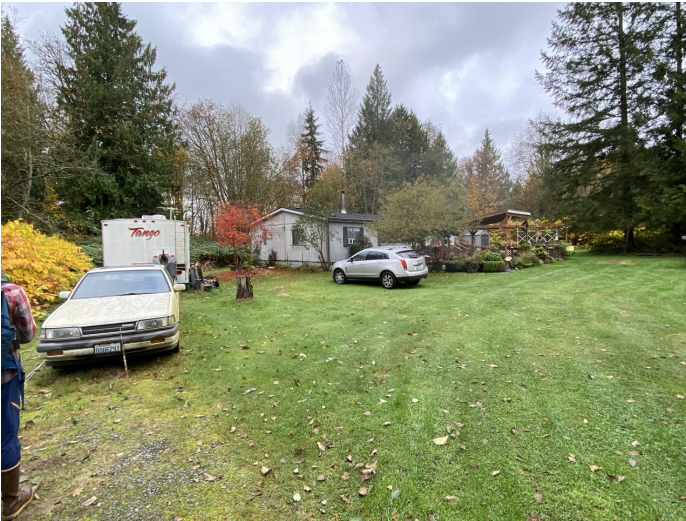
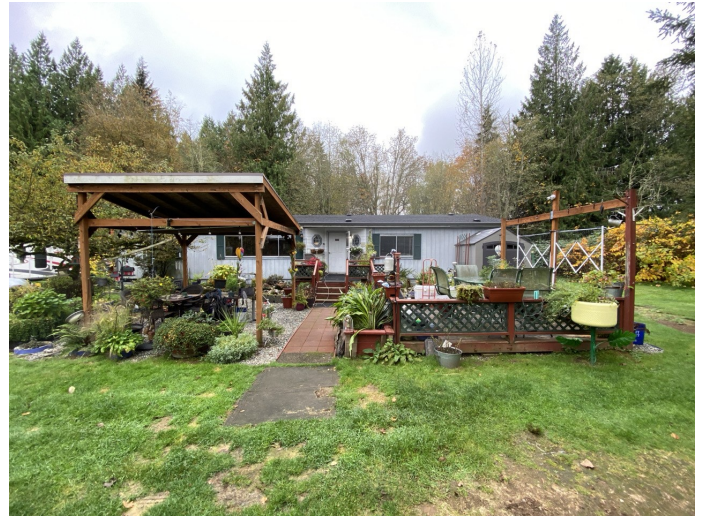
Photo 6-8 (Map Photo ID 229): Overview of the front yard (east) and side yard (north). Typical household items were seen, no issues.

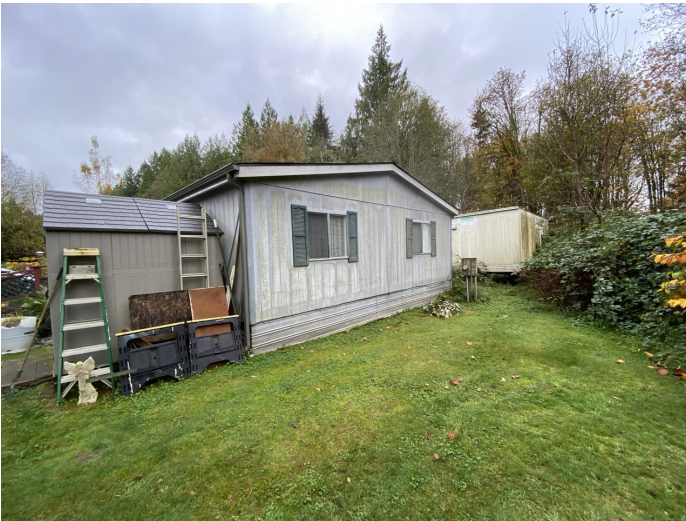
Photo 9 (Map Photo ID 231): Another view of the south side of the house, a pile of junk was seen along the blackberry bush.

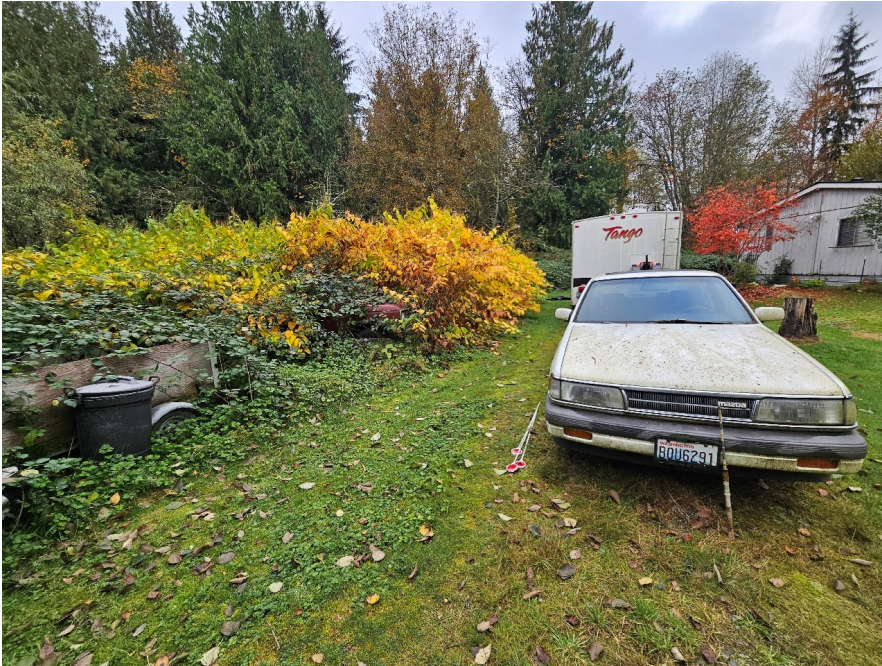
Photo 10 (Map Photo ID 230): Another view of the south side of the house. An old car, a trailer, and a vehicle and utility trailer being consumed by blackberries were located. No obvious signs of contamination were present.

**Conclusion and Recommendation:** This parcel had broken down cars and smaller concentrations of junk and general refuse. All broken down cars should be removed and checked for soil contamination. Blackberry bushes should be further investigated to ensure more junk, cars, etc. aren't hidden. All other junk should be properly disposed. Overall, this property has a **Low Level of Risk that can be Mitigated.**

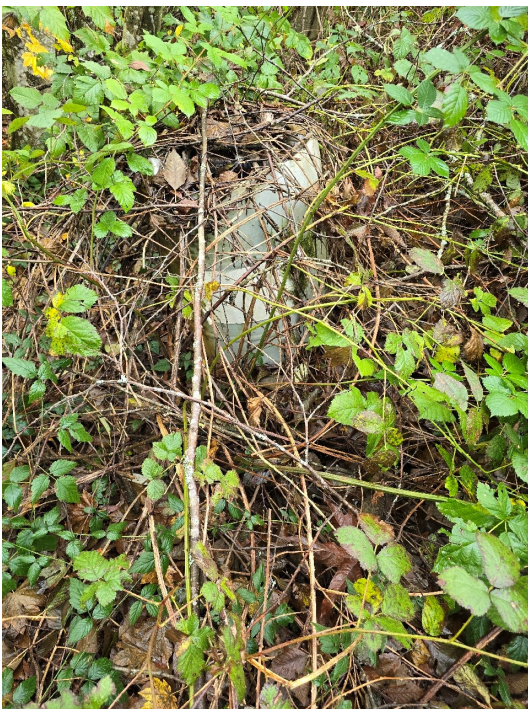
Photo 10 (Map Photo ID 232): A 55-gallon barrel filled with unknowns located near the eastern property line.

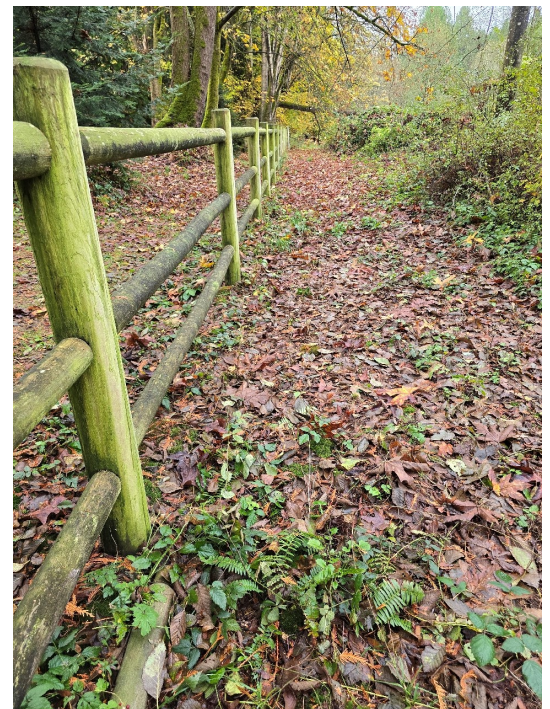
Photo 11 (Map Photo ID 235): The eastern property line, looking south.

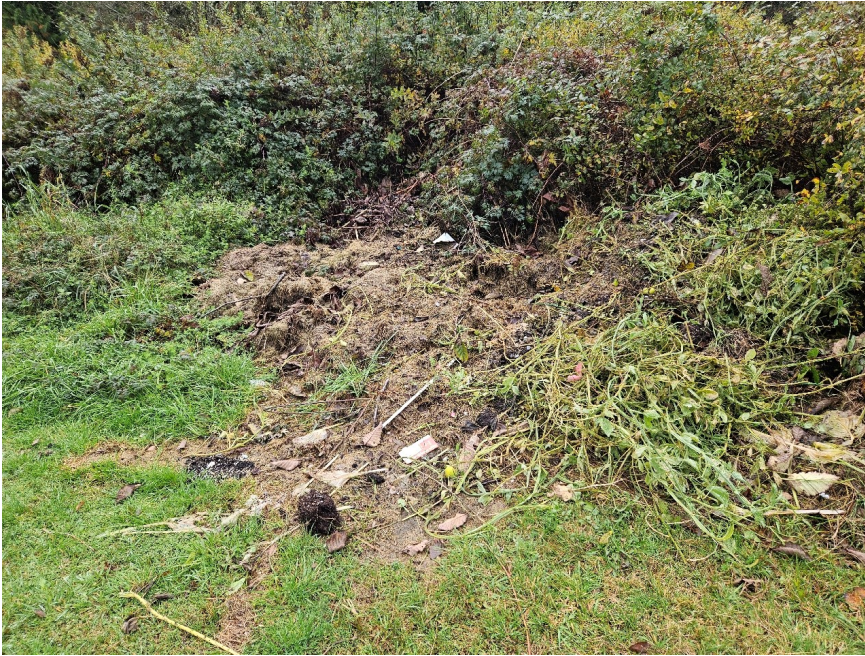
Photo 12 (Map Photo ID 239): A compost pile near the center of the property. Most of this area is a meadow. The western portion of the meadow is a wetland.

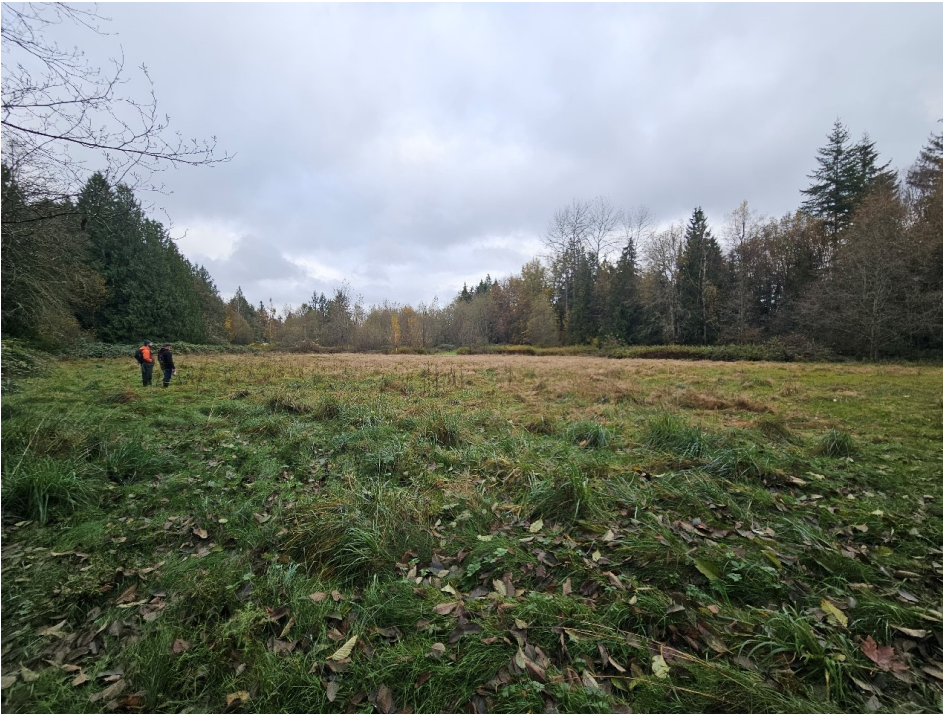
Photo 14 (Map Photo ID 242): Looking across the meadow which makes up the majority of the southern portion of the parcel. Photo taken looking north towards the house. No serious environmental concerns were seen.

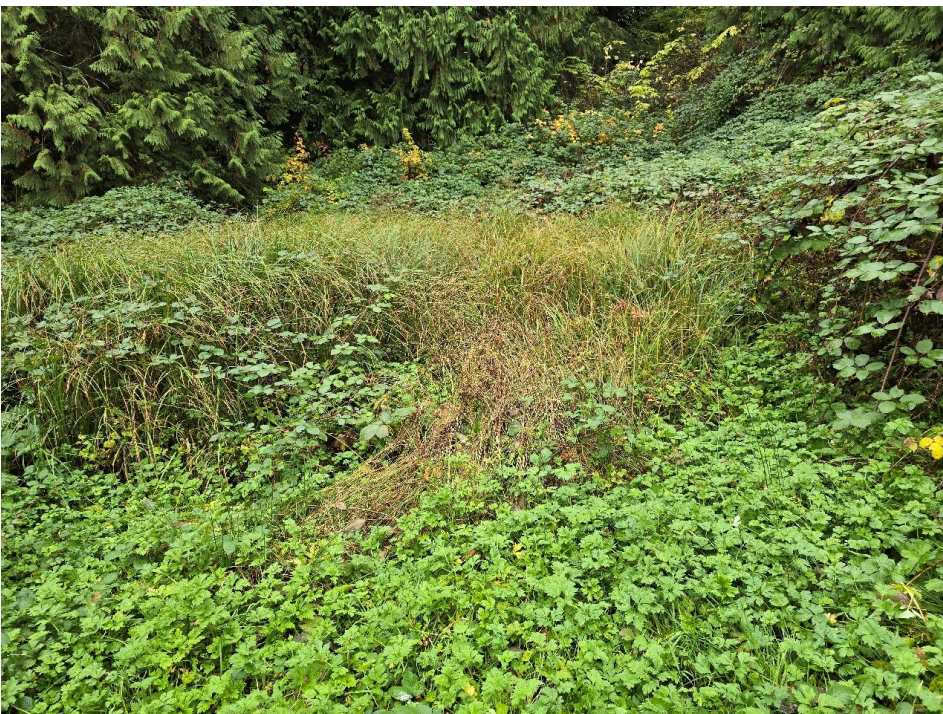
Photo 15 (Map Photo ID 240): A wetland near the southwestern corner of the property. Many wetland species of plants were seen.
