**Stillaguamish Tribal Response Program**

**2025 Public Record Packet Summary**

**Schultz Clan Property Site Assessment (Parcel 1)**

Assessment date: 10/29/2024

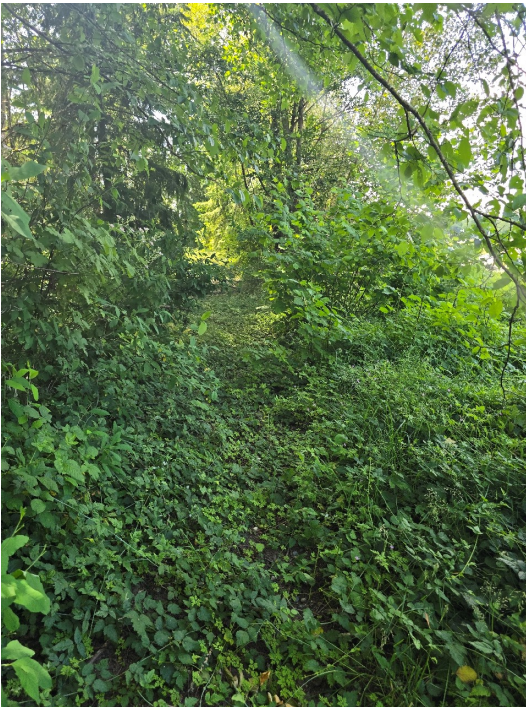
Photo 1 (map photo ID 250): Vegetated northern border of the property line along 268th St NW

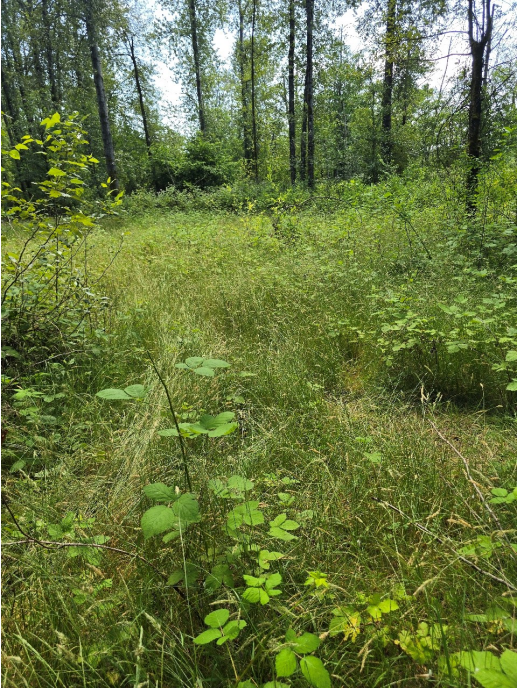
Photo 3: A 1300 square foot grass area near the center of the property.

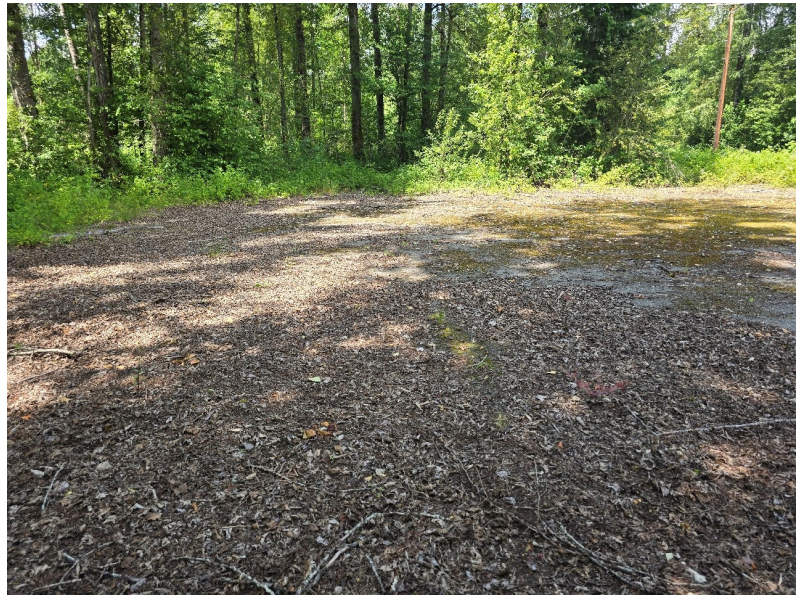
Photo 4 (map Photo ID 245): Cleared area looking north, adjacent to Dahl Road.

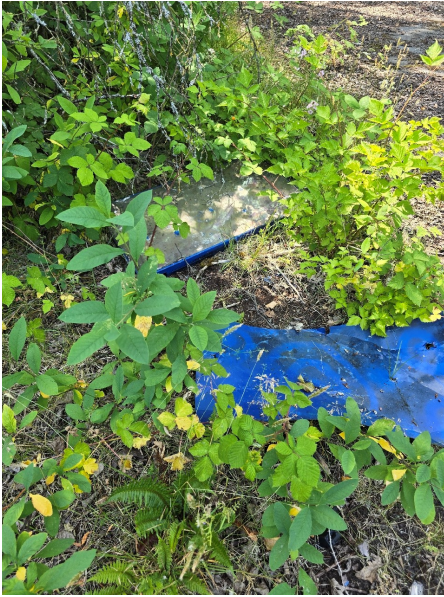
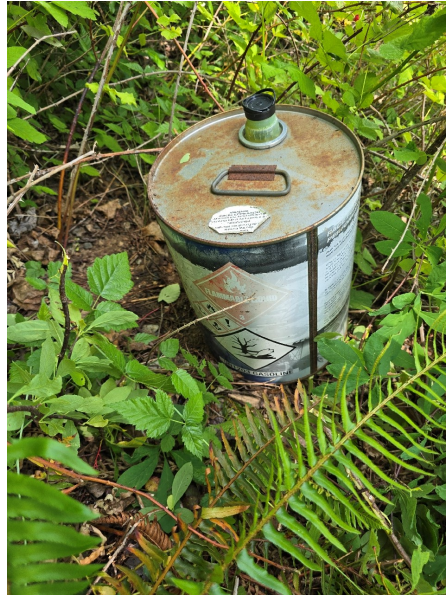
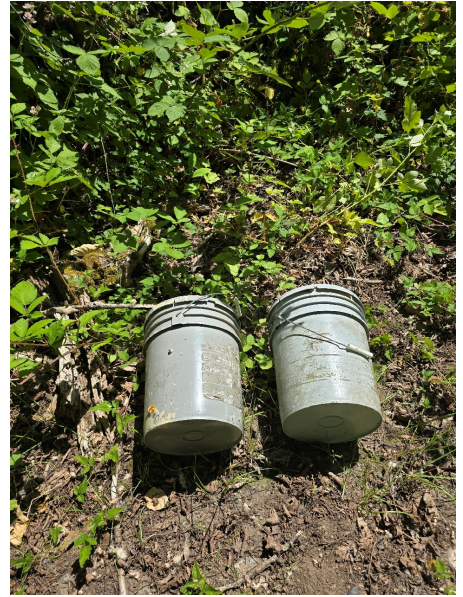
Photos 6-8 (map Photo IDs 251, 244, and 246, respectively): Various household garbage located just south of the cleared area adjacent to Dahl Road. All containers had no original product and only contained rainwater.

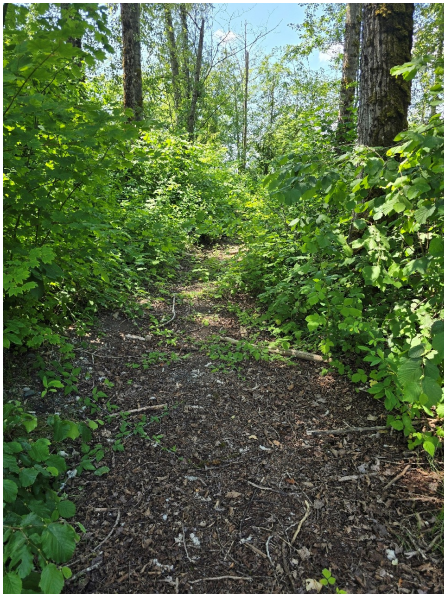
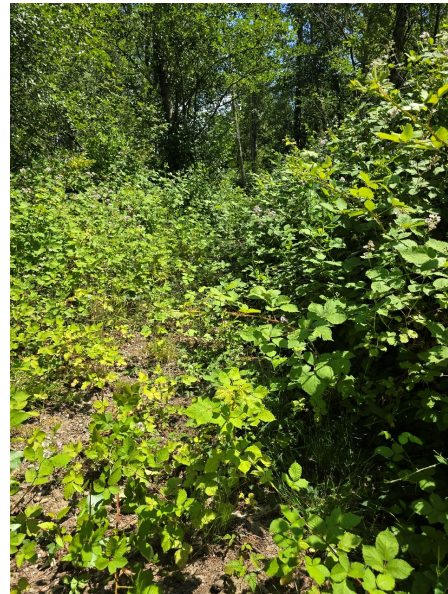
Photos 9 & 10 (map Photo IDs 247 and 249, respectively): A small trail that begins just east of the cleared area, terminating near the center portion of the property near the western property line.

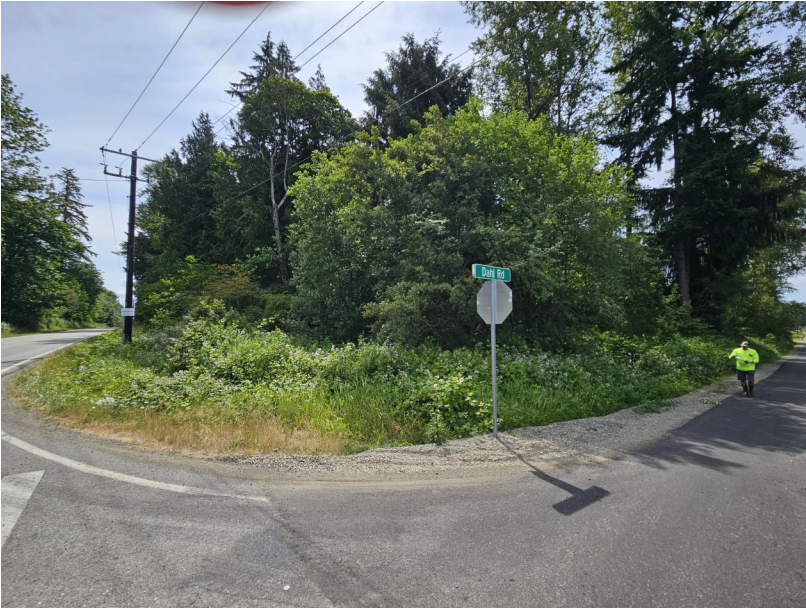
Photo 11: The northwest corner of the property at Dahl Road and 268th St NW, looking southeast.

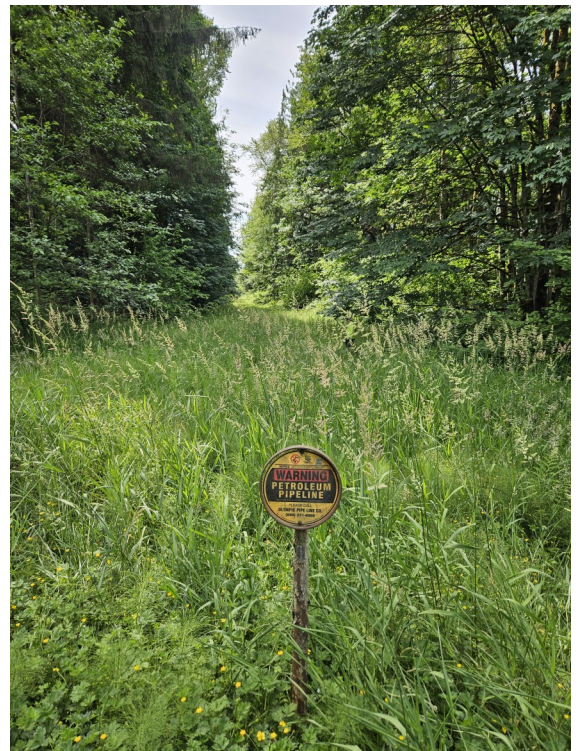
Photo 13: BP Olympic Pipeline corridor that enters the property near the northwest corner and exits halfway across the southern property line.

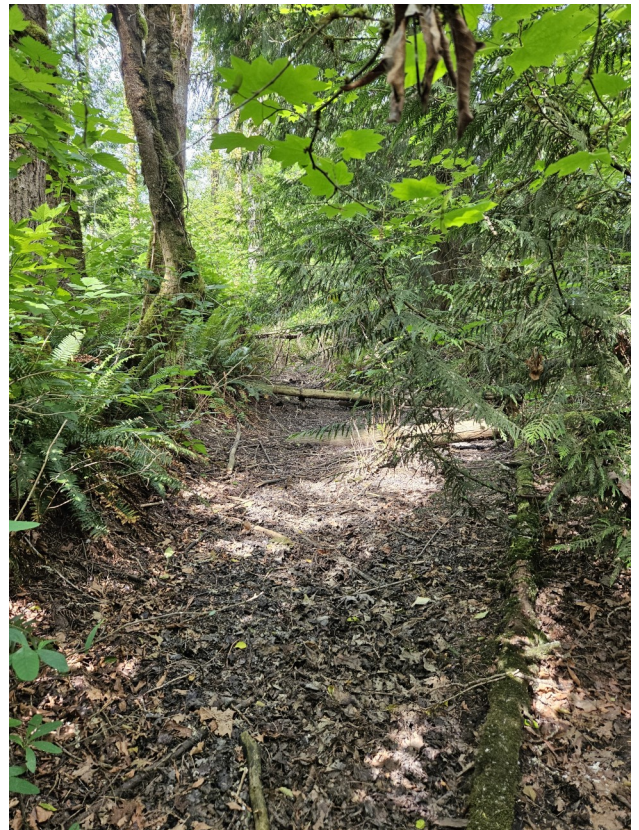
Photo 16 (map Photo ID: 253): Another wetland area, likely connected to the wetland in Photo 15.

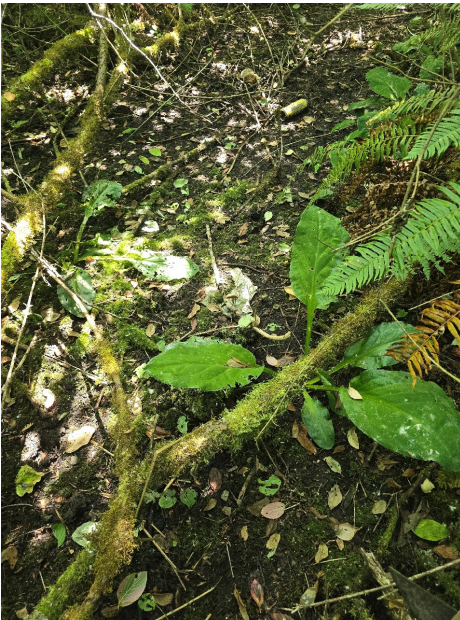
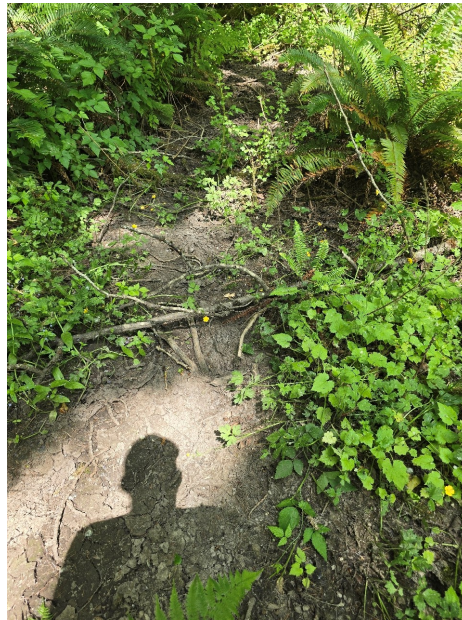
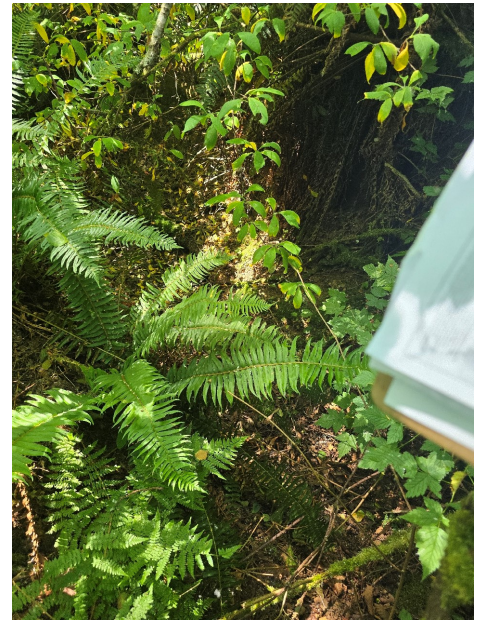
Photos 19-21 (map Photo IDs: 257, 256, 255, respectively): A channelized wetland system which begins near the northeast corner of the property and flows south, eventually turning west near the centerline of the property. This channelized system likely enters the large wetland complex near the center of the property.
